Trail Erosion Mitigation at the Fairfield Osborn Preserve

Katherine Bruzzone
Sonoma State University Preserves

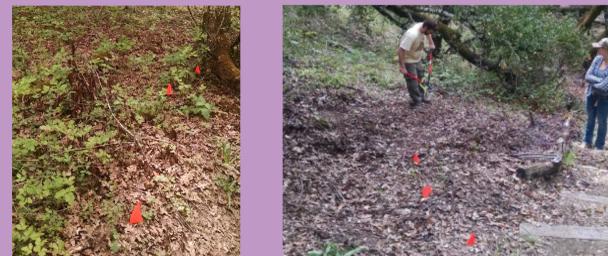
During a heavy rain event the water that flows over the staircase will cause the following issue:
 Decrease in water quality
 Loss of pore space in stream bed
 Soil loss
 Erosion
 Next to the trail worked on there is a small stream, and every time there is a heavy rain event the sediment-filled runoff flows into the stream. The sediments pollute the stream, and fill the pore spaces in the gravels and rocks that make up the bed. Soil is lost on the trail and it will become incised which creates safety issues. Also the area directly under the steps is eroded out, leaving a poorly supported structure that can seriously harm a visitor. Runoff must be diverted from the trail to prevent the continuation of these issues, and damaged steps must be replaced.

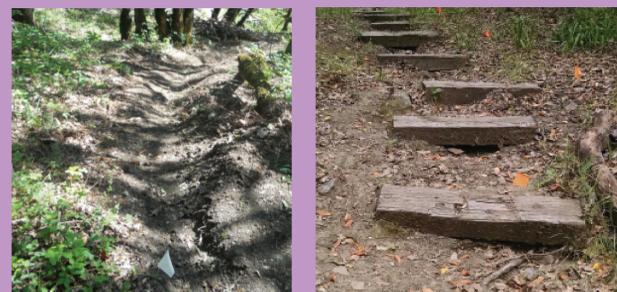
Step number	Erosion Along Horizontal Length	Undercutting Of Step	Additional Notes
1	3'4" wide, 6.5" deep		
2	3'6" wide, 9.5" deep	3"	3" eroded under step
3	3'3" wide, 6" deep	6"	Pooling for 2' in front of step
4	2'8" wide, 8" deep		
5	3' wide, 9" deep	2"	Most erosion occurring at left side of step
6	2'11" wide, 6" deep		Looks sunken, as if fallen from undercutting, but no visible undercutting
7	2'10" wide, 7" deep		Has been pushed forward, possibly due to force of flowing water
8	3'2" wide, 10.3" deep	3"	Pool 2" deep that extends to step 7
9	3' wide, 7" deep	2"	
10	3'11" wide, 8" deep		
11	3'3" wide, 11" deep		
12	4'6" wide, 10" deep	2"	Erosion mainly on right side, step is tilting to the right
13	5'10" wide, 11" deep	9"	Worst undercutting of all steps, occurring at the middle
14	5'10" wide, 7" deep		Has ant hill
15	3'7" wide, 10" deep		Large sediment deposit in front (filling space between 15&14)
16	3'6" wide, 10" deep	3.8"

17	3' wide, 7" deep		
18	2'8" wide, 8" deep	.5"	
19	2'6" wide, 5" deep		Water goes over step
20	2'5" wide, 4" deep

The bottom of the treatment area is 29'6" from the first step, distance traveled over the stairs is 41', and the treatment area extends to 49'3" from the last stair.
