Upper Rancheria Creek
Preliminary Bio-geomorphic Assessment

Prepared By: West Coast Watershed

Prepared For: Mendocino County Resource Conservation District

May 14, 2007

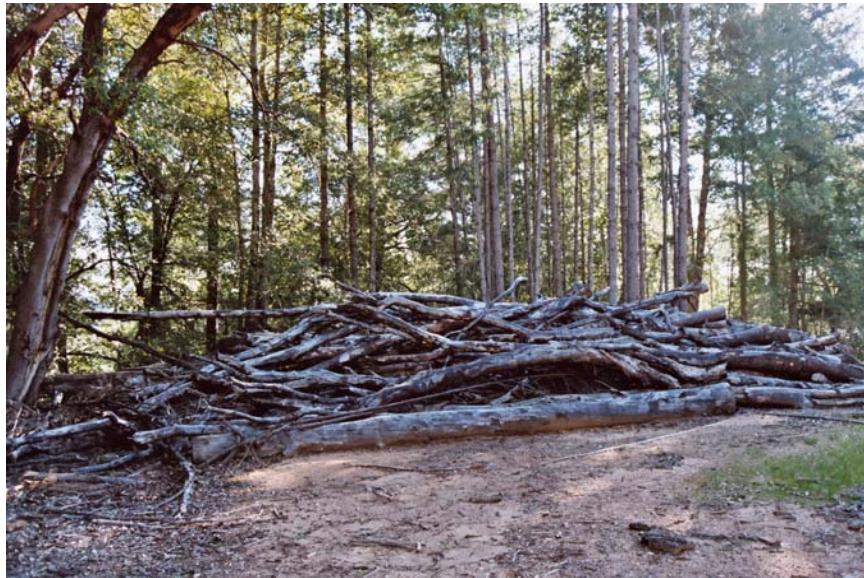
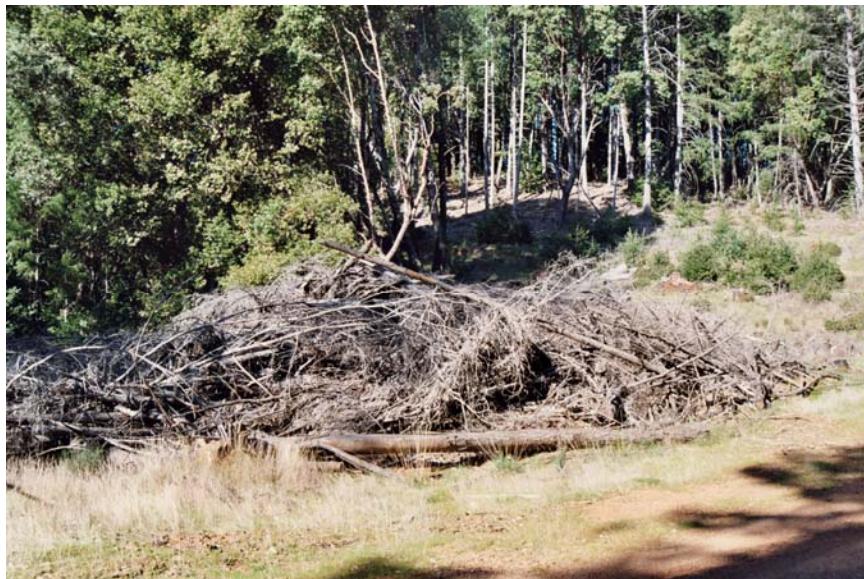
Photo Figure 2. Logging Debris Piles

There are several large debris piles on the Preserve that are comprised of large trees and slash (see photo figure 2). These are presumably remnants of a logging operation. These piles pose a fire hazard to the surrounding forest, and are aesthetically inconsistent with the Preserve's mission of wildland conservation.

The logs in the debris piles may be useful for augmenting pool formation and habitat in aquatic areas where LWD is limited. Once a riparian corridor assessment has been completed (see below) to determine pool frequency associated with LWD recruitment, a management recommendation may be the placement of large logs in stream to enhance pool formation and in-stream habitat values. The largest logs in the debris piles may be of sufficient size for this approach. The slash and smaller debris in the piles may be separated and spread into smaller piles throughout the Preserve as habitat for small mammals, insects and birds. This work can be accomplished with equipment, and/or by hand in areas where equipment will cause excess disturbance.

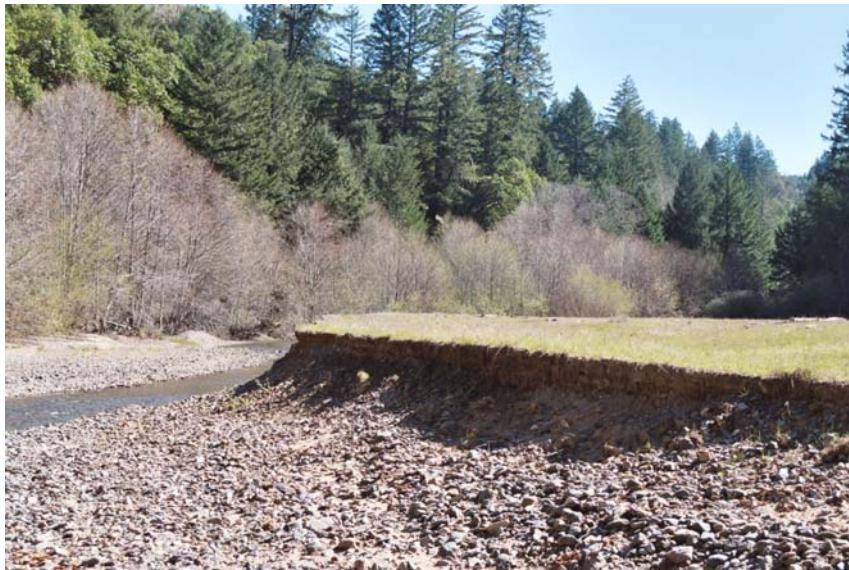
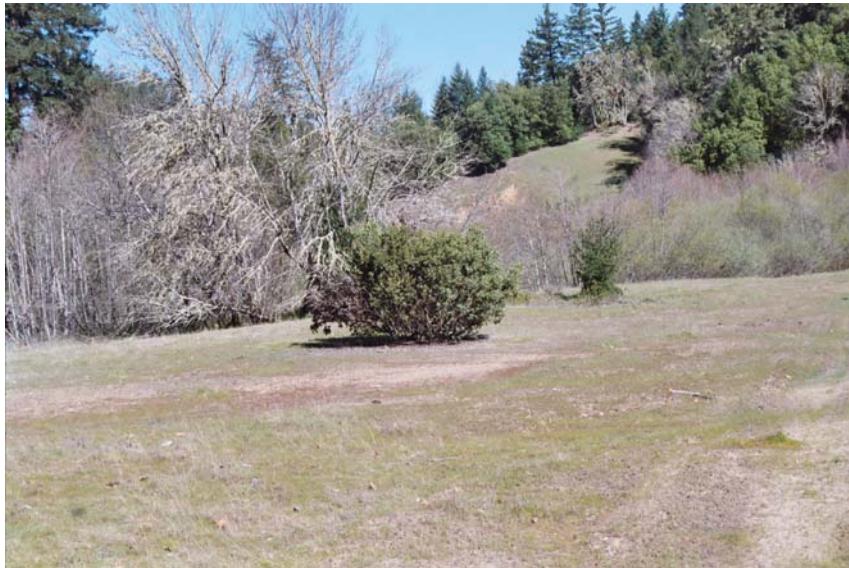
Photo Figure 3. Riparian Corridors

Floodplains - limited riparian vegetation

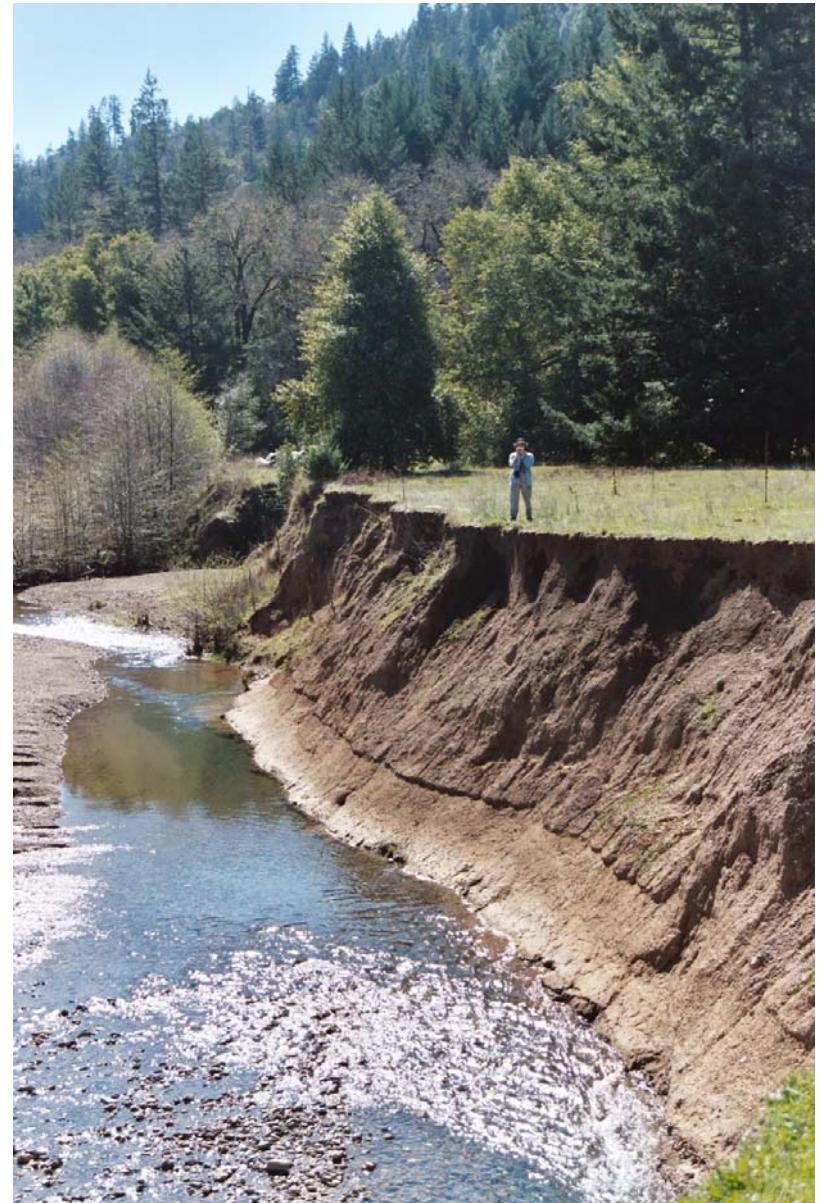
Bank Erosion. Bank erosion appears to be relatively significant source of sediment of fine material derived from erosion of the inactive terrace. Bank erosion is also active in some areas along floodplain channel margin. Some evidence of recent widening exists, with channels apparently recently cut into adjacent floodplain; recent bank erosion on channel-floodplain margin; and tension cracks along edge of floodplain.

Vertical banks – fine sediments

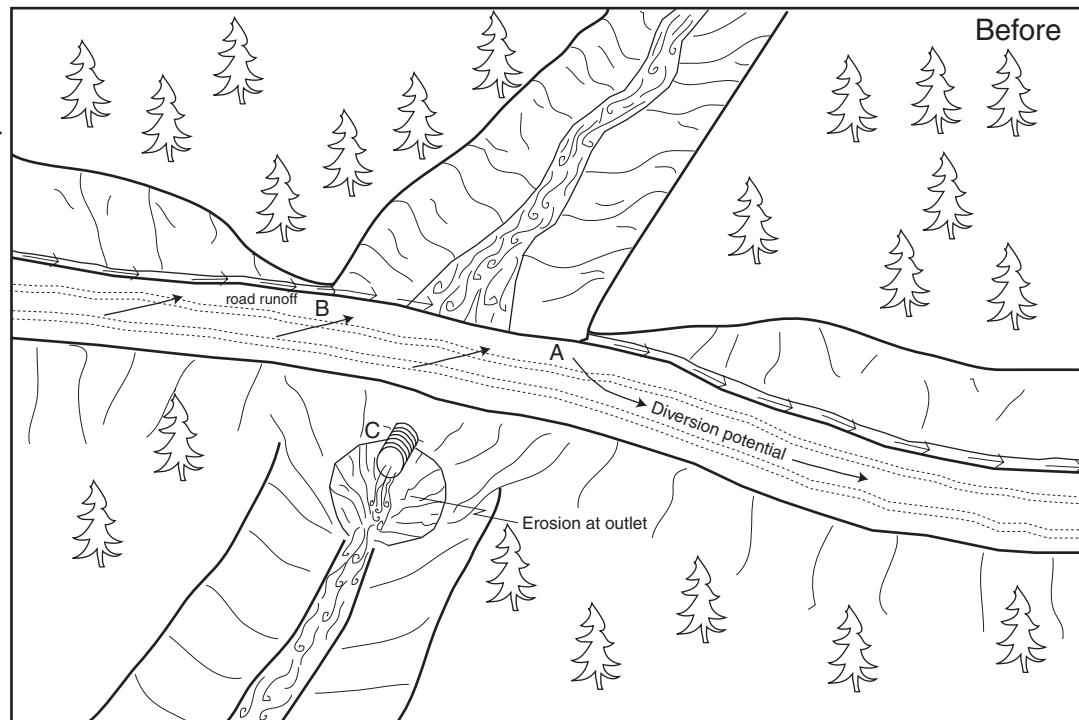
B - Road surface and
ditch drains
to stream

C - Undersized culvert
high in fill with
outlet erosion
