Monitoring stream erosion at Fairfield Osborn Preserve

Yadira Ramirez

Geography Department, Sonoma State University

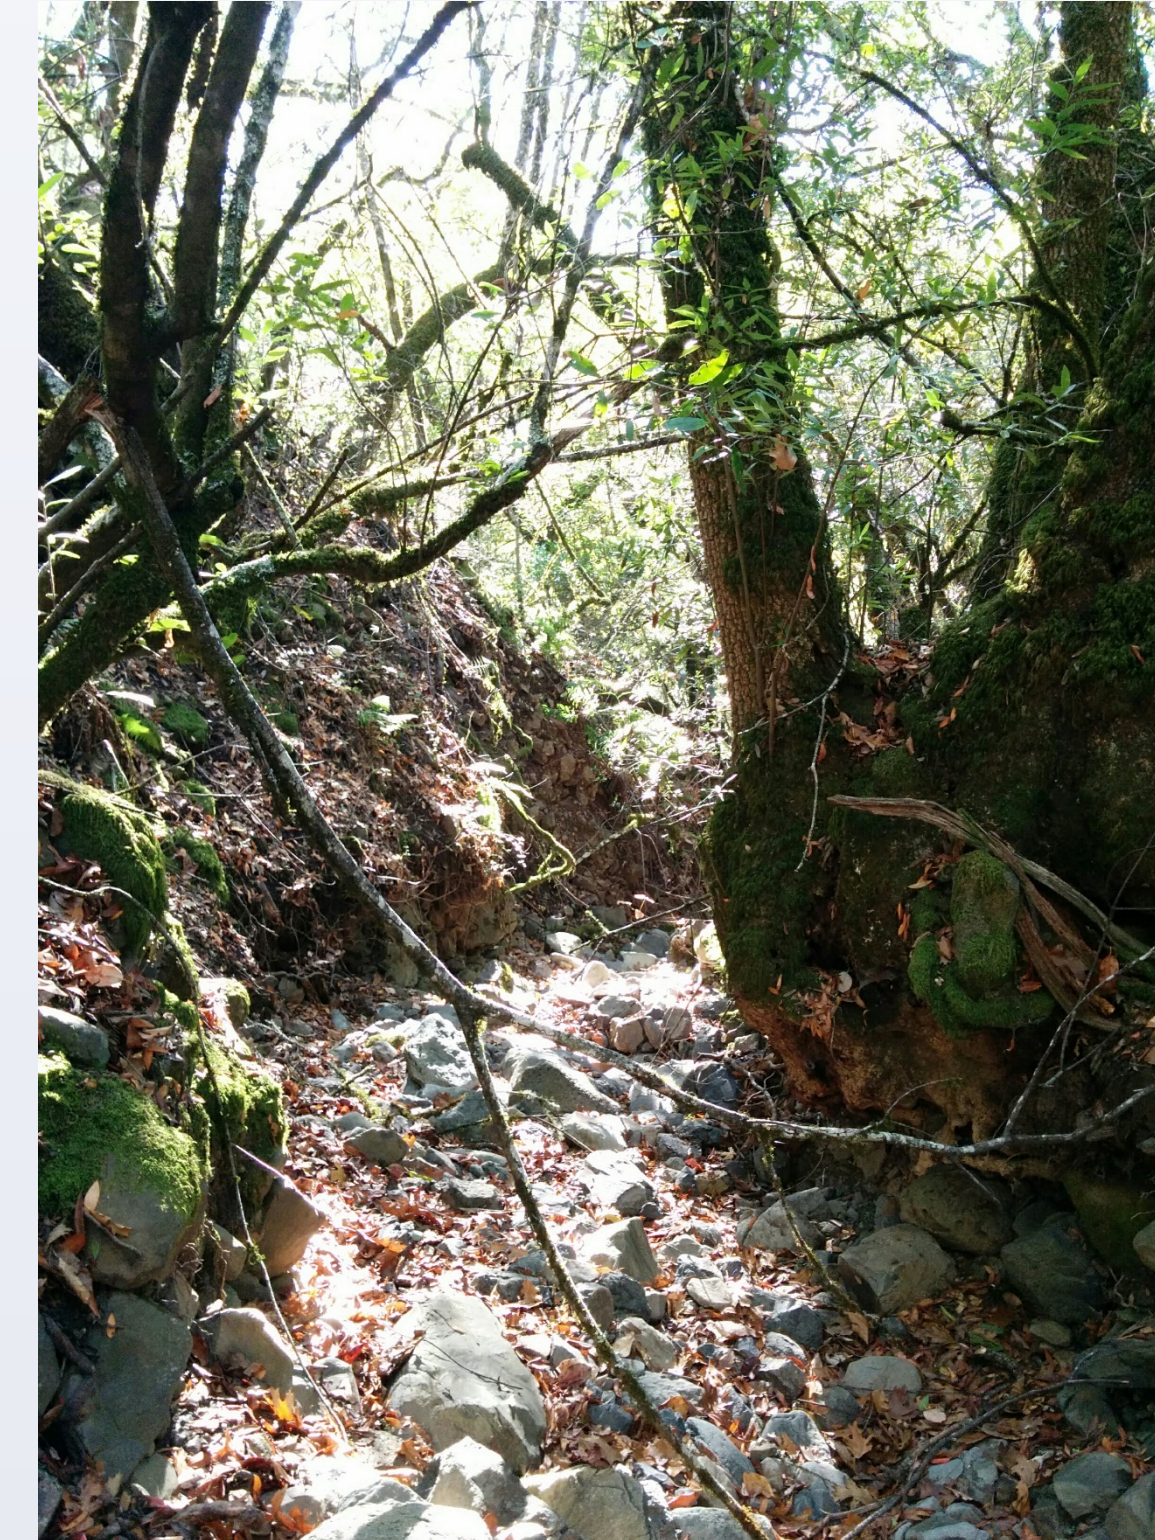
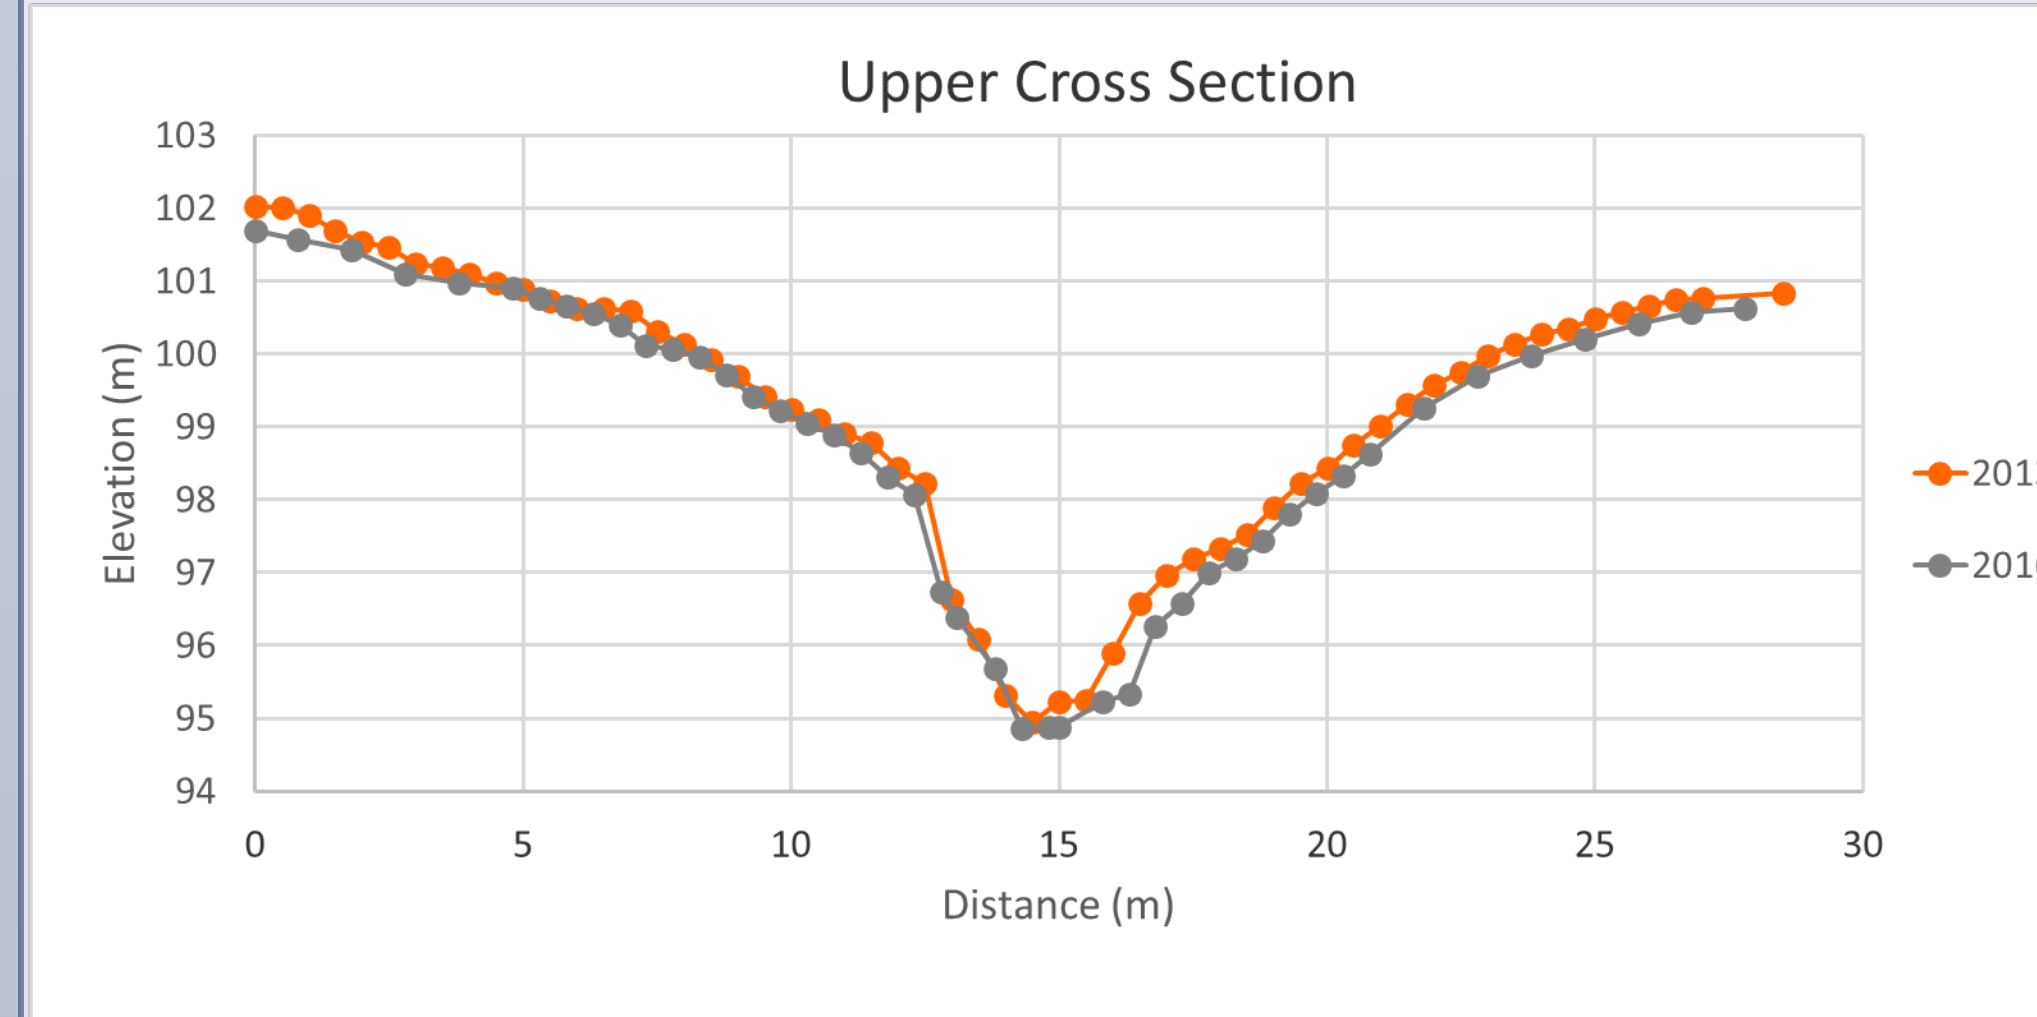
Figure 6

In the upper section, the Ephemeral Creek experienced slight erosion and bank cutting towards the North (0 m direction; Figure 6). In contrast, the lower section shows variable erosion and deposition occurred in this much shallower stream channel (Figure 7). Figure 8 shows the longitudinal profile for the creek, notice the downstream migration of a "plunge pool".

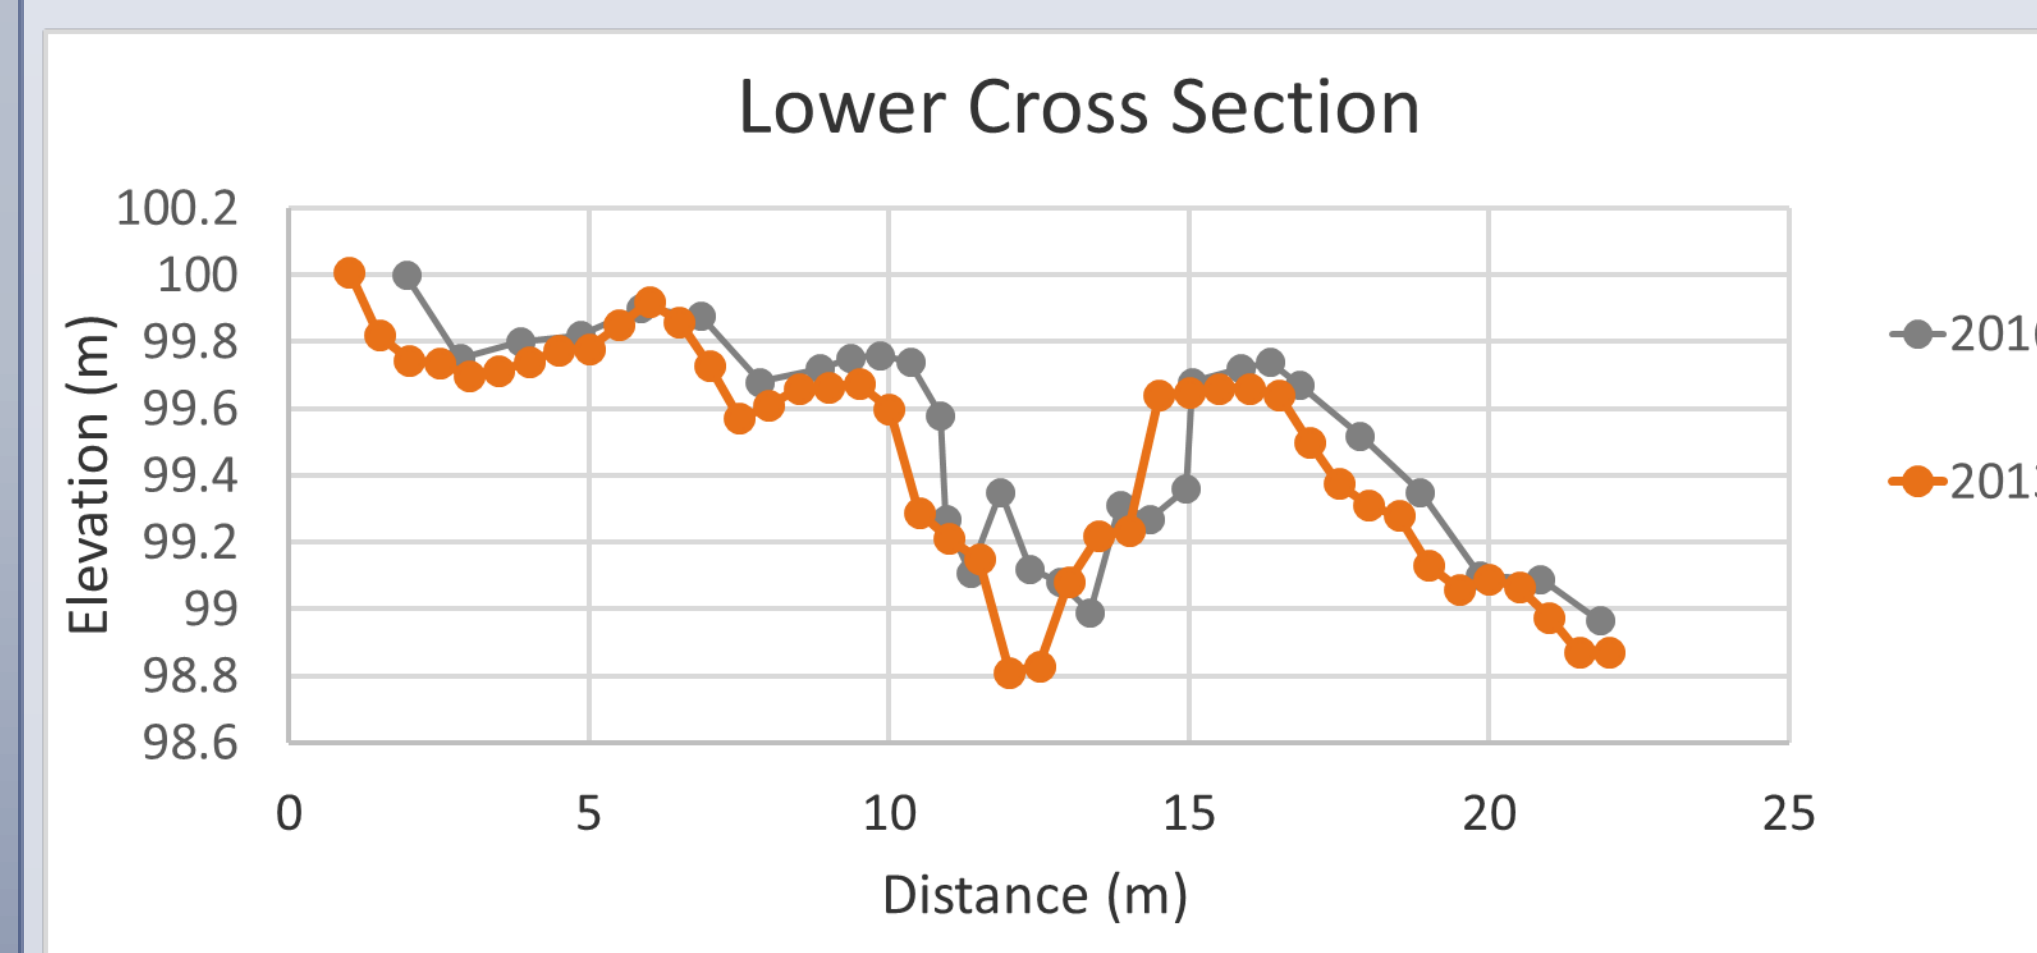
Figure 7

As of 2017, the Ephemeral creek has abandoned its old lower channel (Figure 7 and 10A) and is in the process of creating a new channel (Figure 10B). Previous erosion pin data indicate deposition on both banks as a result of discharge during extreme weather conditions. These pins are now buried or eroded away.

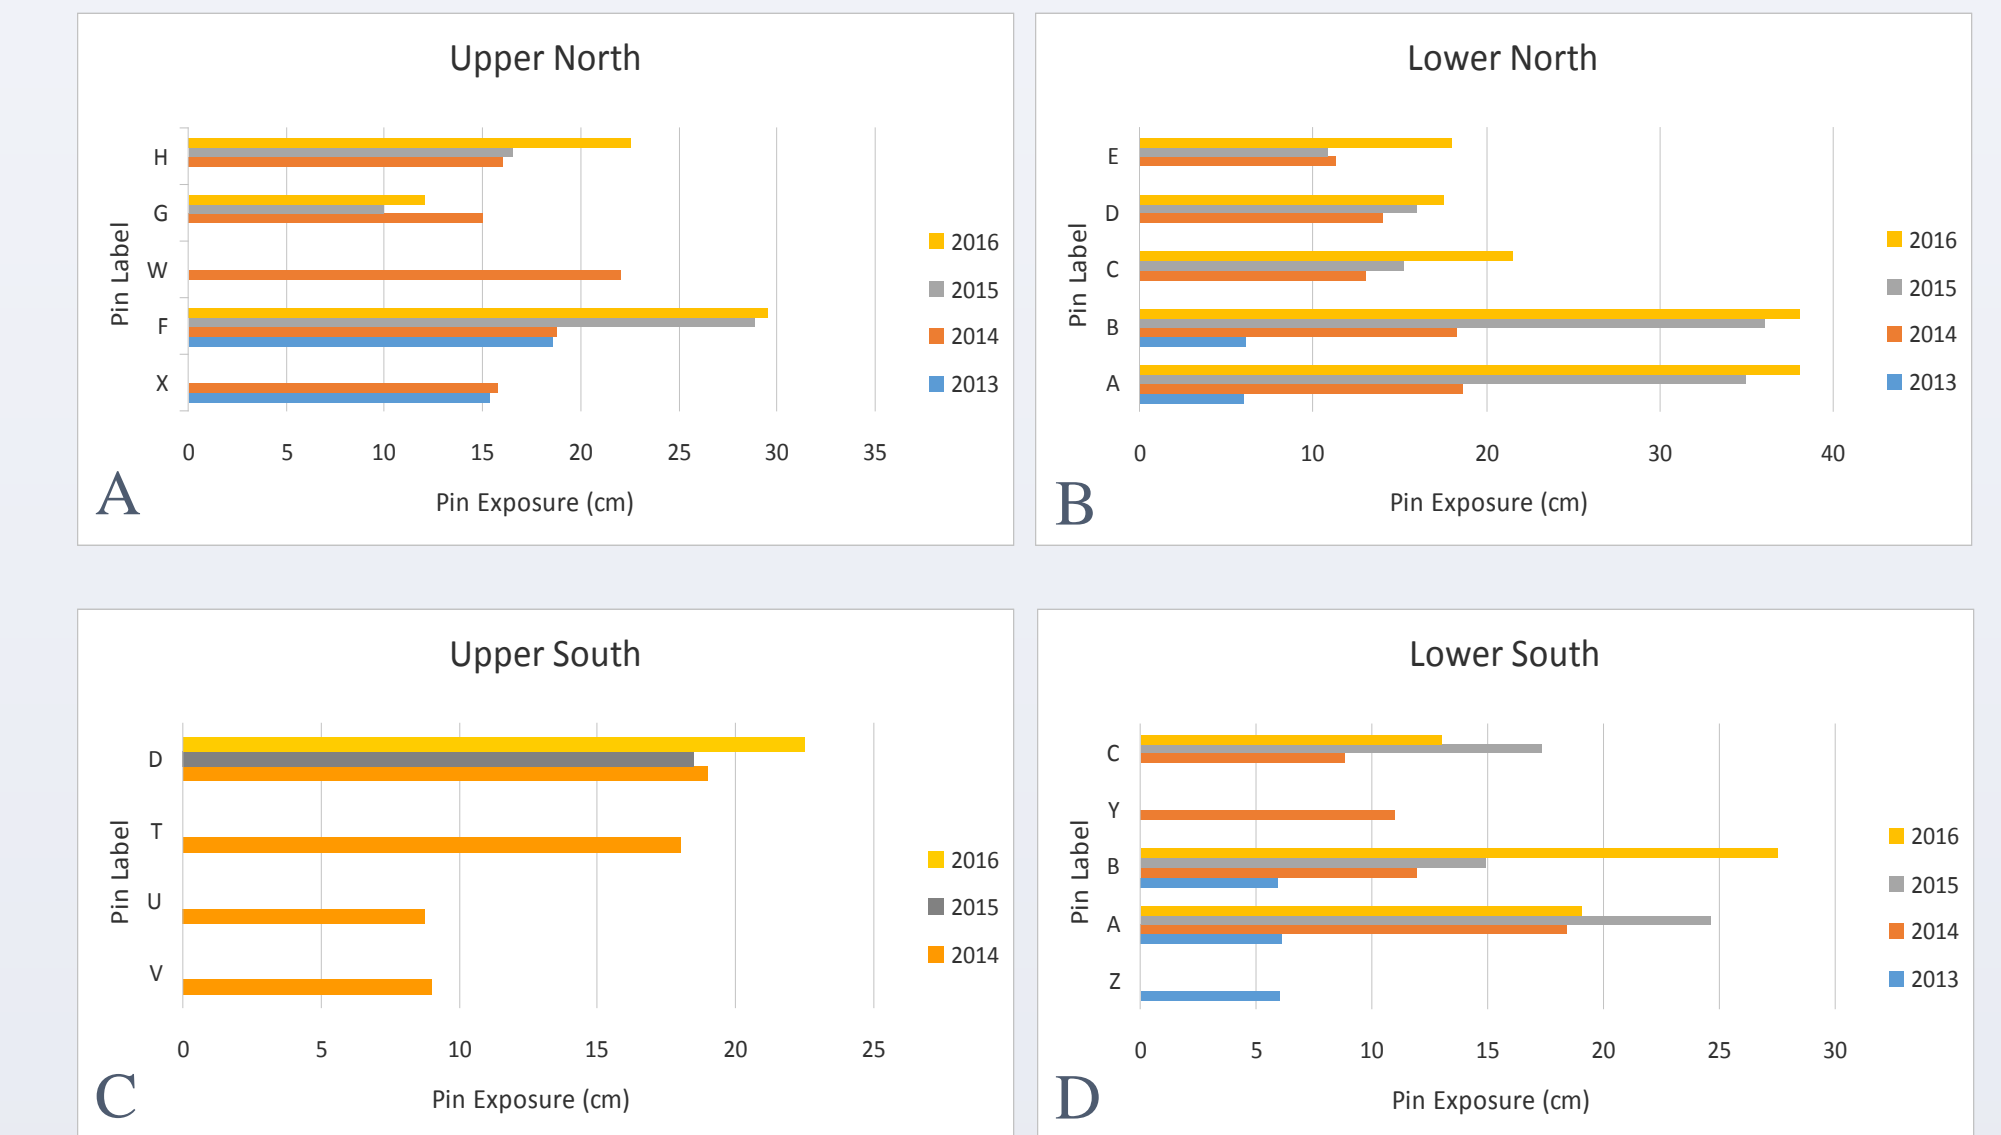
Figure 9

The monitored erosion pin data for the North bank shows significant increases in pin exposure, signifying major erosion on both sections, more so on the lower North of the creek (Figure 9A,B). All erosion pins, except D, for the upper South bank were not relocated, likely due to erosional removal. Pin D, however, shows slight erosion (Figure 9C). The lower section of the
