Upper Rancheria Creek
Preliminary Bio-geomorphic Assessment

Prepared By: West Coast Watershed

Prepared For: Mendocino County Resource Conservation District

May 14, 2007

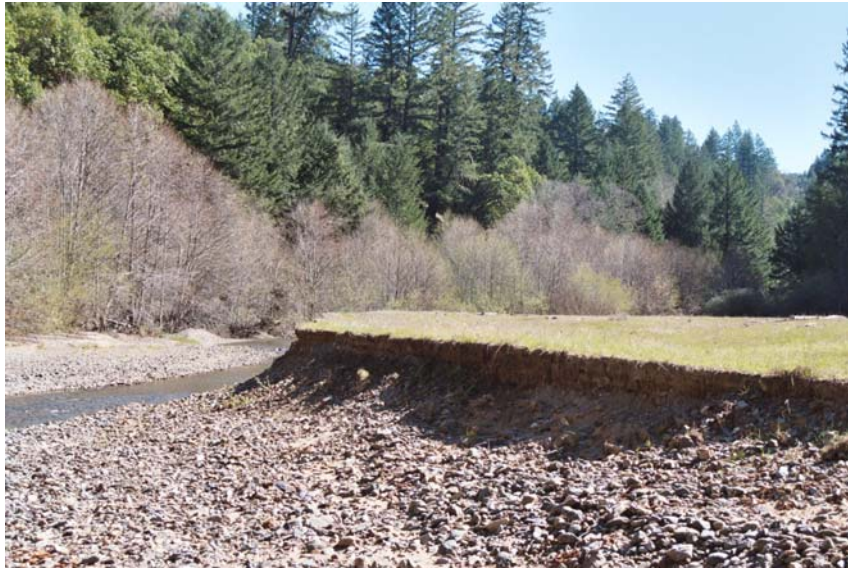
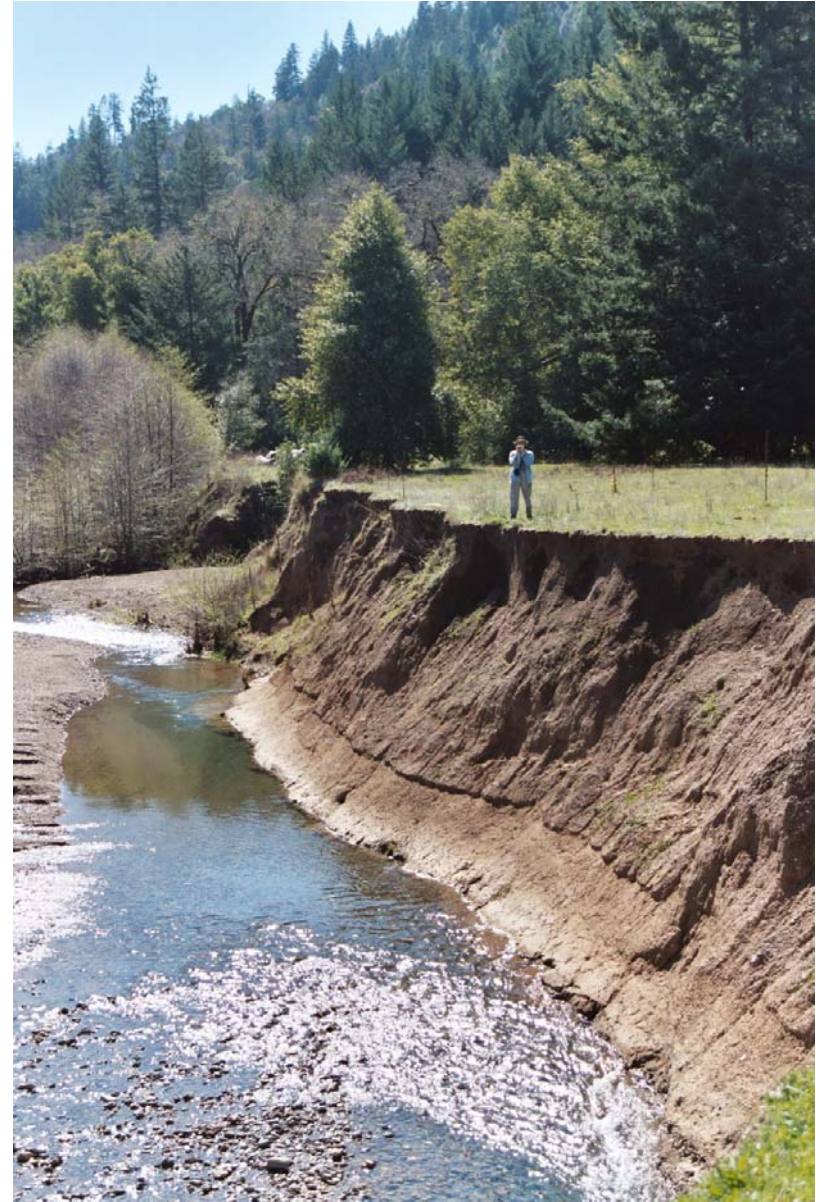
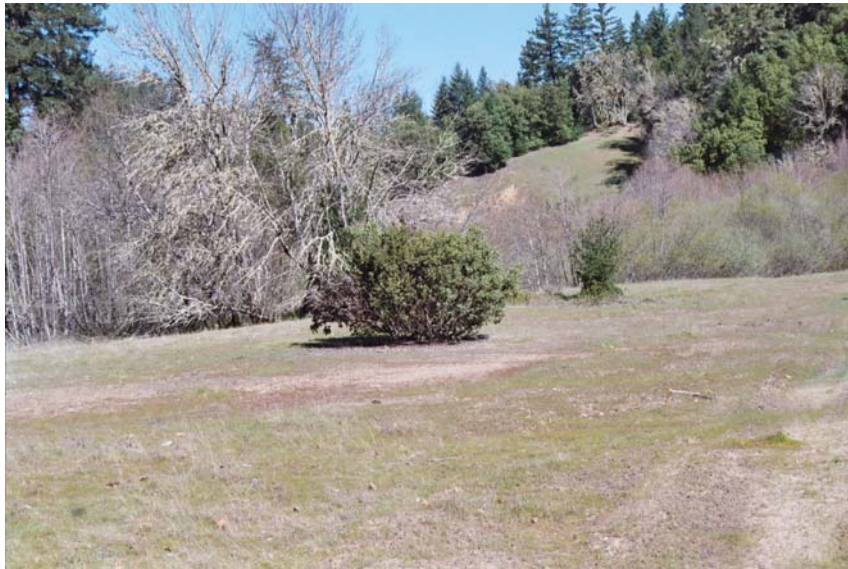
Photo Figure 4.
Bio-geomorphic Research and Management Demonstration Sites

Floodplains - limited riparian vegetation

Vertical banks – fine sediments

A series of bio-geomorphic management and research sites should be established (see Map E and Photo figure 4) that will allow for a multi-year investigation of the riparian corridors along Rancheria Creek, and upslope processes affecting these areas. Following are recommendations to aid in understanding the relationship between geomorphic features and ecology.

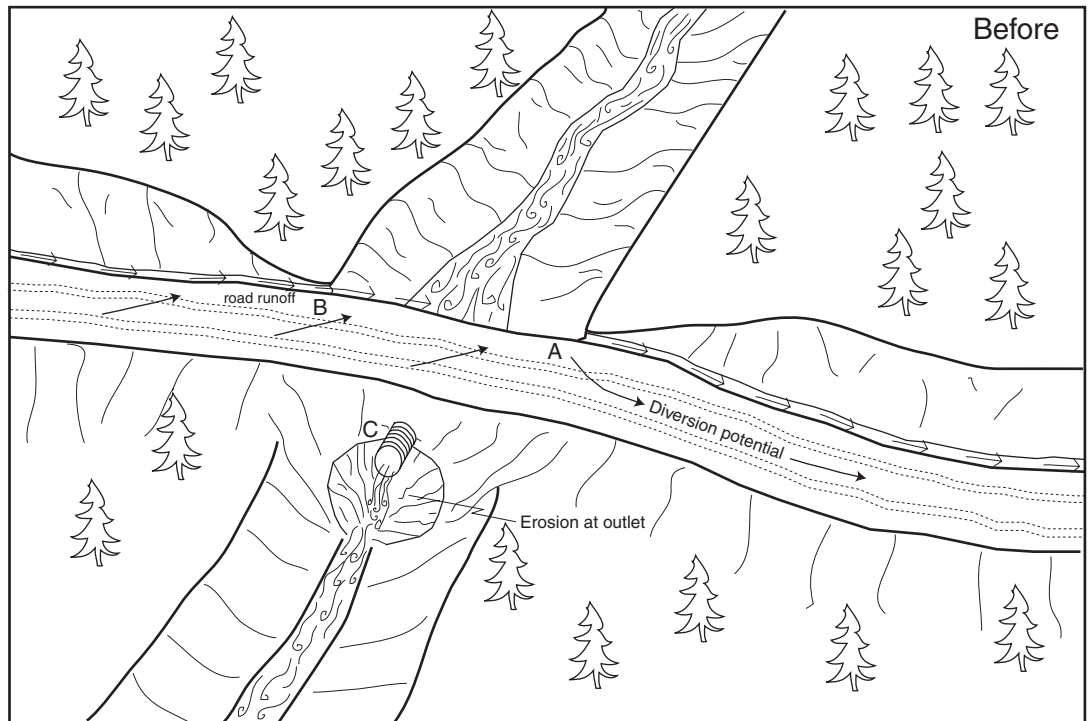
B - Road surface and ditch drains to stream

C - Undersized culvert high in fill with outlet erosion
