# Road crossings of California tiger salamanders (*Ambystoma californiense*) near mitigation tunnels in Sonoma County, CA

Julianne Bradbury<sup>1</sup>, Dustin Howland<sup>1</sup>, Dave Cook<sup>2</sup>, & Derek Girman<sup>1</sup>  
<sup>1</sup>Department of Biology, Sonoma State University, <sup>2</sup>Sonoma County Water Agency

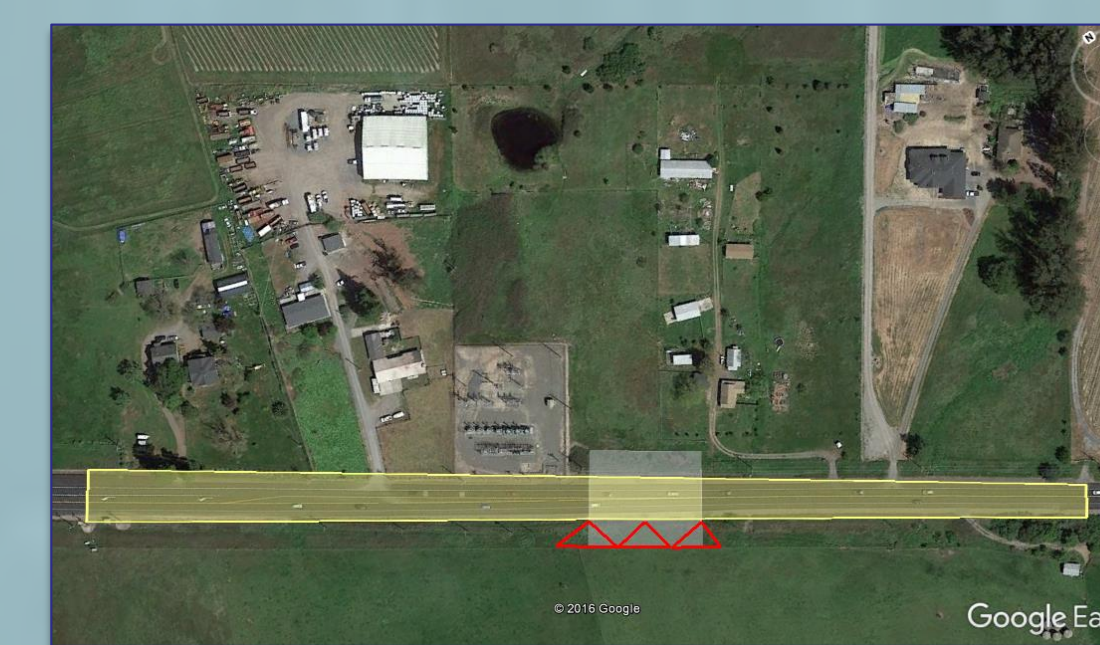
Mitigation tunnel study site at Stony Point Road, Sonoma County, CA. Yellow field is migration corridor surveyed by observers, red triangles are funneling fencing, white rectangle is zone above tunnels.

- Pairs of observers walked along Stony Point Road within the migration corridor of the target CTS population, starting at dusk, on rainy evenings from December to February from 2011-2017
- Locations of sightings of migrating CTS adults were marked with pin flags; subsequently, an observer recorded the GPS location of each sighting using Garmin GPS unit
- Location data was downloaded and analyzed using Google Earth Pro and JMP Pro 13

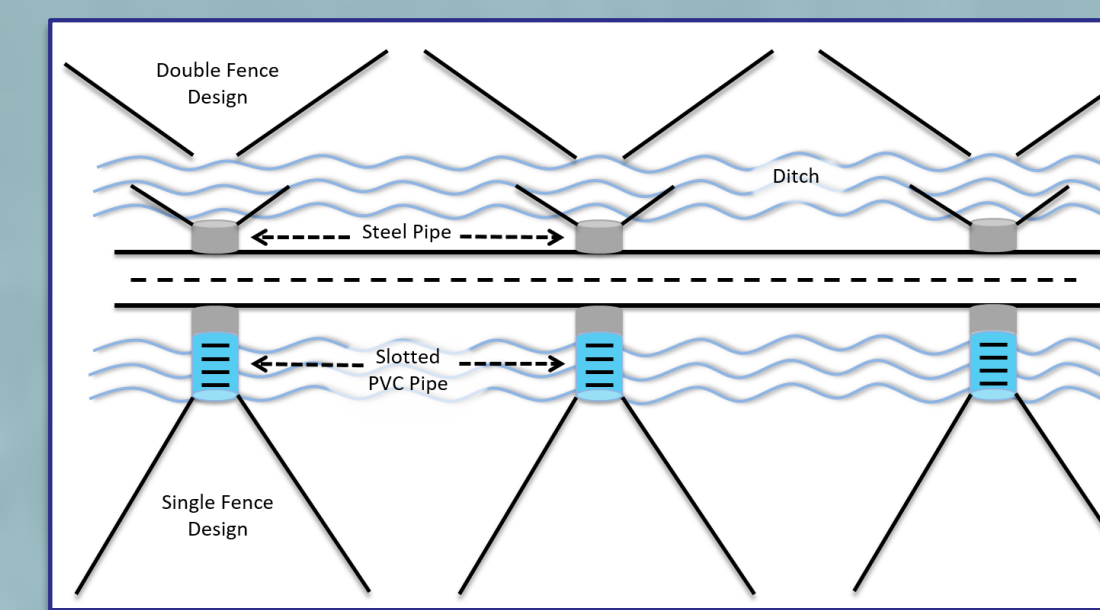
Tunnel and fencing design at mitigation site.

- To mitigate this problem, Sonoma County constructed three tunnels under Stony Point Road within the migration corridor in 2011; additionally, fencing to funnel migrating salamanders into the tunnels was installed (4,5,6)

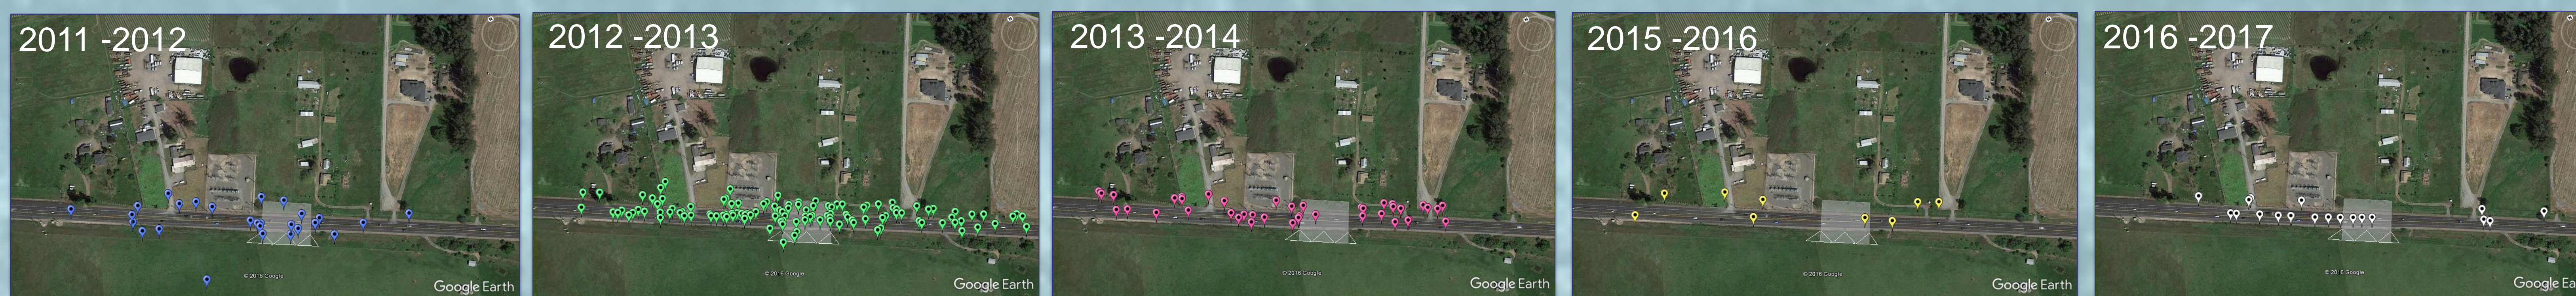
Contingency analysis shows a significant difference between likelihood of CTS being observed inside the tunnel zone in the early years following tunnel construction, compared with more recent breeding seasons

- These data show an apparent change in the migration pattern across the road near the mitigation tunnel site; the likelihood of observing a CTS within the migration tunnel area has decreased since the years immediately following installation of the tunnels and fencing

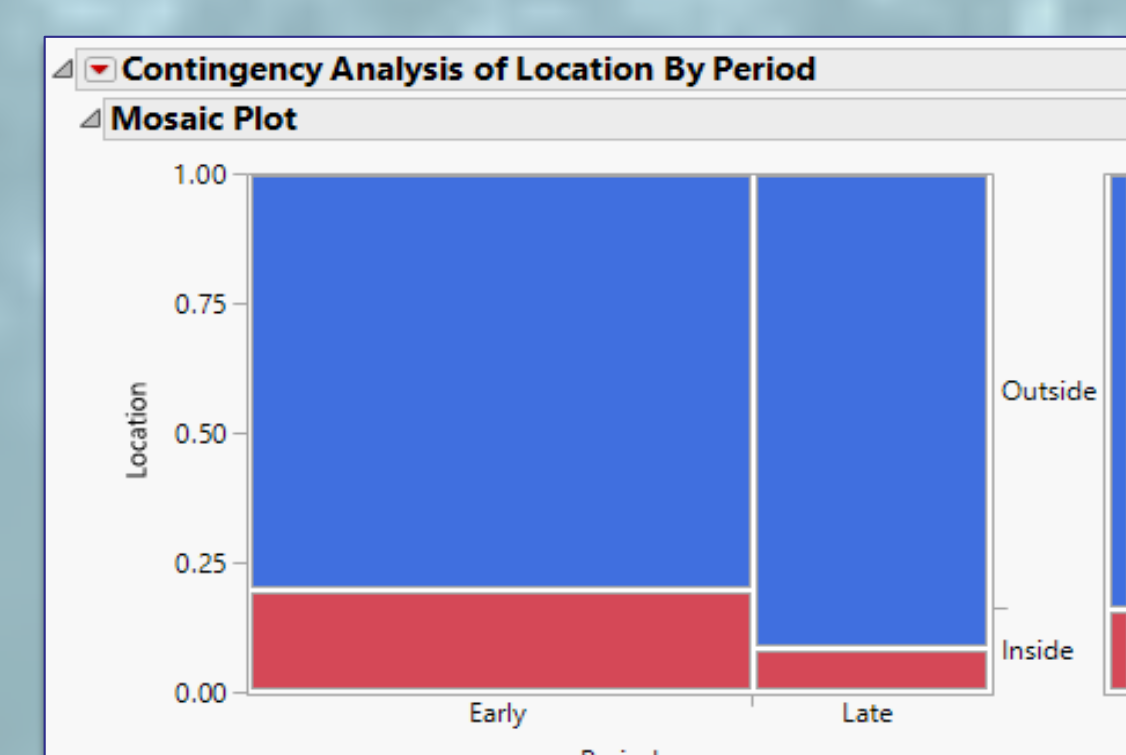
Chart 1. Contingency analysis of location of migrating CTS sightings by time period; Early is 2011-2013, late is 2013-2017; Time period does predict location of sighting (Likelihood ratio,  $\chi^2=5.015$ ,  $df=1$ ,  $p=0.0251$ )

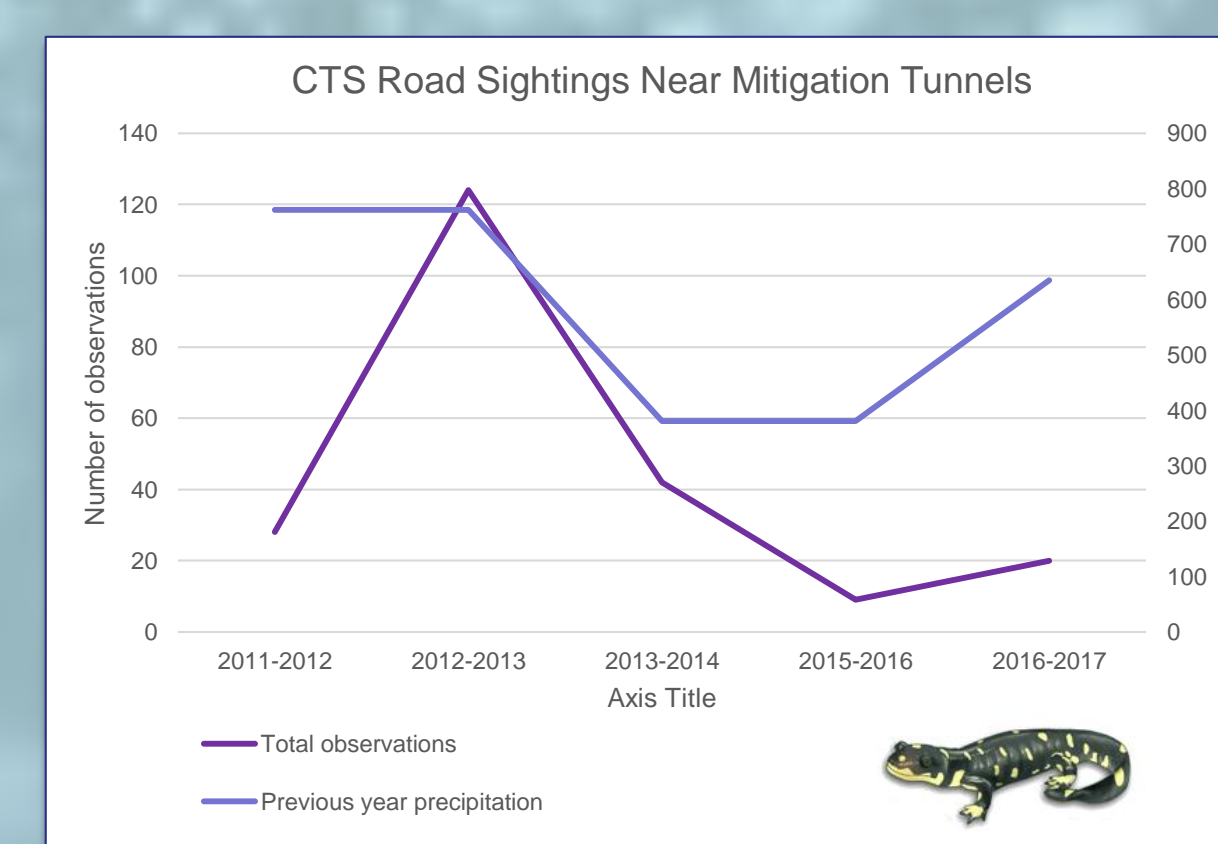
Chart 2. Progression of total number of CTS road sightings by year (purple) and total precipitation in previous year (blue) (7)

Total sightings increased substantially the year after tunnel installation, decreased from 2013-2016, then increased slightly in the 2016-2017 breeding season; this pattern is mirrored by total precipitation for the previous year (7)

- The overall number of observations per breeding season has decreased substantially; this trend coincides with a prolonged period of drought
- In order to determine whether the decrease in observations within the tunnel zone is due to use of the mitigation tunnels or avoidance of fencing by migrating CTS, it will be necessary to examine video footage from camera traps positioned at the entrance of the mitigation tunnels

- The increase in observations during the 2016-2017 breeding season, following an increase in total precipitation in the 2015 water year, gives reason to hope that this population may rebound with improved abiotic conditions
