Fairfield Osborne Preserve Restoration Assessment

By: Nick Hagerl, David Wentworth, Josh Brown- Herrera, Martina Schnitzler, Oscar Lucario

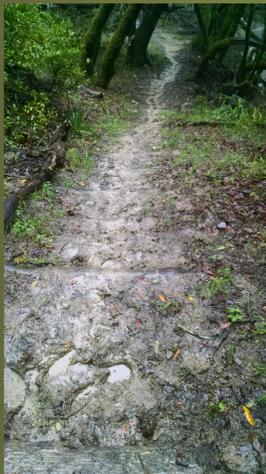
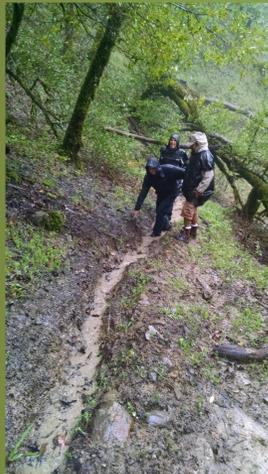
The 20 steps the previous group installed did a good job slowing down the water. However, the drainage ditches, channelized and possibly sped up the diverted water. The bottom of the lower drainage ditch did not meet up with the trail below. However the water did reach the trail from the drainage ditch. We engineered and dug two pits at the lower end of each drainage ditch with a berm on the lower side. The berm included two railroad ties. With the pits and berms, the water will slow down. Additional work was done on the steps and two water bars were created uphill.
