Monitoring stream bank erosion and migration at the Fairfield Osborn Preserve Lauryn Hopper and Quinten Rodriguez Geography Department, Sonoma State University

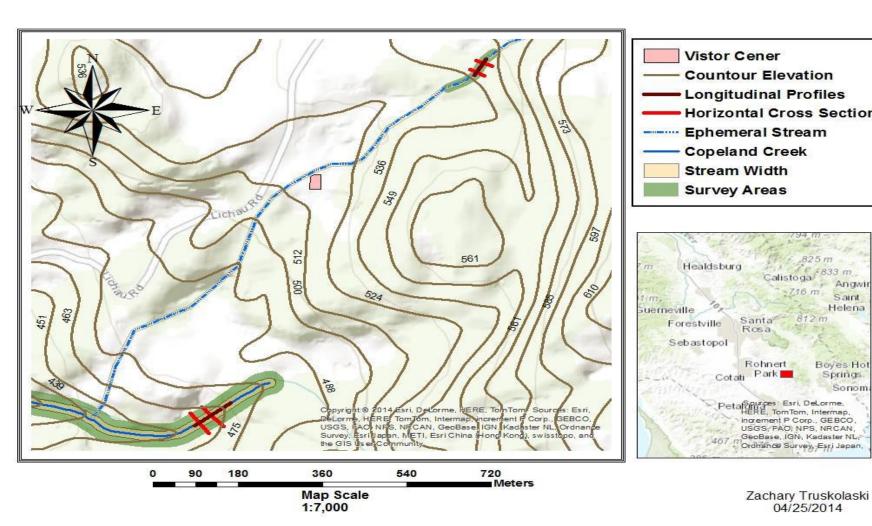
Figure 1

Using auto levels we constructed two cross sectional profiles of each creek. Elevation along the cross sections was measured approximately every 0.5 m and related to a temporary benchmark. The cross sections are designated upper and lower for each site (Figure 1).

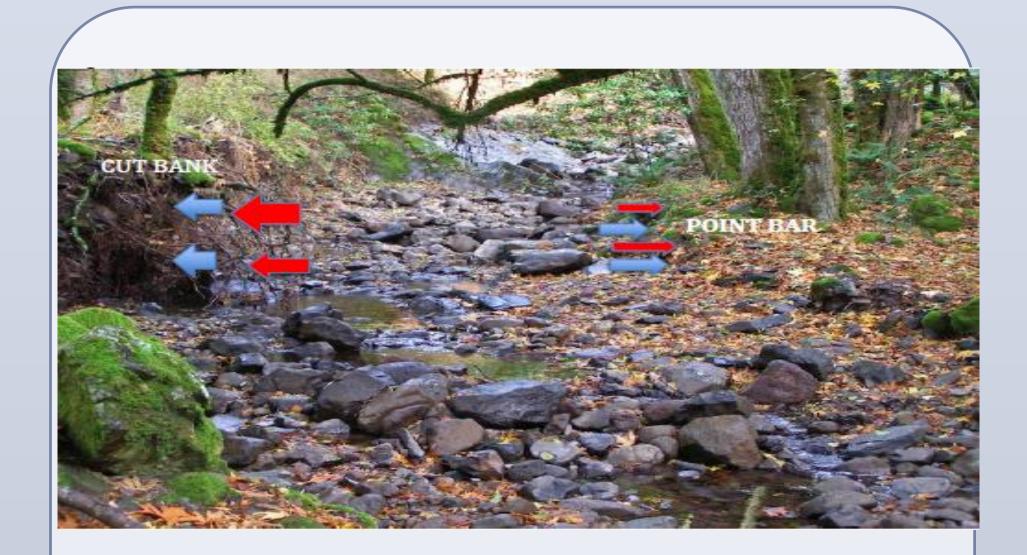
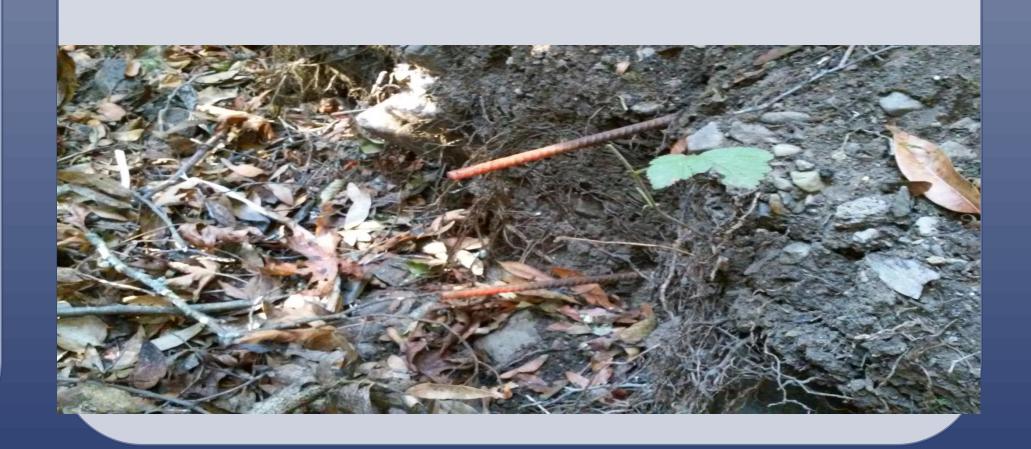
Copeland Creek is experiencing erosion along its northern bank. This side of the channel is characterized by a steep cut bank face (Figures 2 and 3). Both cross sections show erosion on the northern side but with the lower cross section experiencing the most erosion (~12 cm lost). The south bank is also experiencing erosion (~8 cm lost). Overall the stream is maintaining its channel form and overall depth The Wolman Pebble count (figure 6) shows that this active creek has a bed load characterized by large pebbles in the 128-256 mm range (~ 80%).

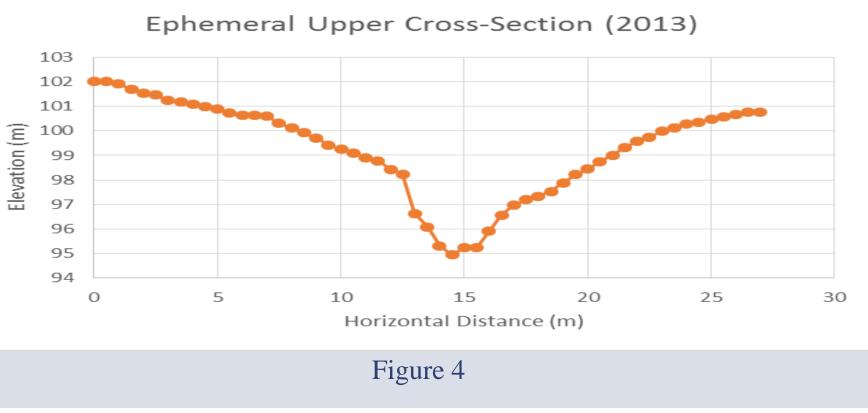
The Unnamed Ephemeral Creek only experiences discharge during extreme rainfall events such as atmospheric rivers. One such event prevented our class from re-measuring the upper cross section in the fall of 2014. However, the data from the lower cross section shows that the creek, in spite of its typical dry state, has changed in the course of the year (Figure 4 and 5). Erosion pin data shows that the lower cross section experienced ~ 2 cm of erosion on the south bank, but showed deposition on the north bank, ~1 cm. While we do not have a cross sectional profile of the upstream cross section for 2014, we do have erosion pin data that showed deposition on the north and south banks ~1cm.

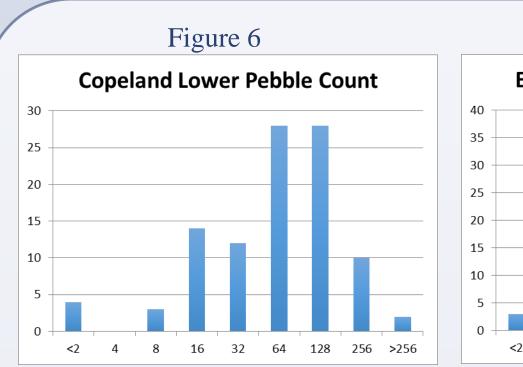
The Wolman Pebble count data (figure 7) indicates shows that the majority of pebbles fell between 64 and 128 mm. The large pebbles > 256 mm indicate that the creek is able to move this large material during high flows.
