# Monitoring Impacts of a Sediment Removal Project in the Laguna de Santa Rosa

**GEP 359 Water Research Methods, Sonoma State University**

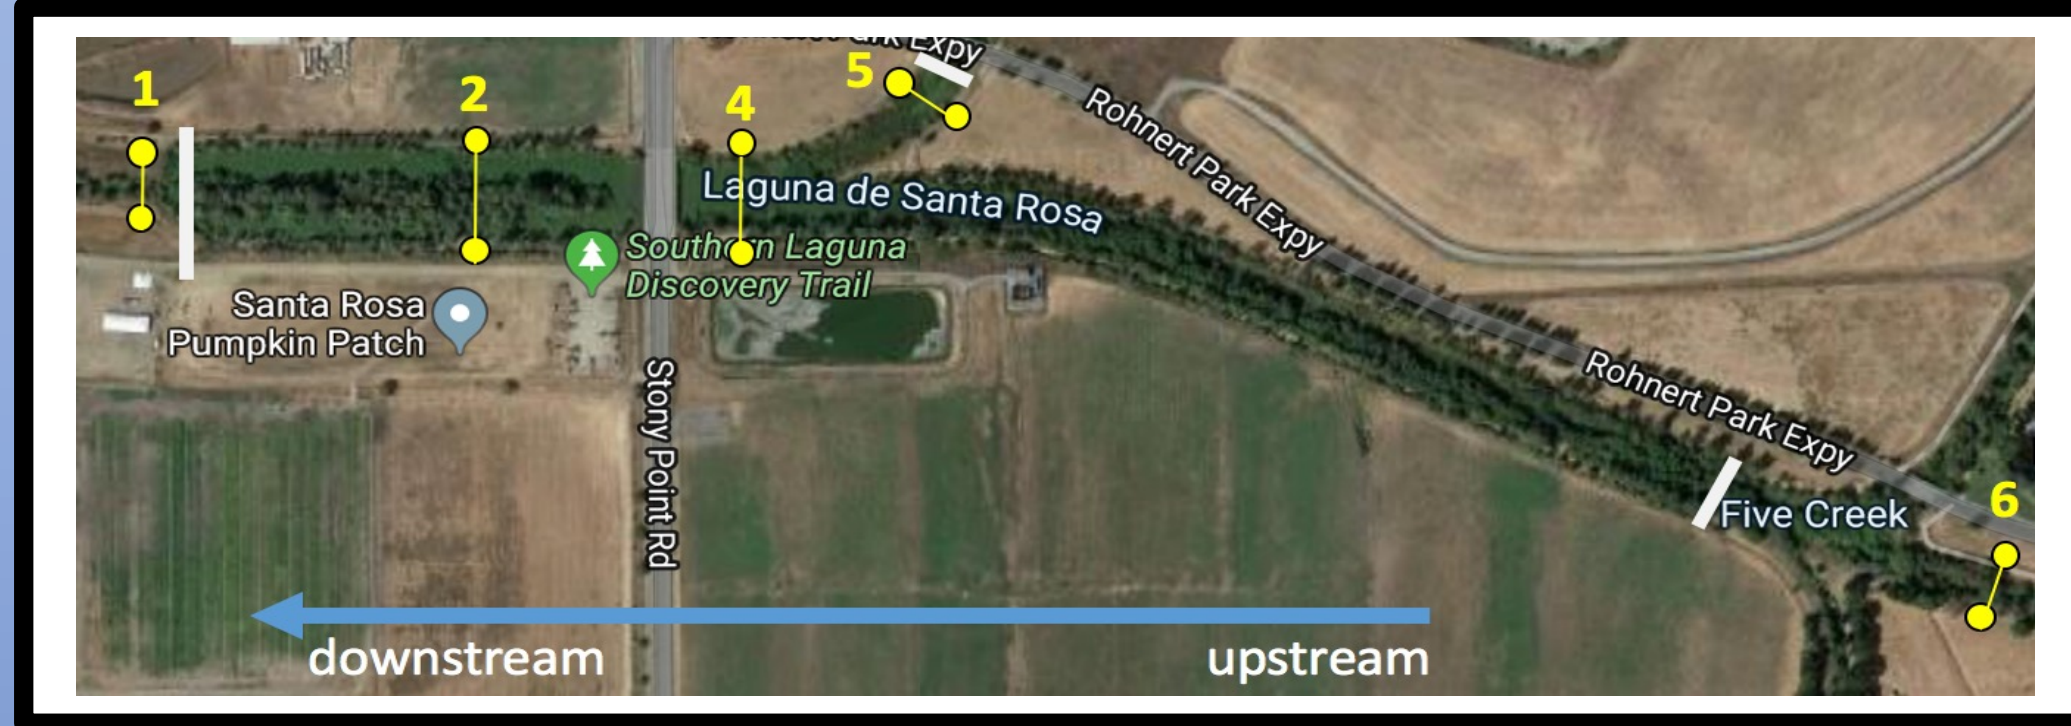
Sites 2, 4, and 5 were within the sediment removal site (boundaries marked by white lines)

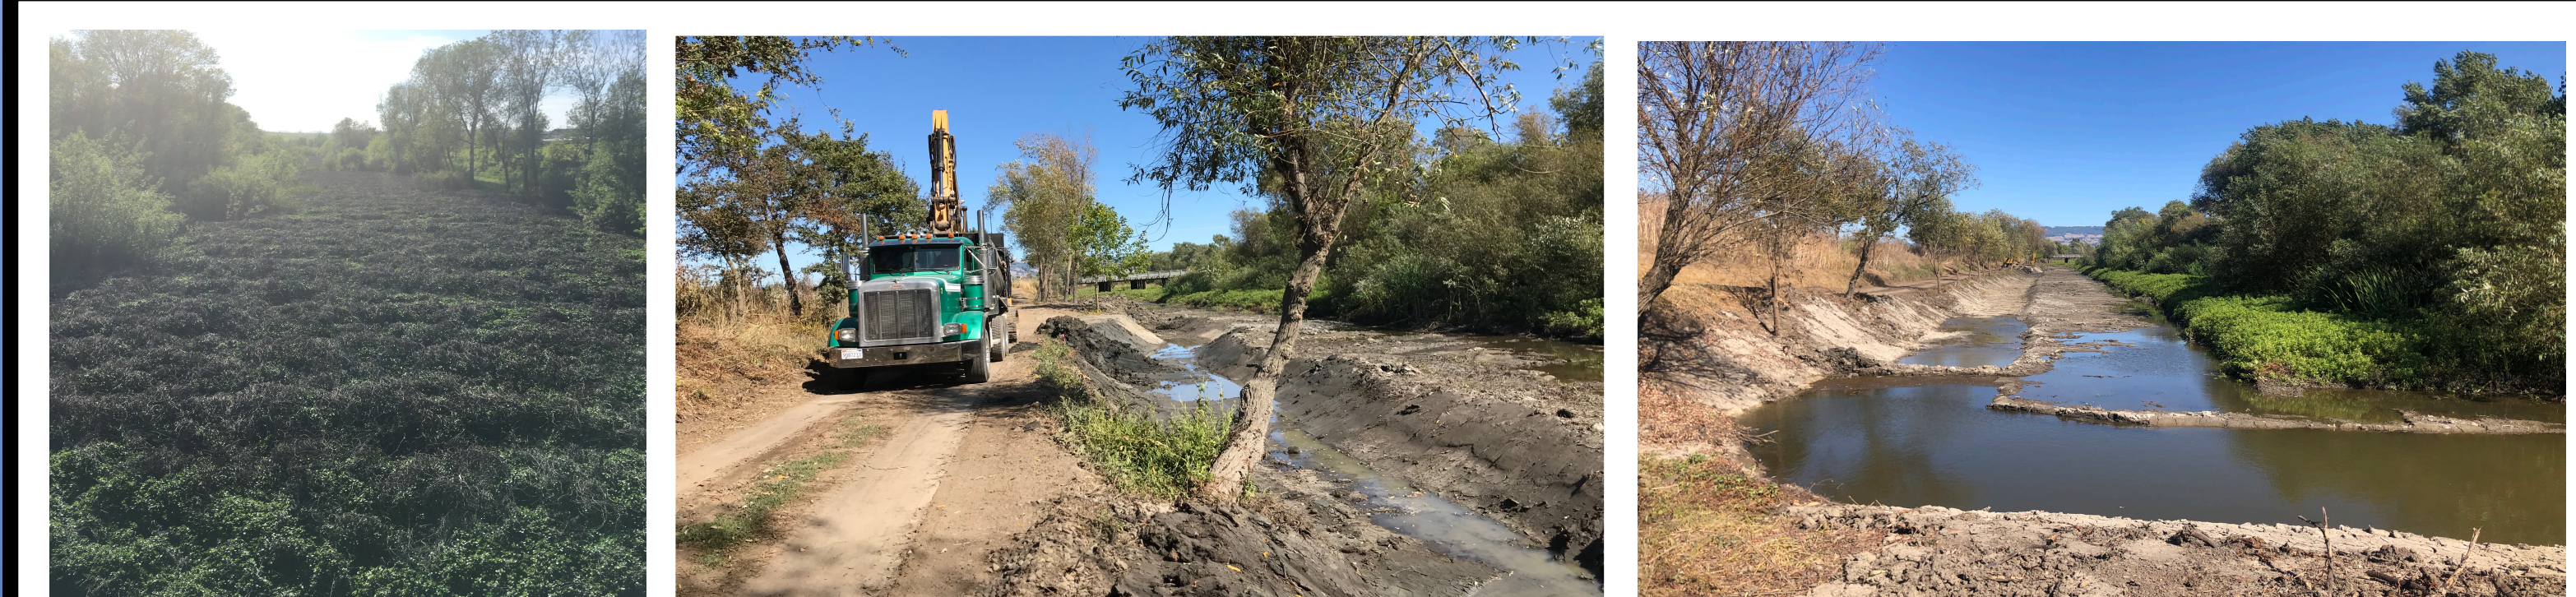
**Looking upstream from Site 1 towards Site 2**

- Left panel: Swampy study area clogged up with *Ludwigia* before sediment removal
- Middle panel: Deepening 8 foot reach from north bank, removing sediment
- Right panel: Deeper side of channel after completion of sediment removal

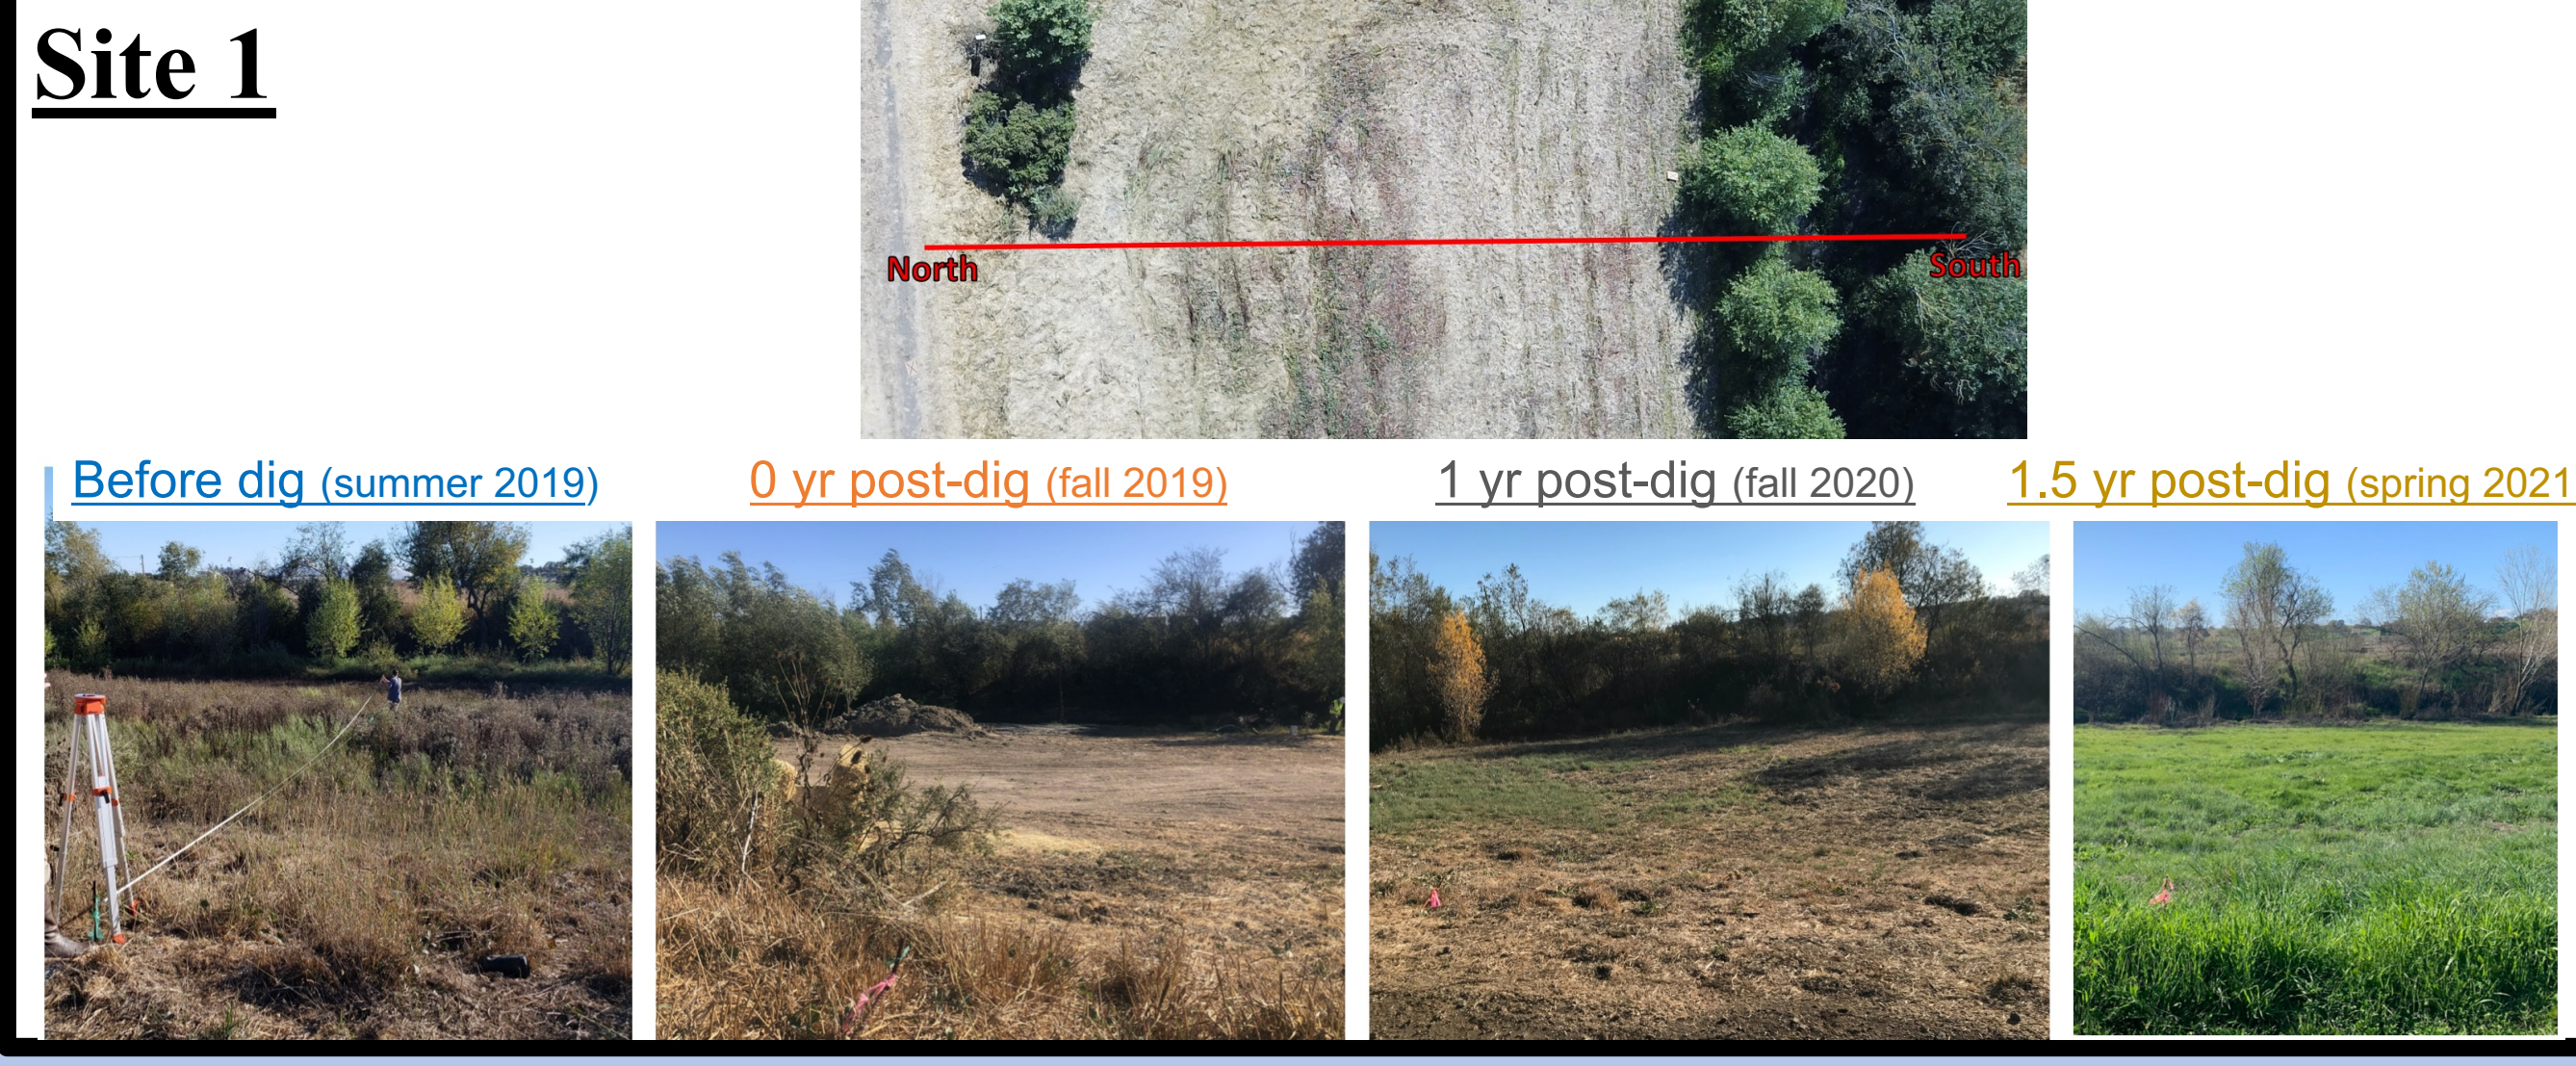
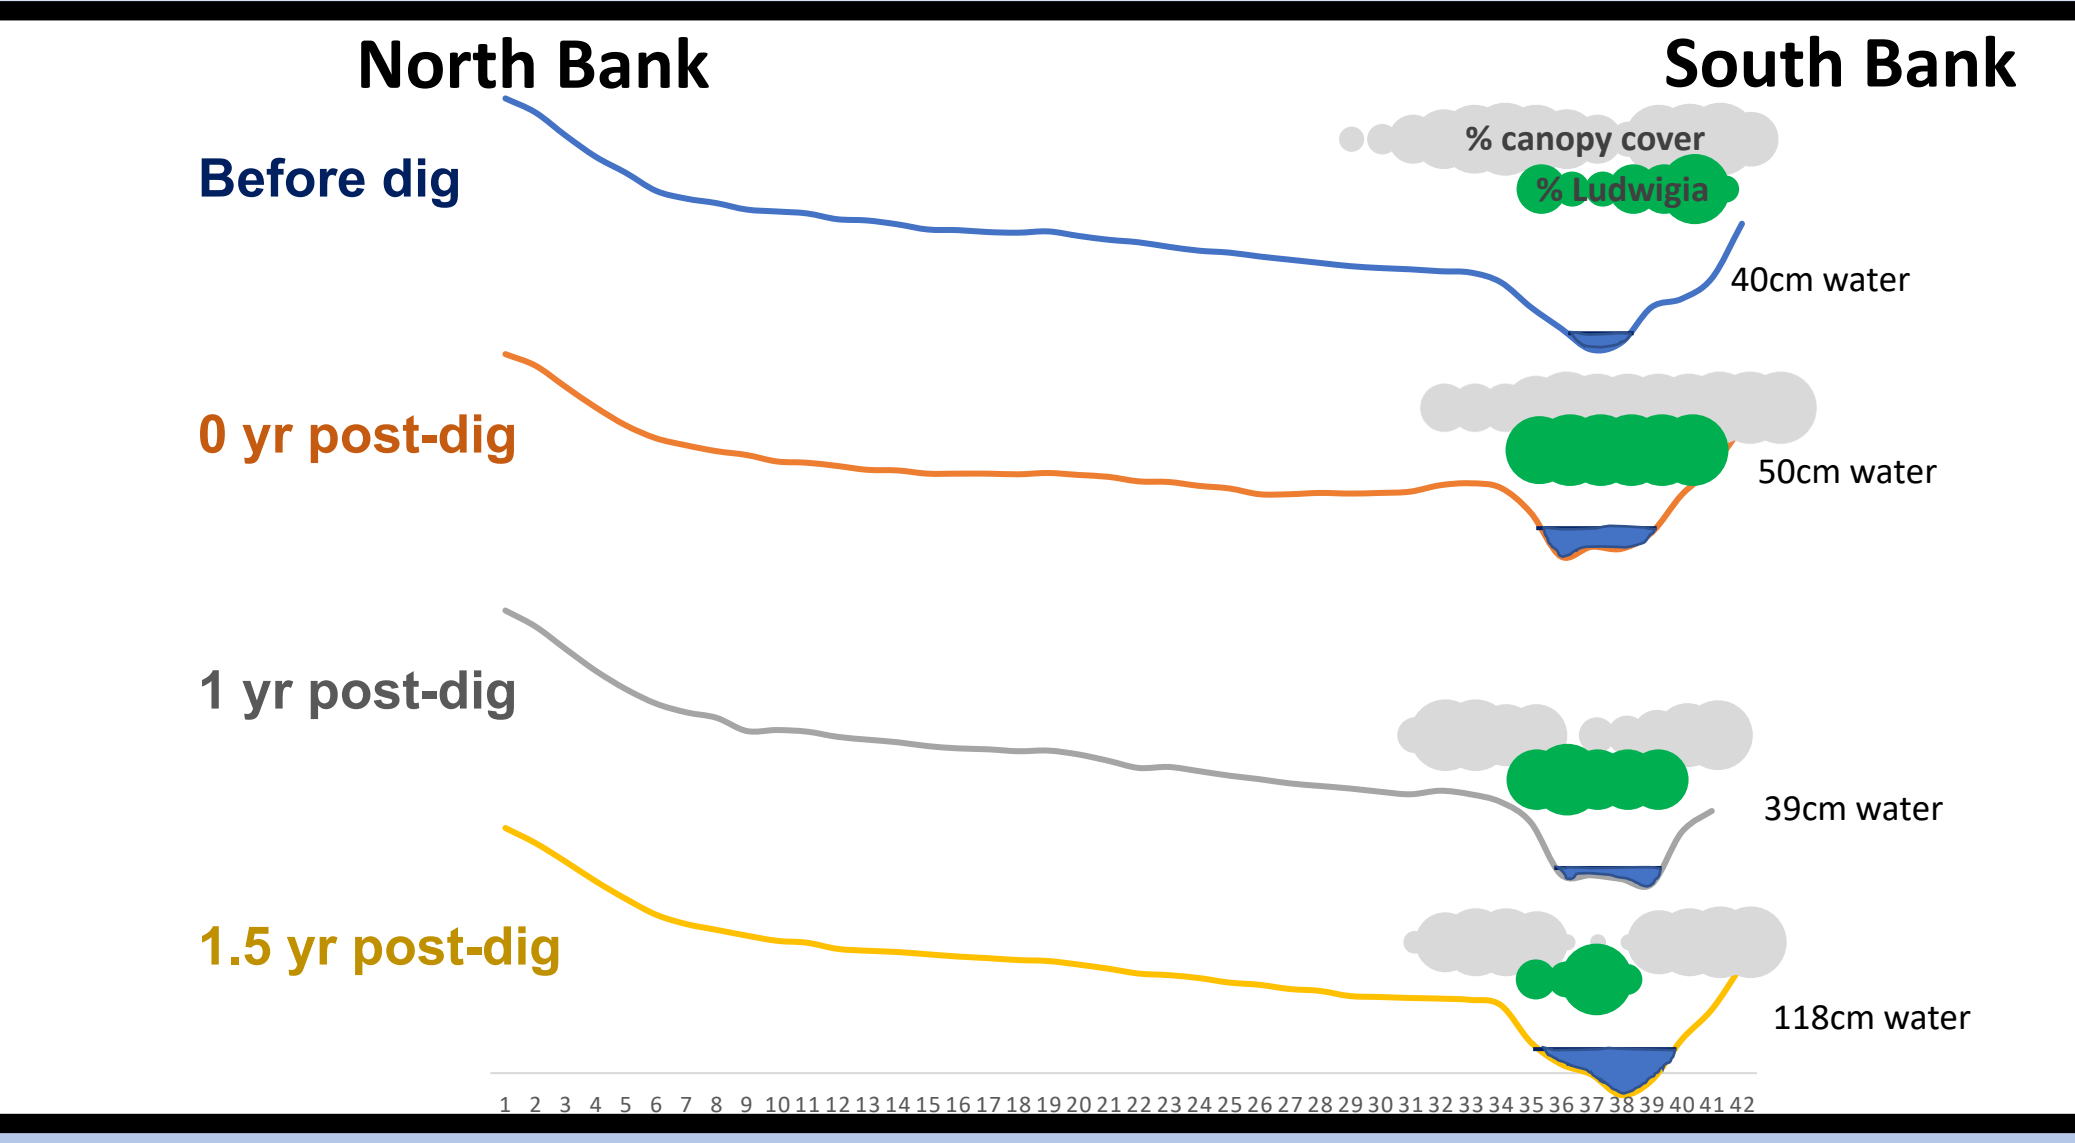
### Site 1

- **SITE ONE:** not modified during the sediment removal
- *Ludwigia* growth is localized to the shaded south side of the channel, where water is present

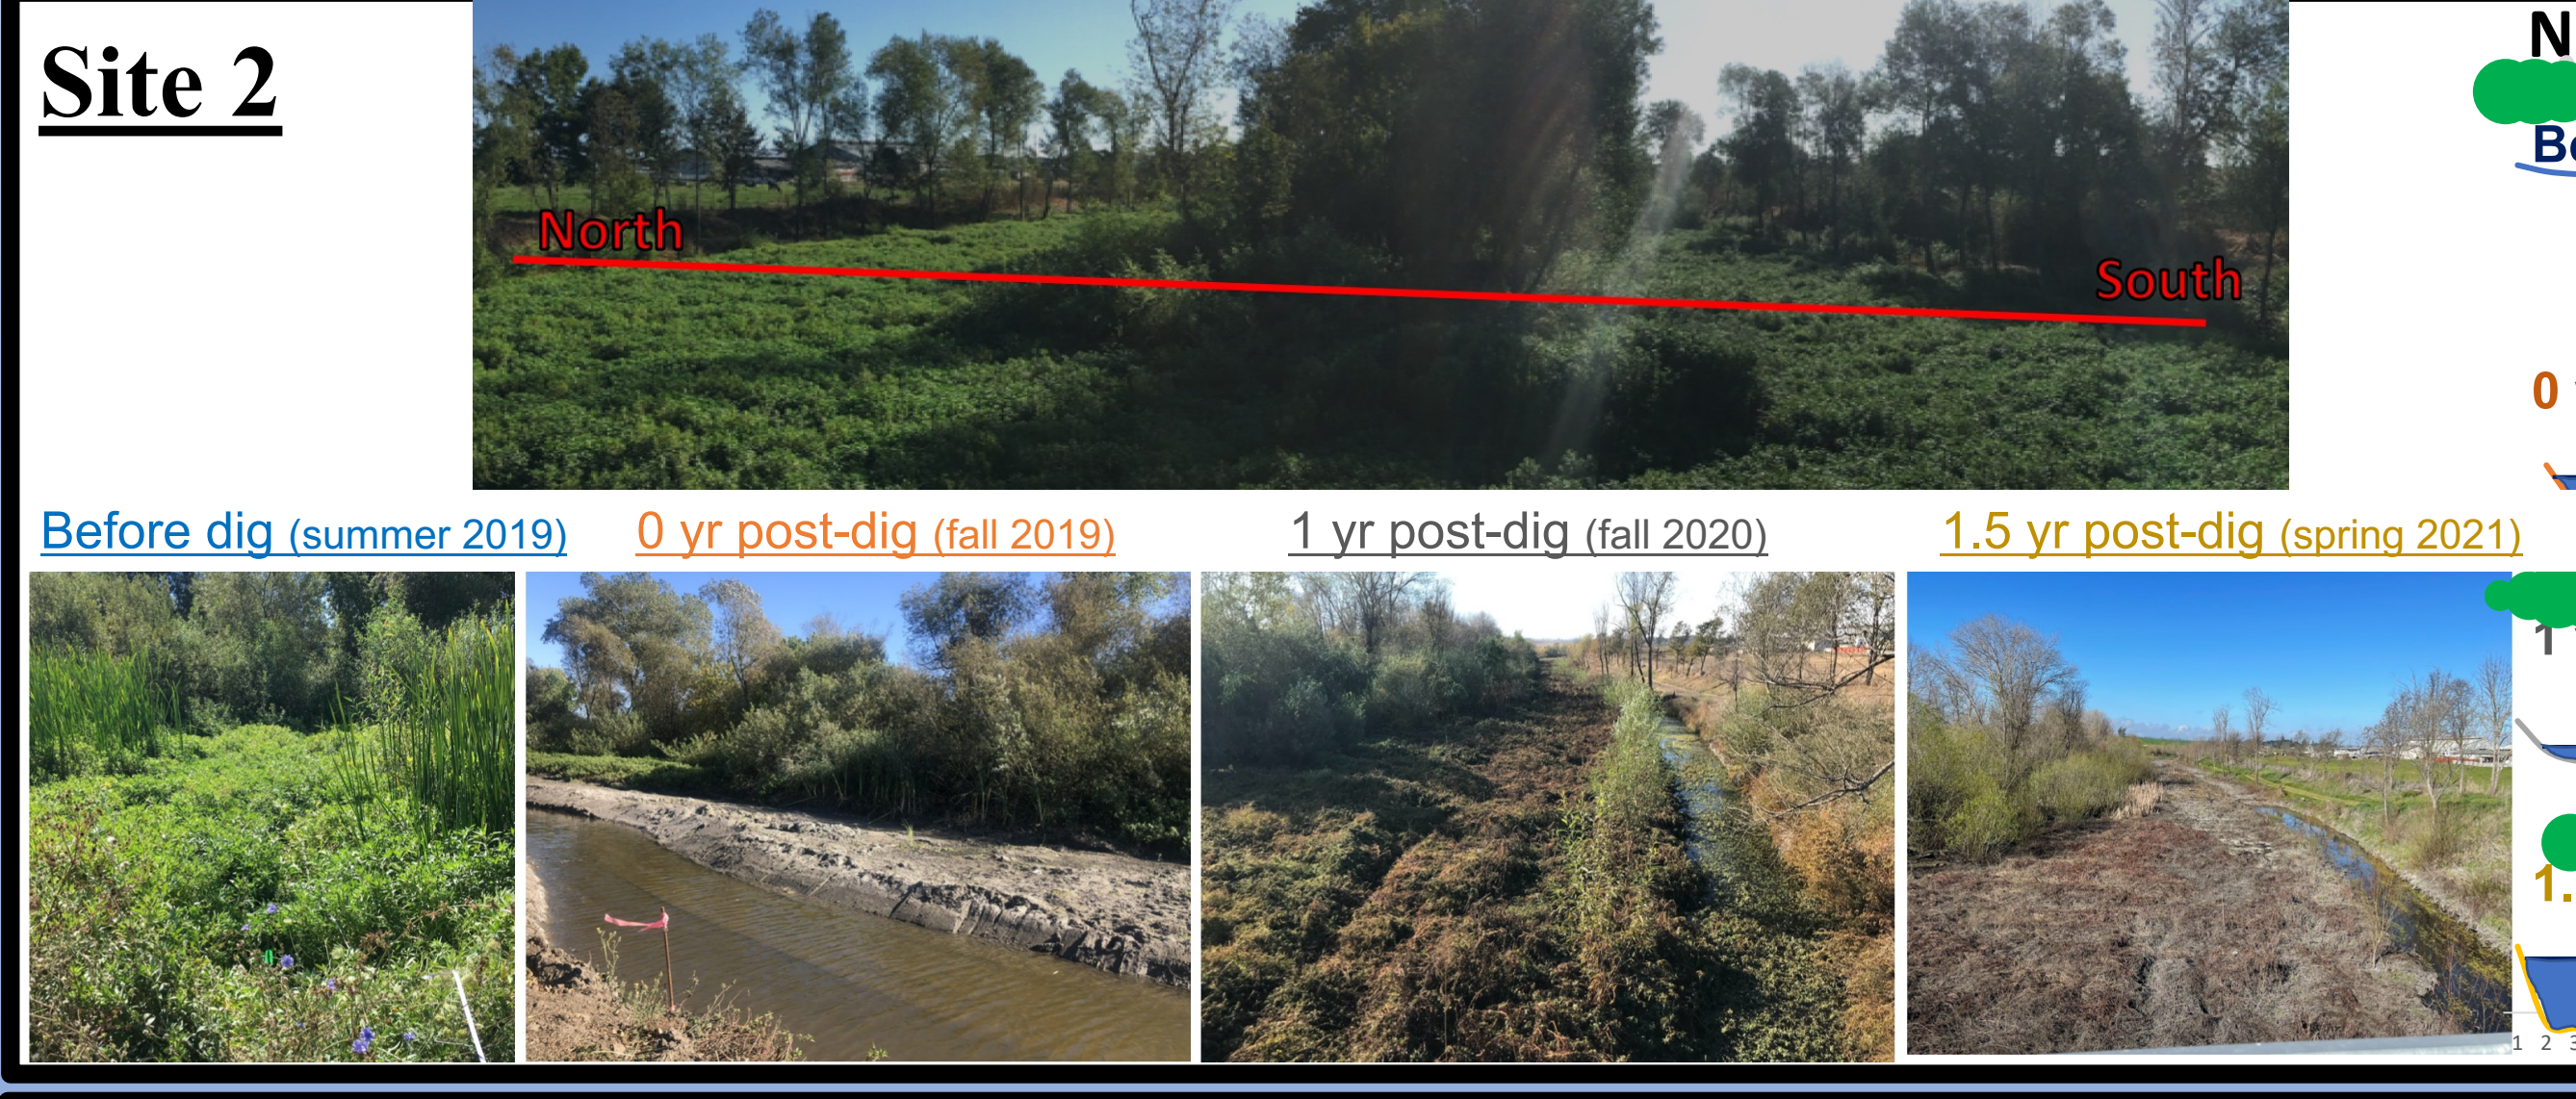
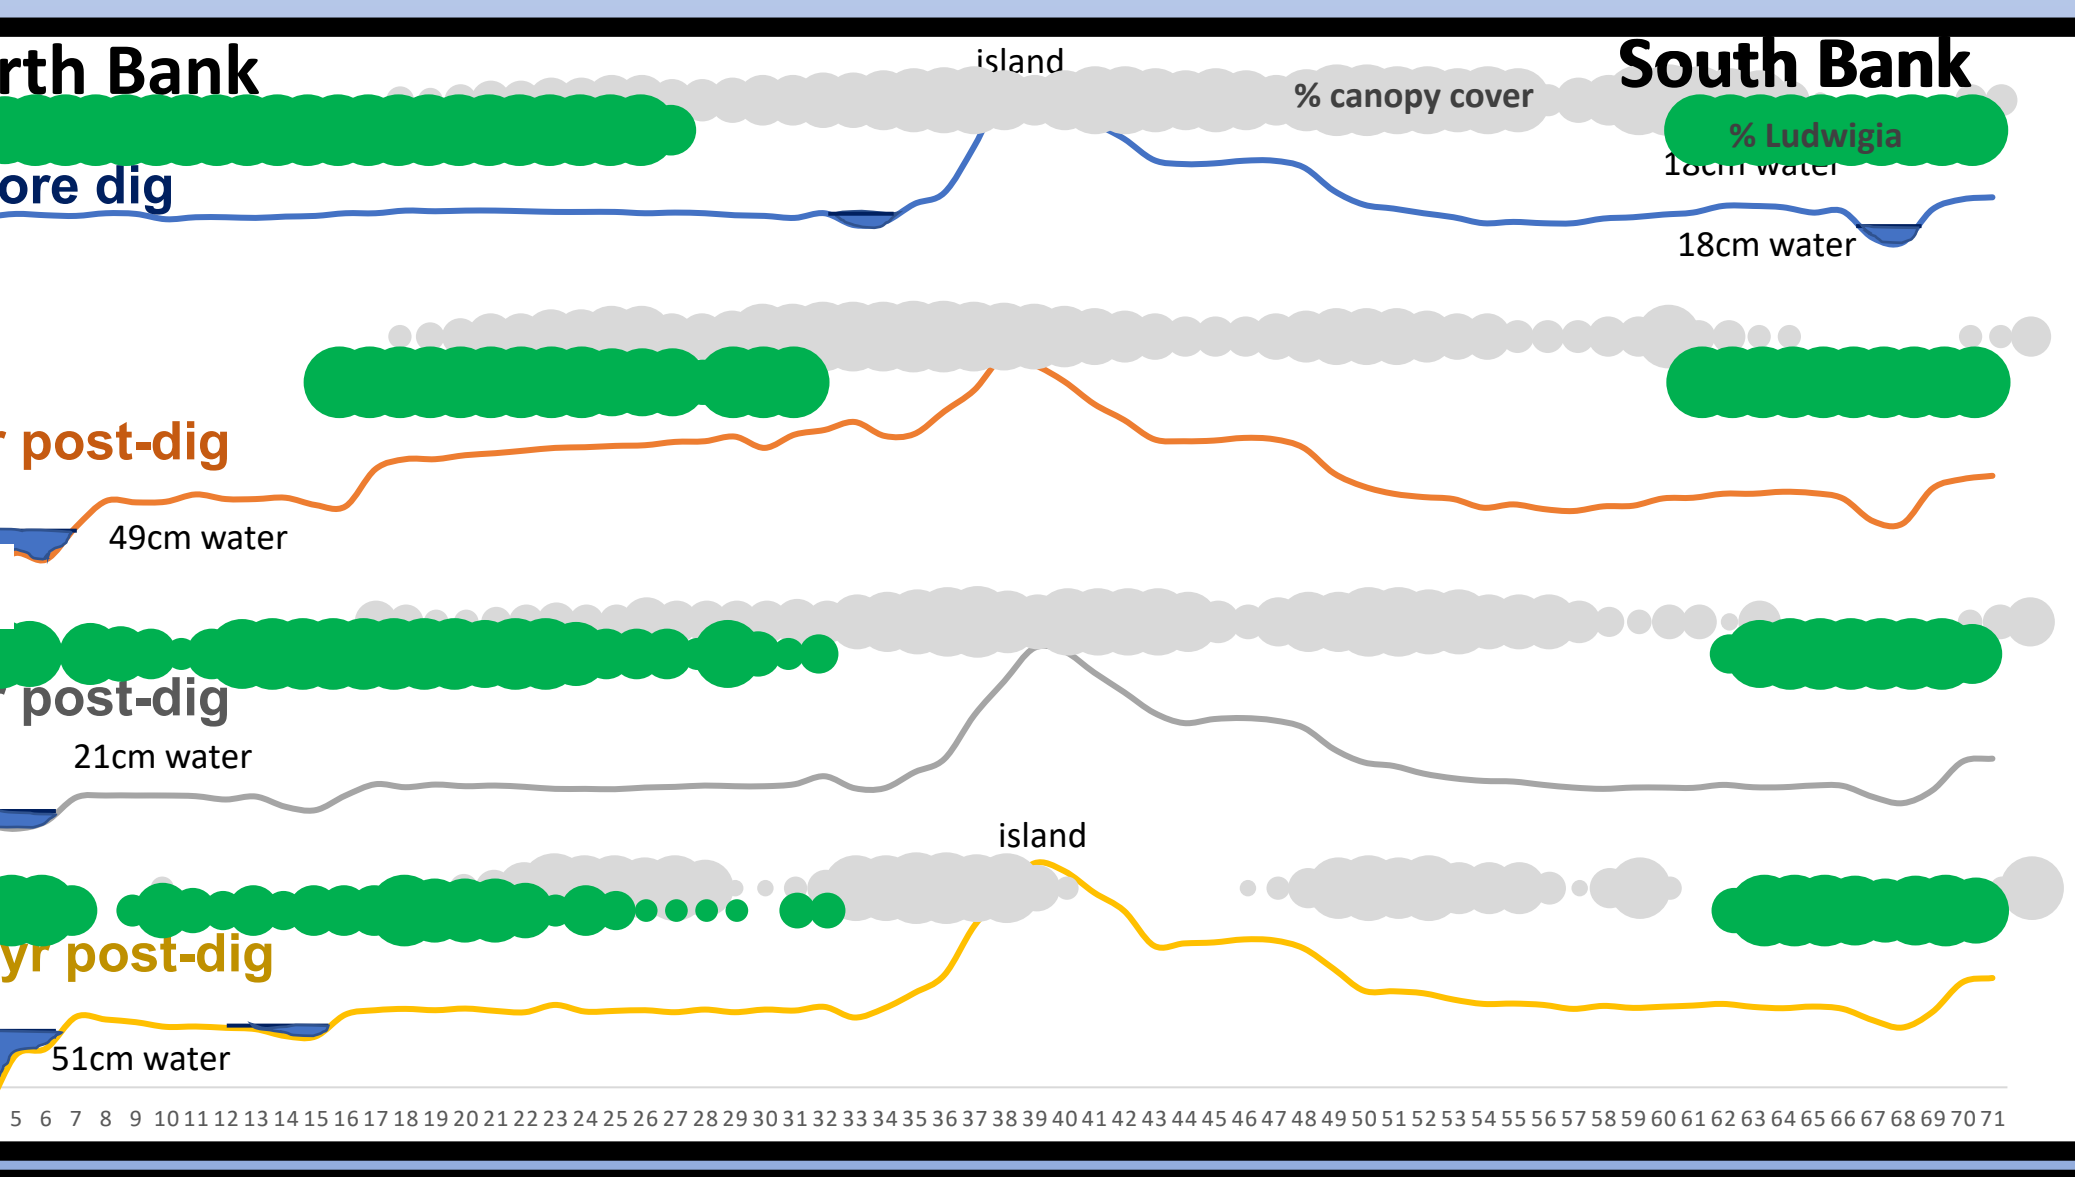
### Site 2

- **SITE TWO:** modified: a deep section was carved along the north bank
- The *Ludwigia* that was removed along the north bank has grown back
- Water from the south bank is now absent but the *Ludwigia* is still present despite the dryer conditions

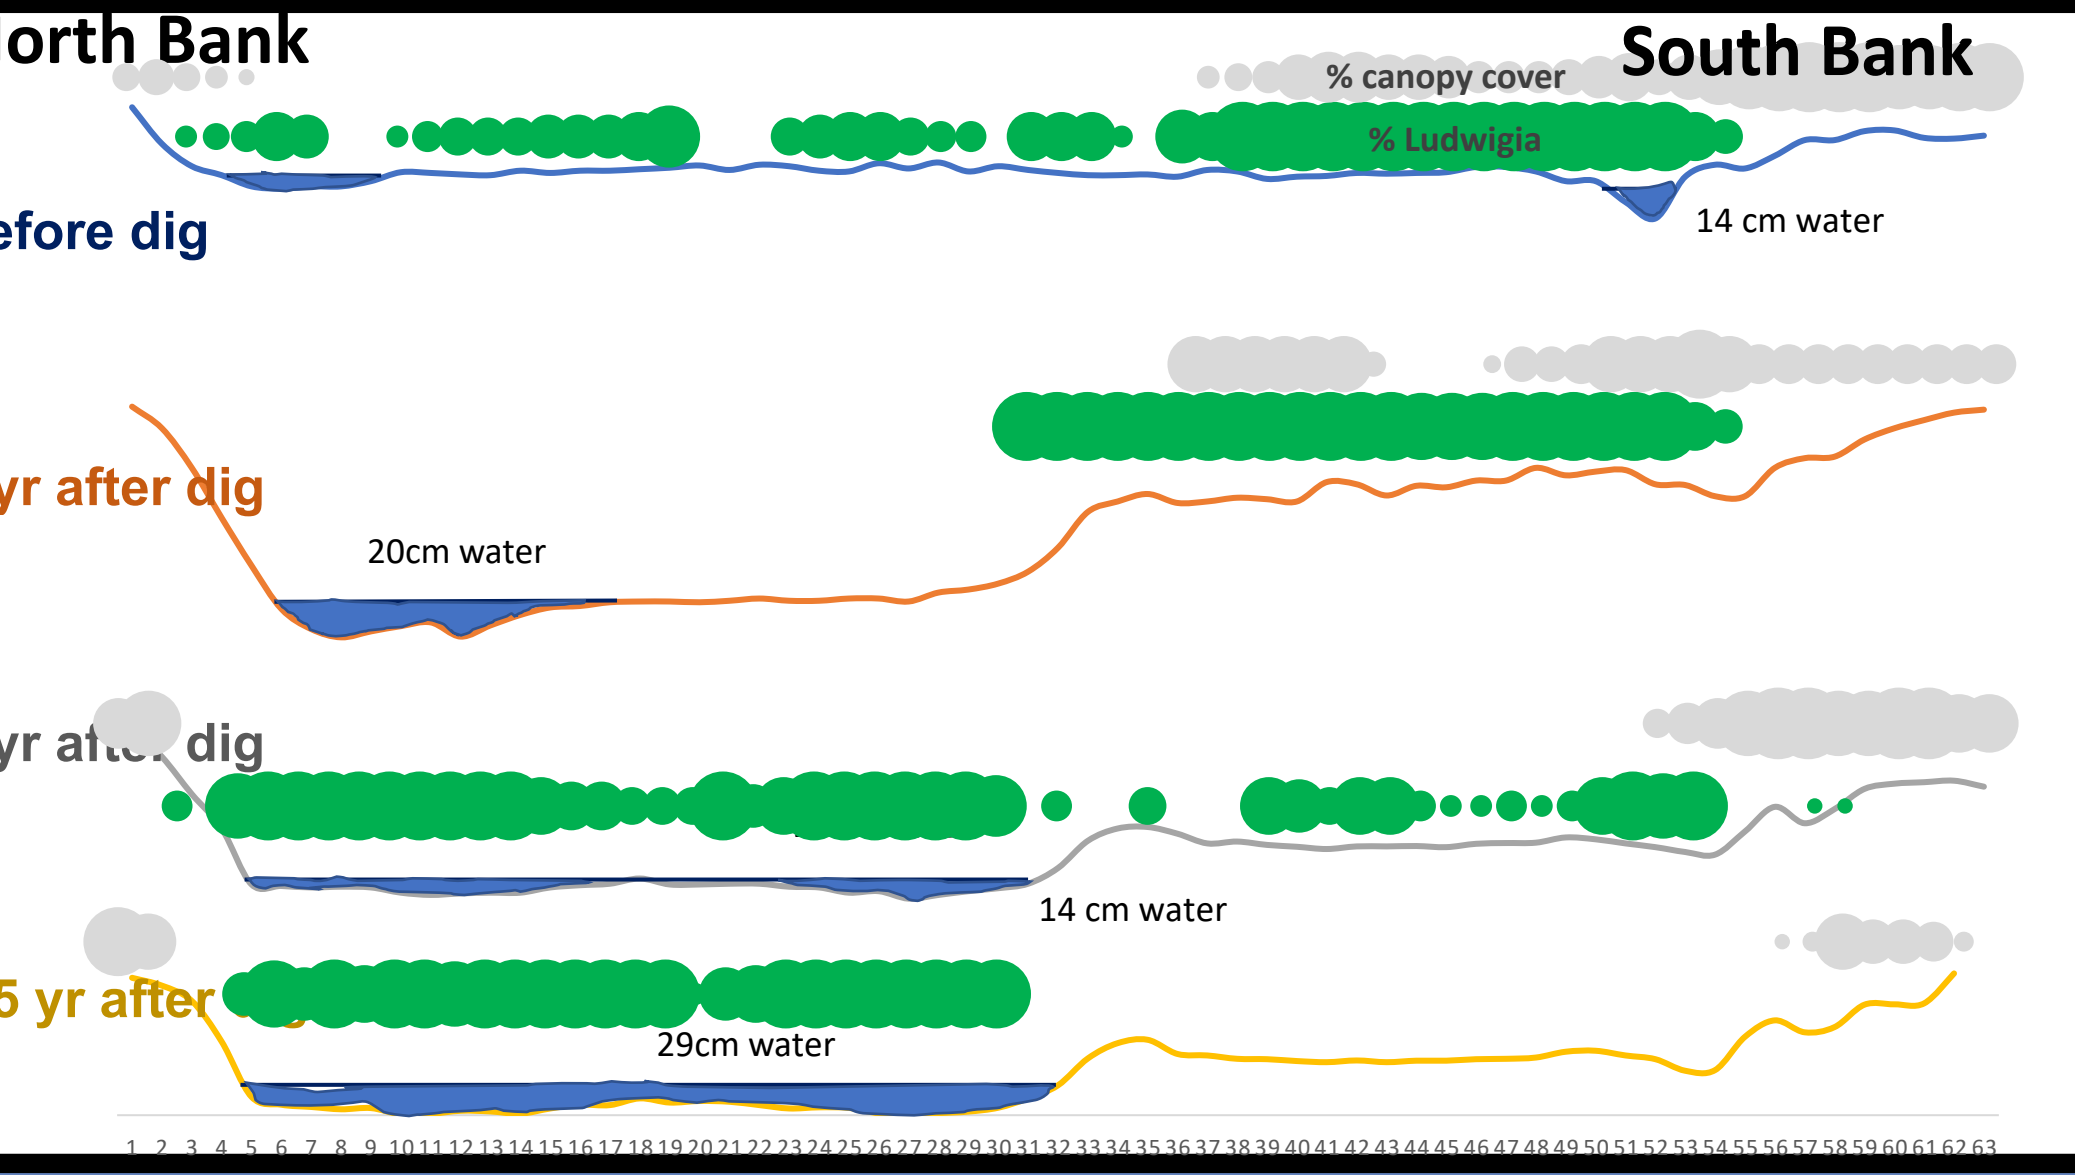
### Site 4

- **SITE FOUR:** modified: the north half now has shallow water and dense *Ludwigia* growth
- *Ludwigia* growth was subsequently reduced on the dryer south side

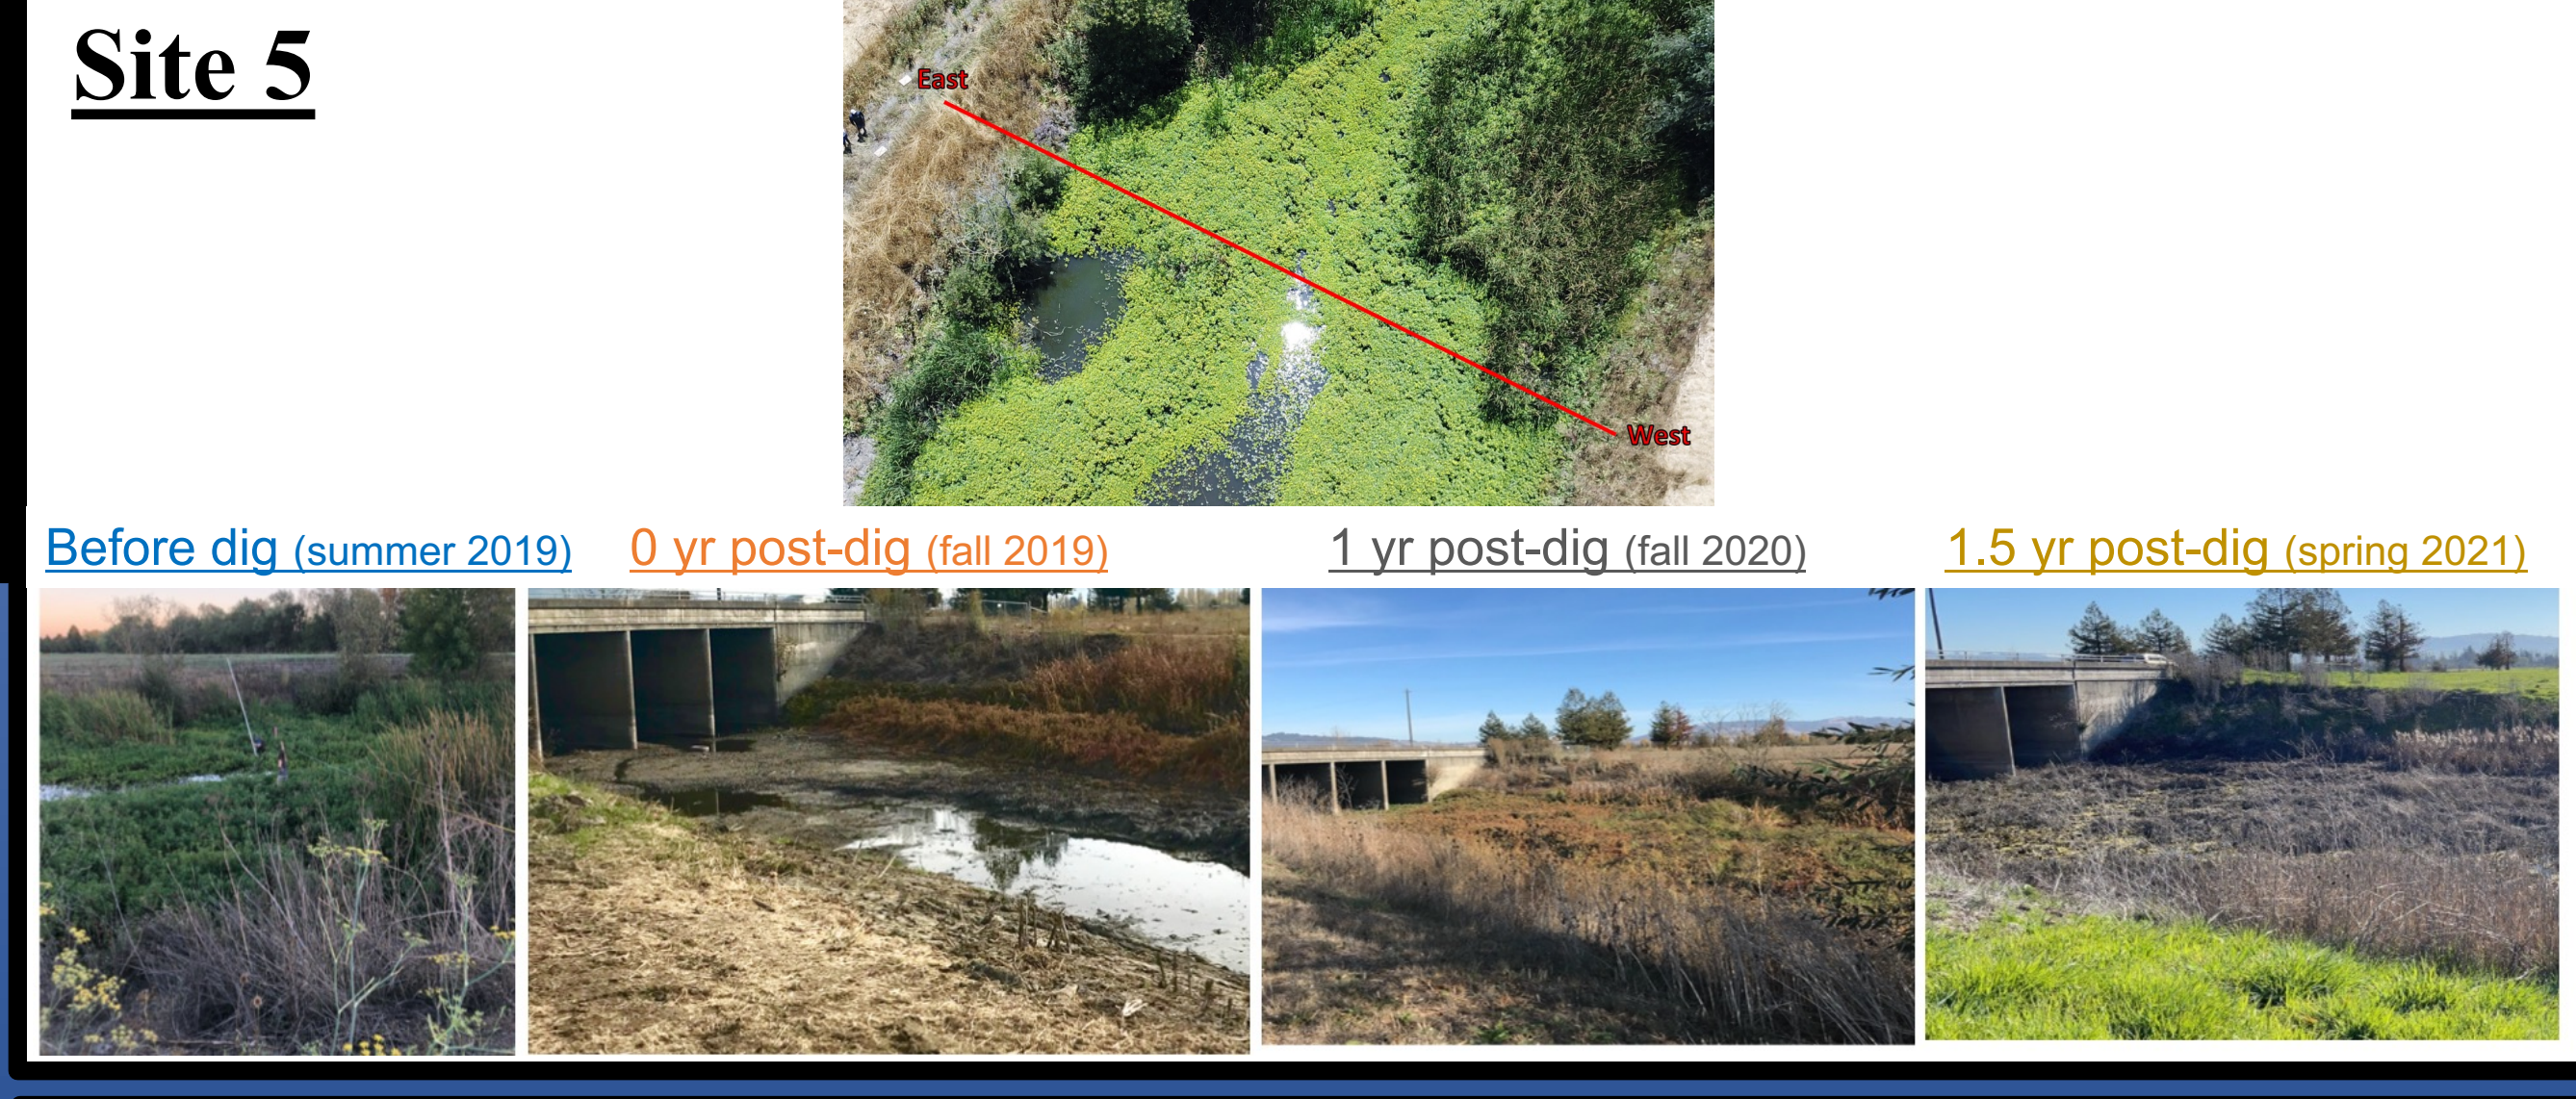
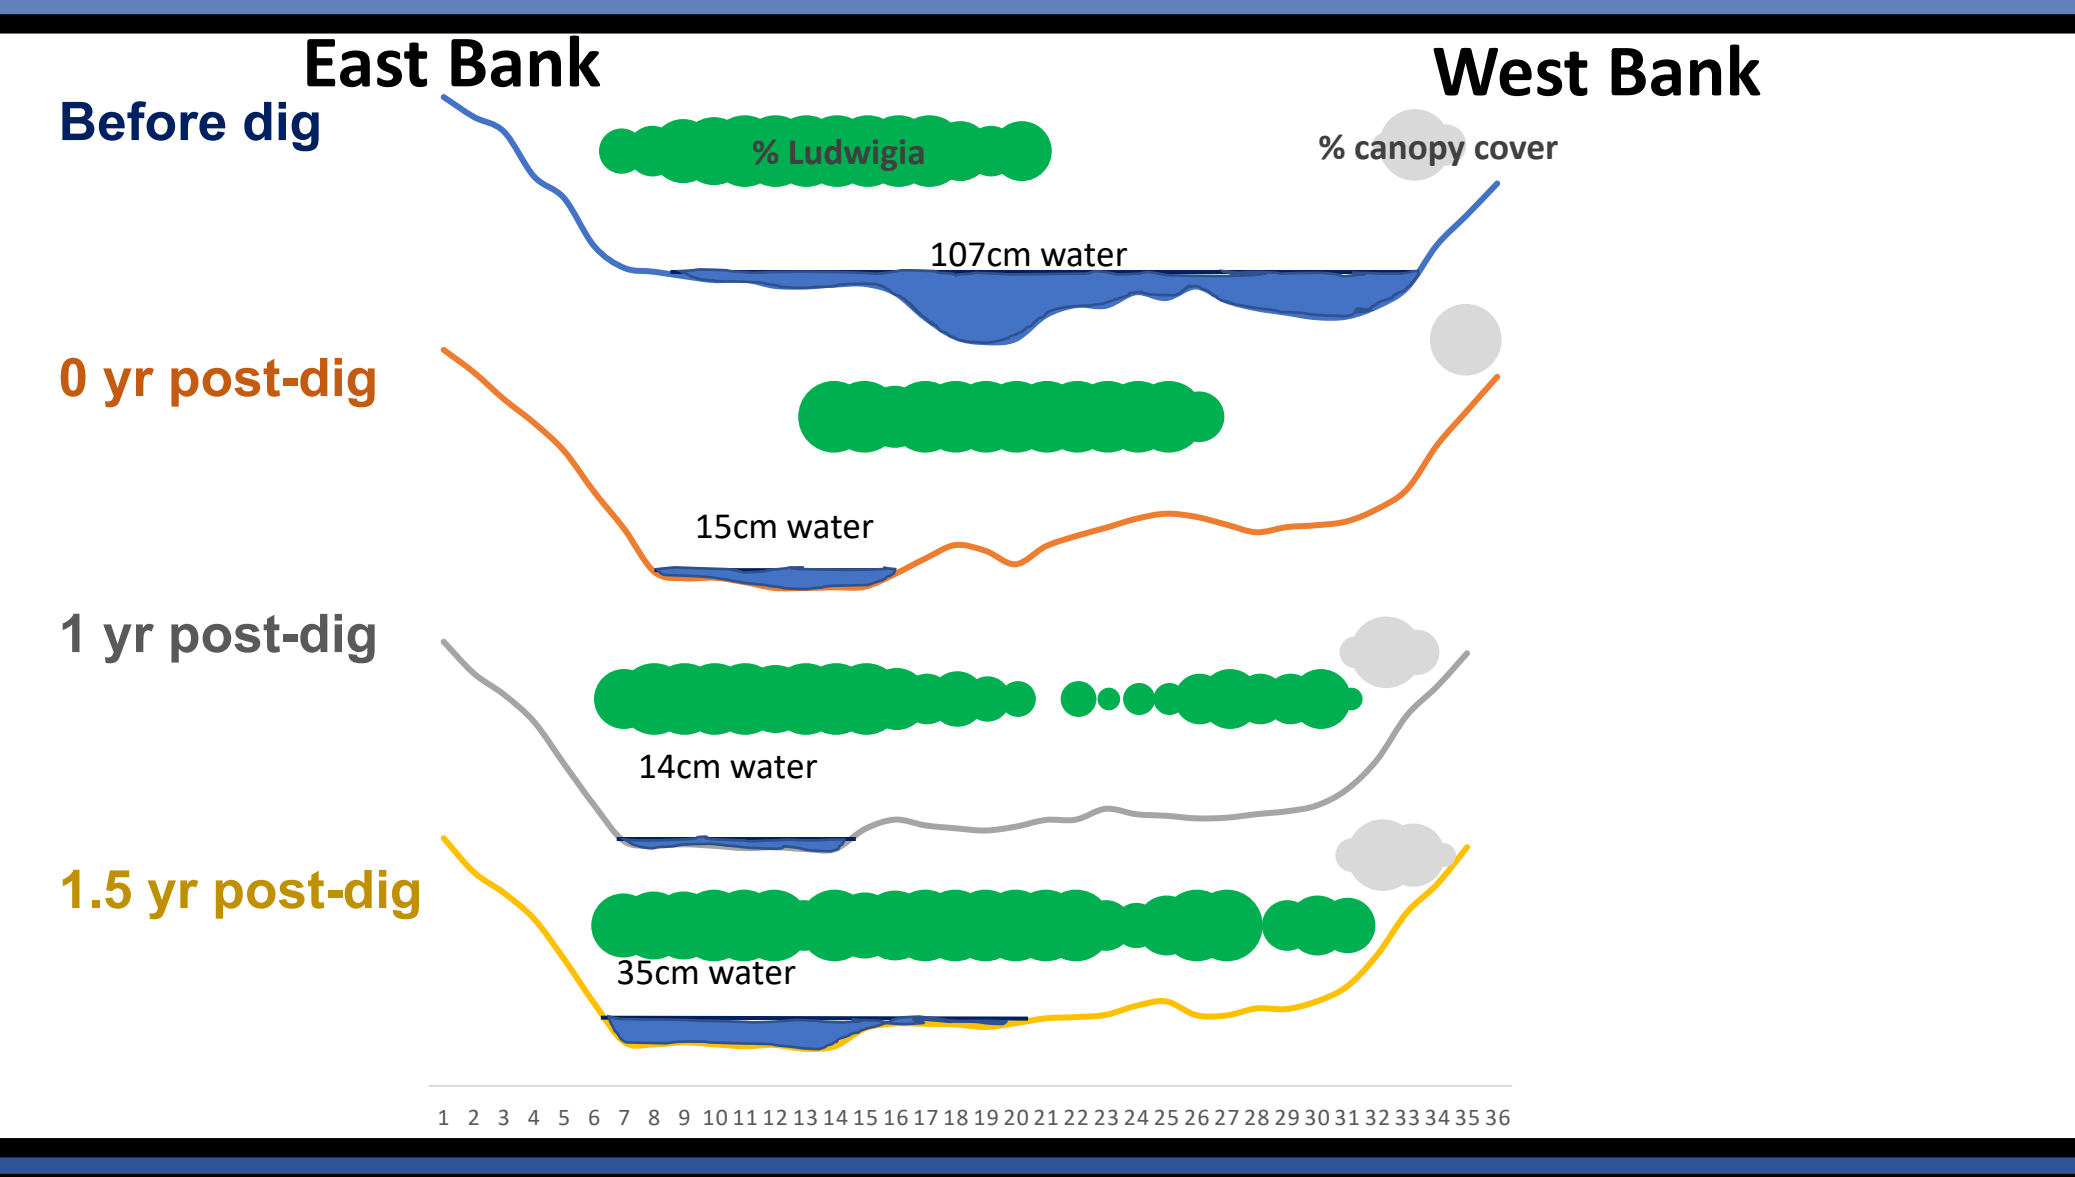
### Site 5

- **SITE FIVE:** modified to have a deep part along the east bank
- During the sediment removal, previously deep standing water flowed out
- *Ludwigia* has spread as the water has become shallower
