# Monitoring Impacts of a Sediment Removal Project in the Laguna de Santa Rosa

**GEP 359 Water Research Methods, Sonoma State University**

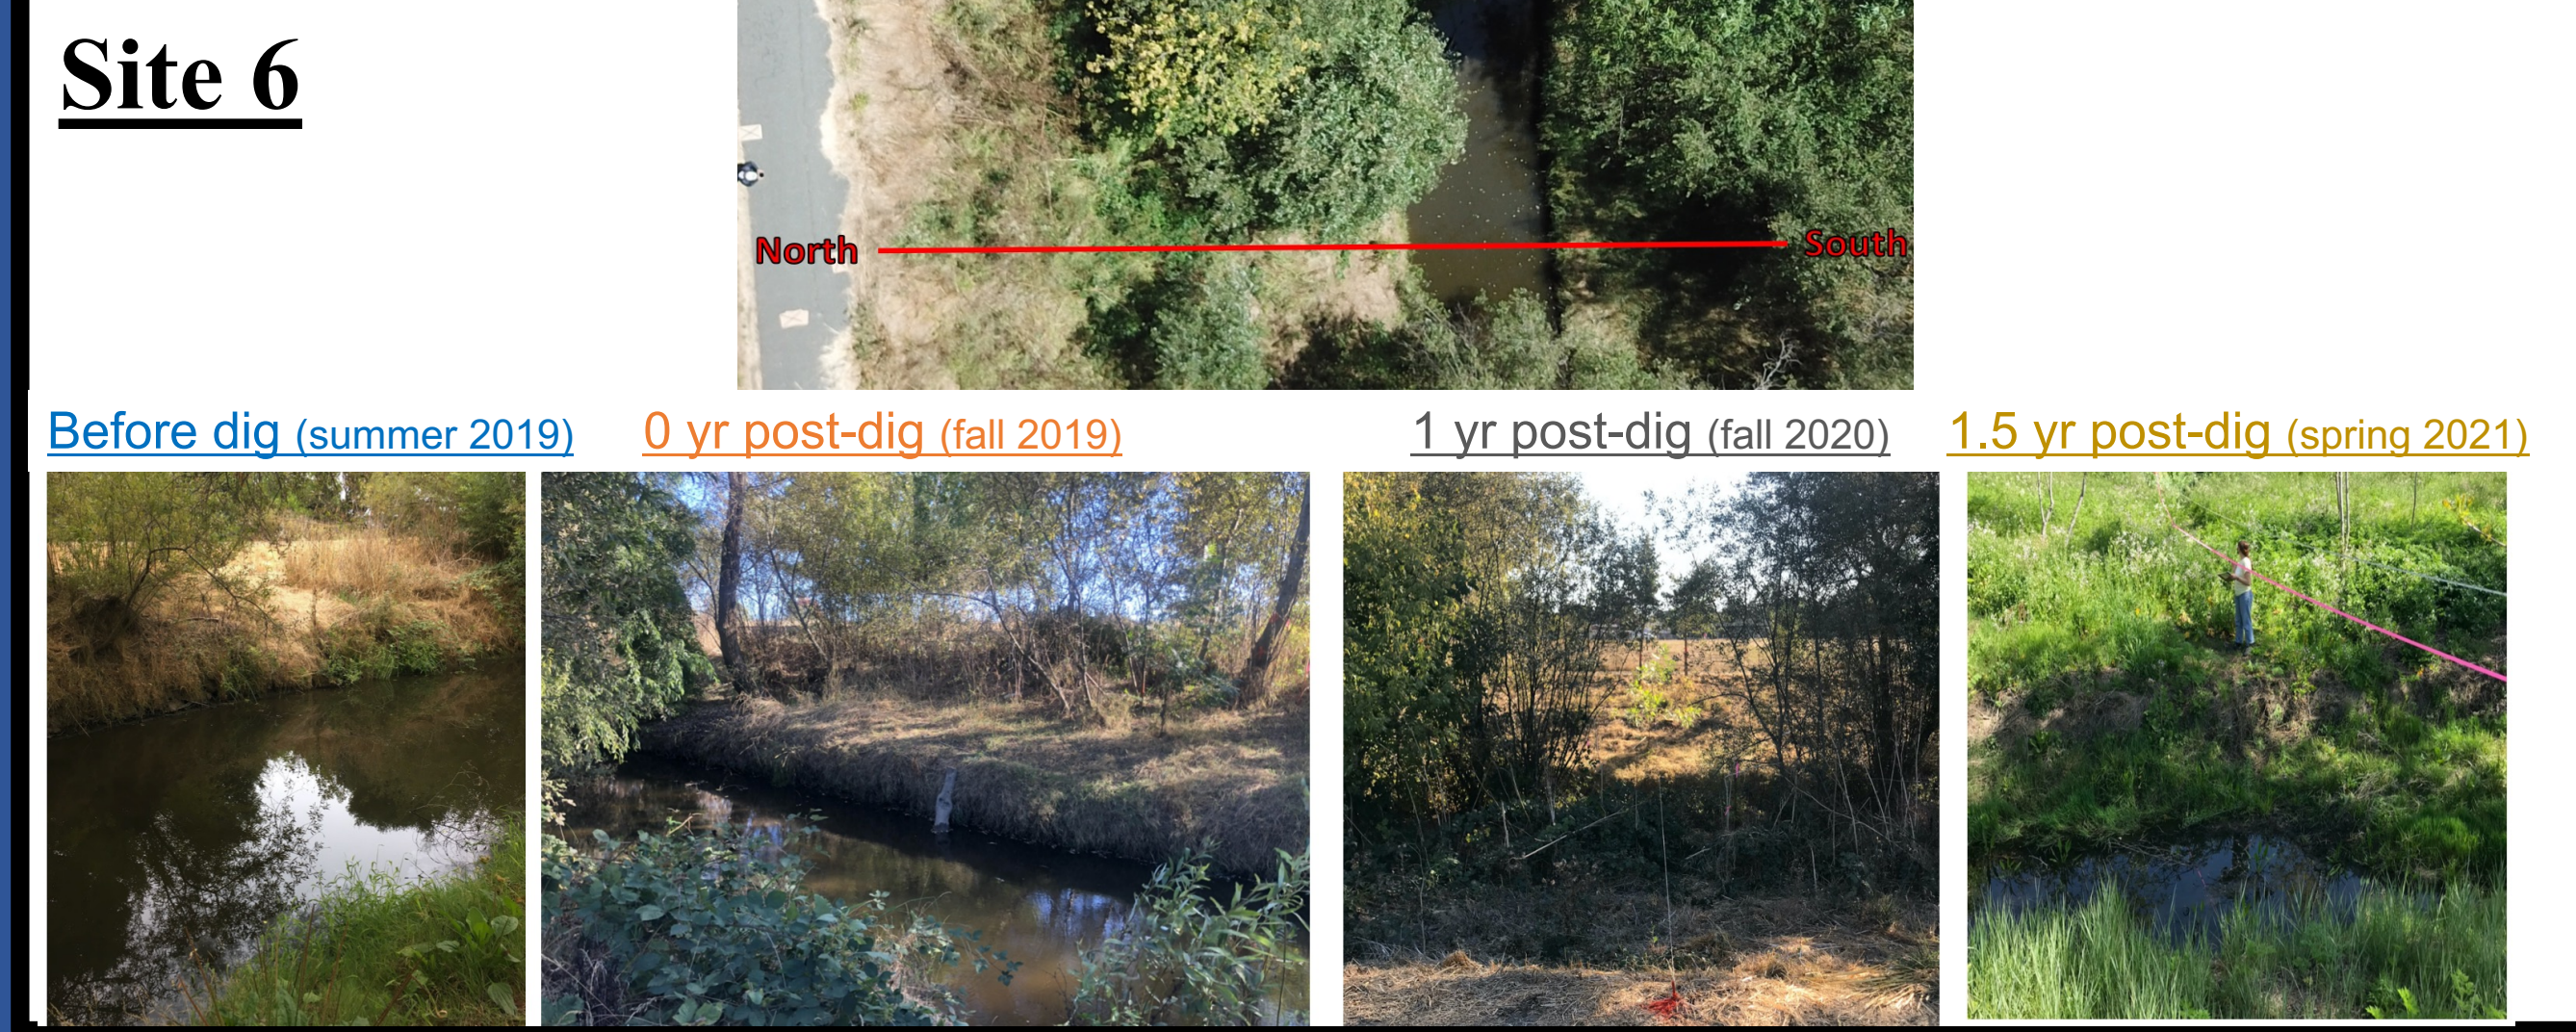
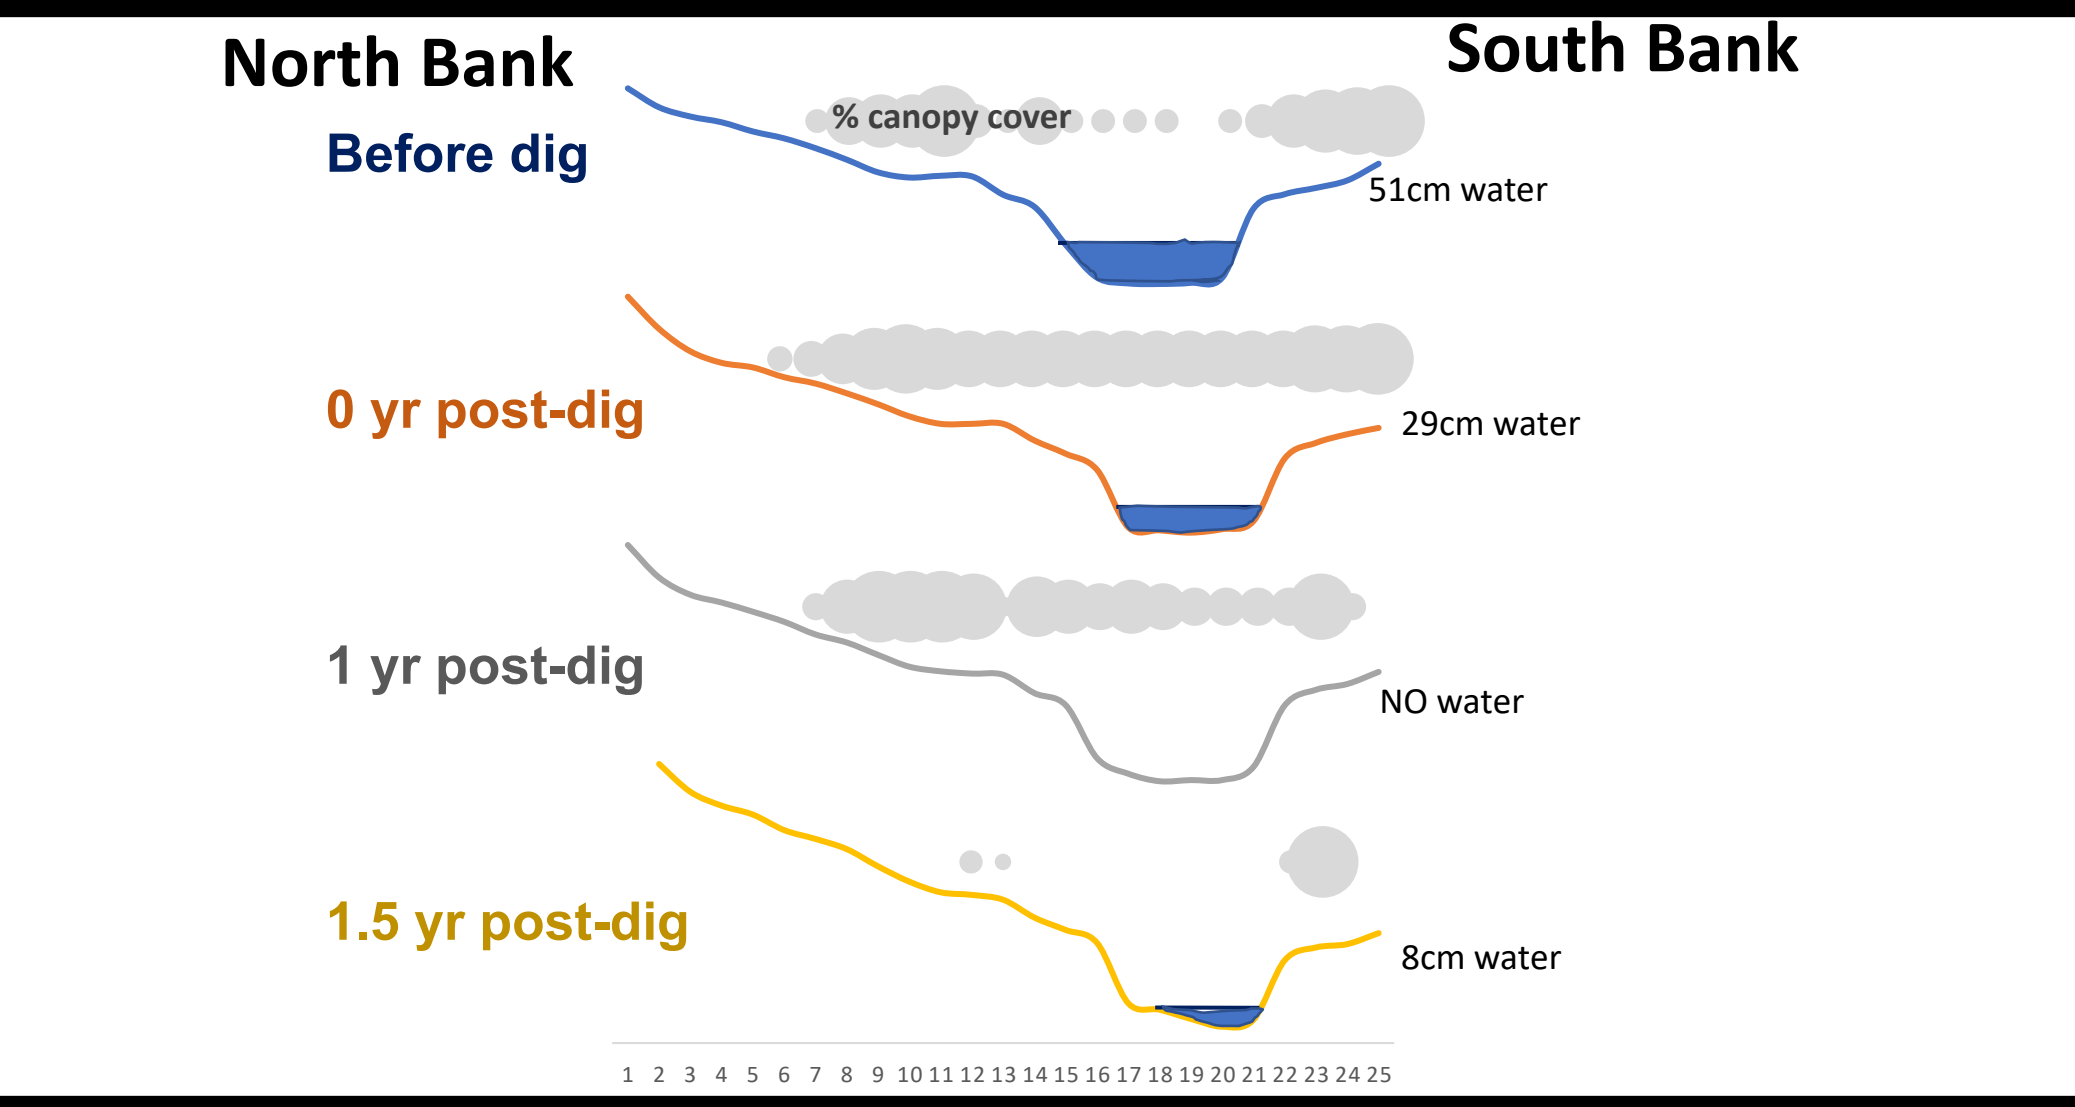
### Site 6

- **SITE SIX:** not modified during the sediment removal
- *Ludwigia* is consistently absent from this site
- The sediment removal caused this site to be dry the following summer
- Most canopy cover as recently been removed
