GEP359 Water Research Methods, Sonoma State University

Abstract

Sonoma Water plans to dig out sediment from the Laguna de Santa Rosa near Stony Point Road in Rohnert Park as part of their Water Quality Credit Trading Program. This part of the Laguna has become progressively shallower over the years as nutrient-rich sediment that washed downstream has slowed down and settled out. The problem with it being wide, shallow, and sunny is that the invasive weed *Ludwigia* thrives in these conditions and has overgrown the Laguna in this area. The digging project will result in a narrower, deeper, more shaded channel (Figure 1). We have identified six study sites in the area that will have sediment removed. At each site, we have taken photographs and characterized the shape of the channel, water depth, and plant types present. We plan to revisit these six sites each semester and repeat the measurements, expecting that the deeper channel design will prevent *Ludwigia* growth and improve habitat health.

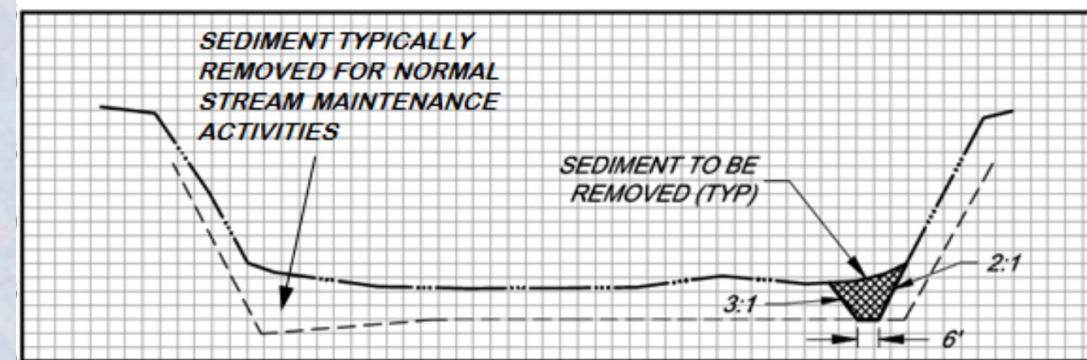
Figure 1. Channel shape.

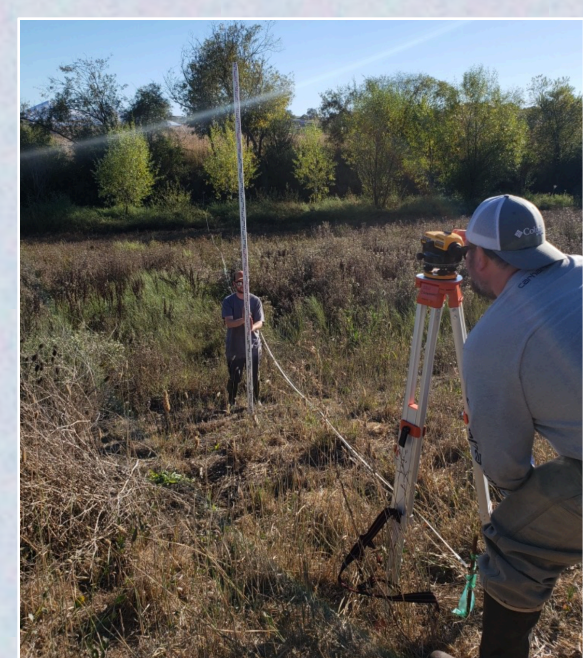
Creek morphology - the shape of the channel bottom was measured every meter using auto level equipment and visualized using Excel.

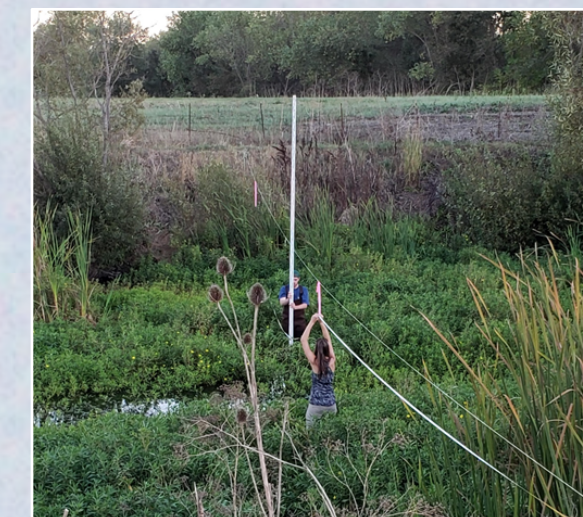
Water Depth – measured every meter using a meter stick (pushed down to root level if *Ludwigia* was present).

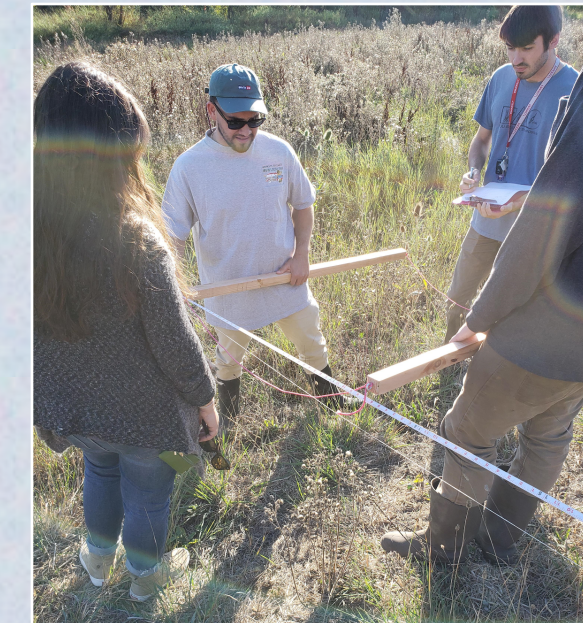
Mapping Plant Species – 4'x4' quadrats were used to mark off plots along the transect lines at each of the six sites. Plant type and coverage were recorded for each quadrat.
