**ASSESSING COPELAND CREEK INTER-WATERSHED
OVERBANK FLOW, A PILOT STUDY**

A THESIS

Presented to the Department of Geography, Environment,
and Planning of Sonoma State University

May 9, 2018

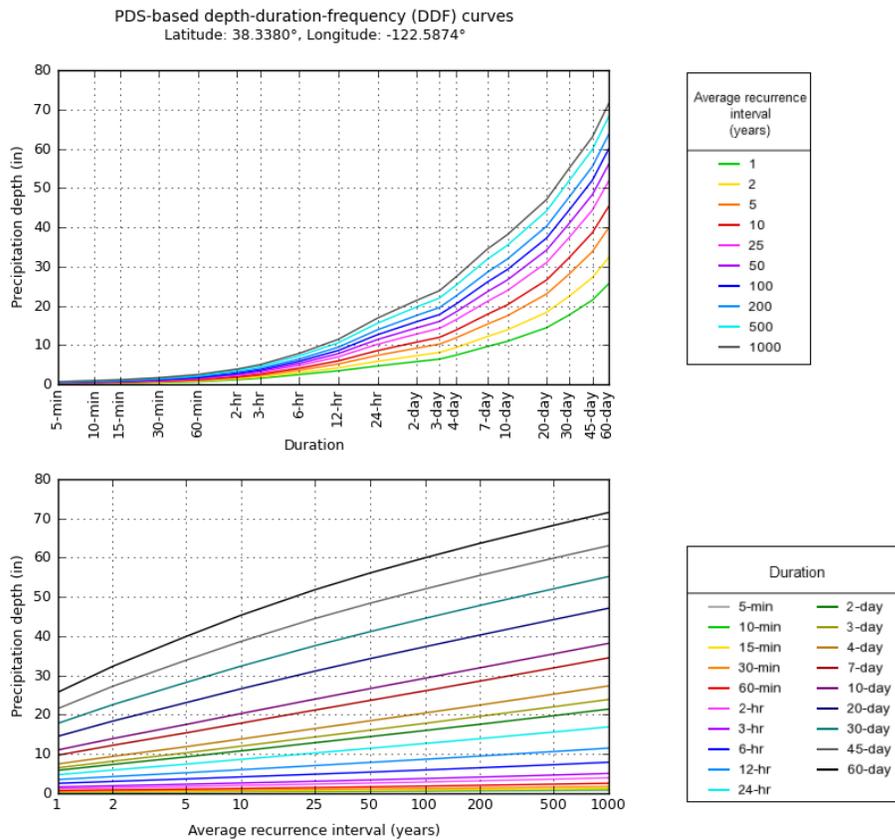
Figure 3 - Partial Duration Series (PDS) graphical representation of various storm events in the Copeland Creek headwater (Source: NOAA Atlas 14, Volume 6, Version 2, n.d.)

(NOAA n.d.). It is determined based on the probability that a given amount will be met or exceeded in any given year. For example, a 1-year storm is produced or exceeded every year (1/1, or 100 percent), a 25-year storm has a 4 percent chance of occurring or being exceeded in any given year (1/25), while a 100-year storm has a 1 percent chance (1/100). Using this statistical tool in combination with measured precipitation data, one can estimate the likelihood a storm event of a given magnitude is to happen at a given location. Thus, in the headwaters of Copeland Creek, a 24-hour storm 2-year storm has a 50 percent chance to occur in any given year, in which it will precipitate 4.73” of rainfall or more (NOAA n.d.). Similarly, a 24-hour 100-year storm (1 percent chance of occurring in any given year) will precipitate 12.7” or more of rainfall. Table 1 shows the precipitation for each return interval used in this study, and Figure 3 shows this data (and more) graphically.

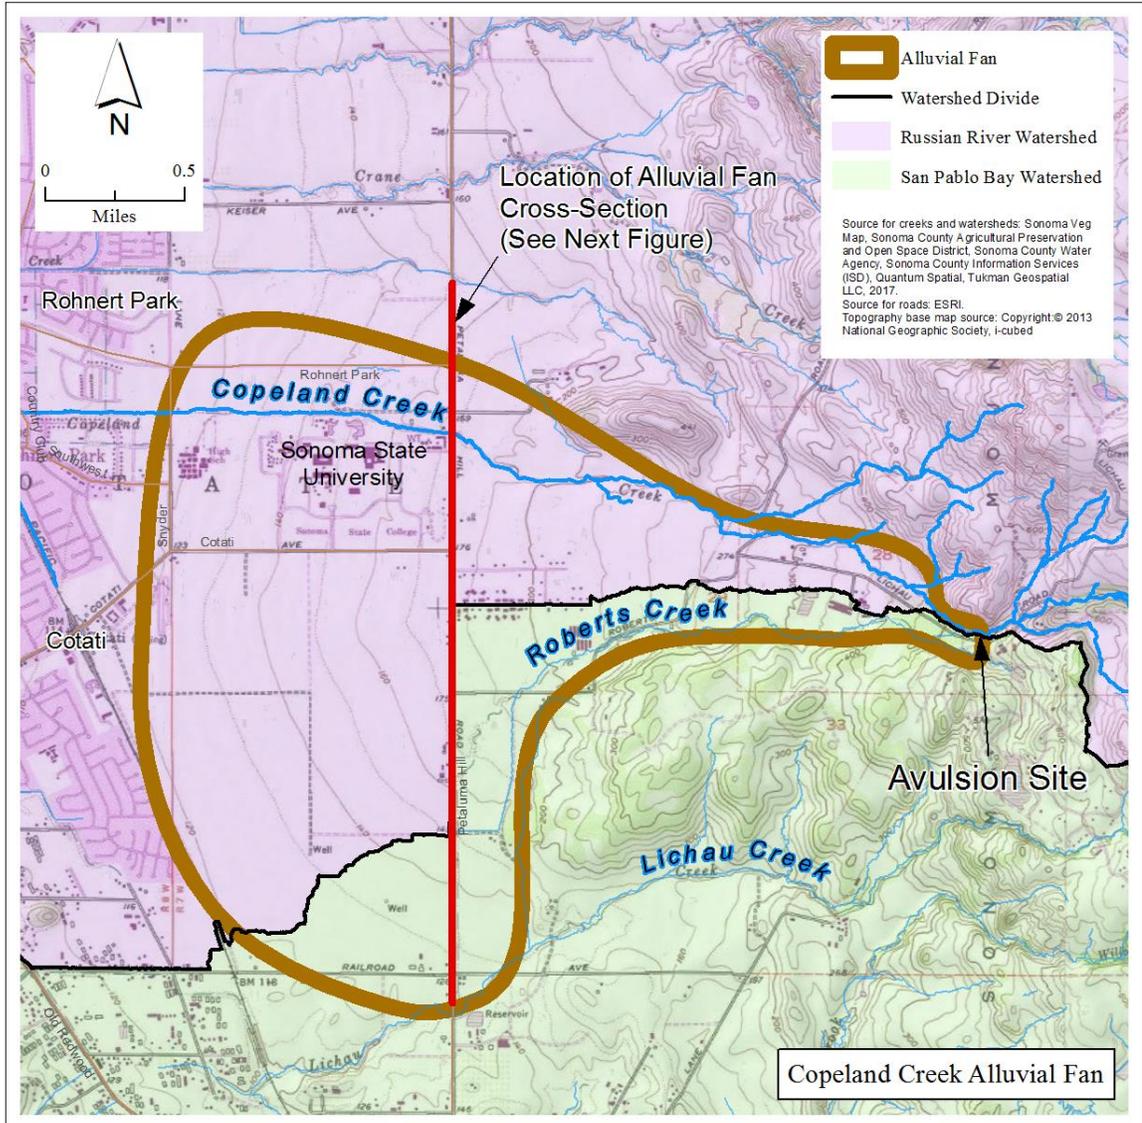
Figure 4 – Topographic map showing alluvial fan (highlighted in brown)

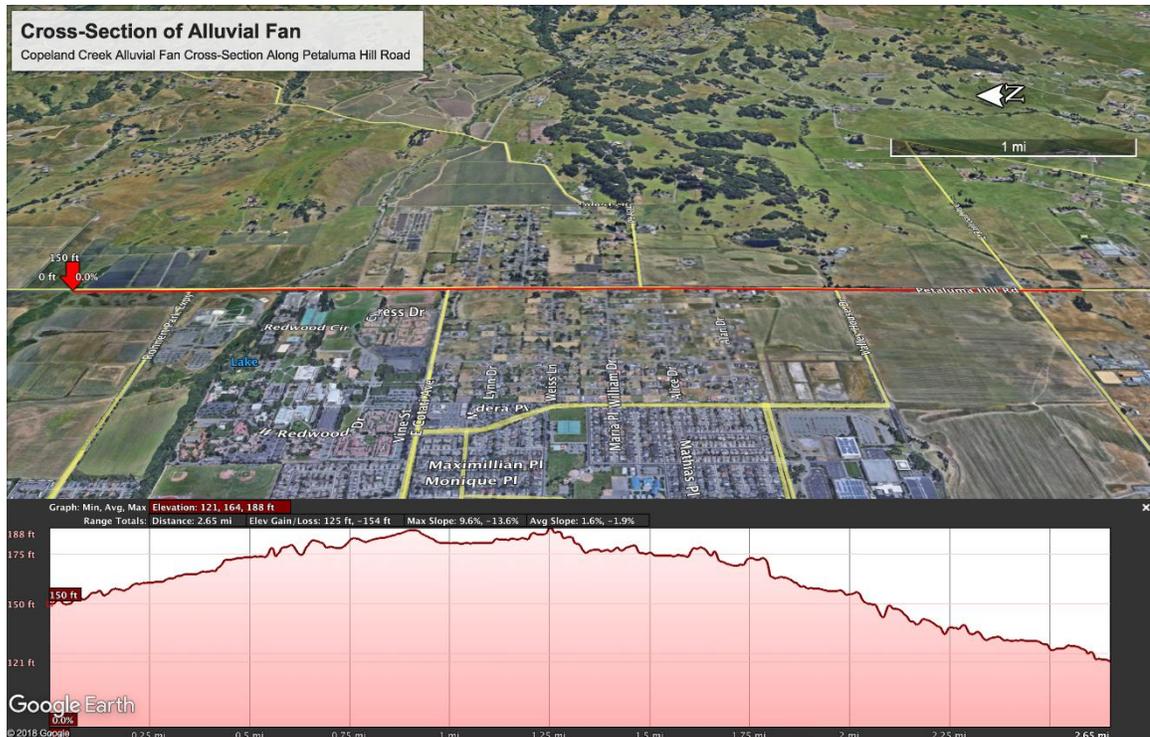
Figure 5 - Cross-section along Petaluma Hill Road of Copeland Creek alluvial fan

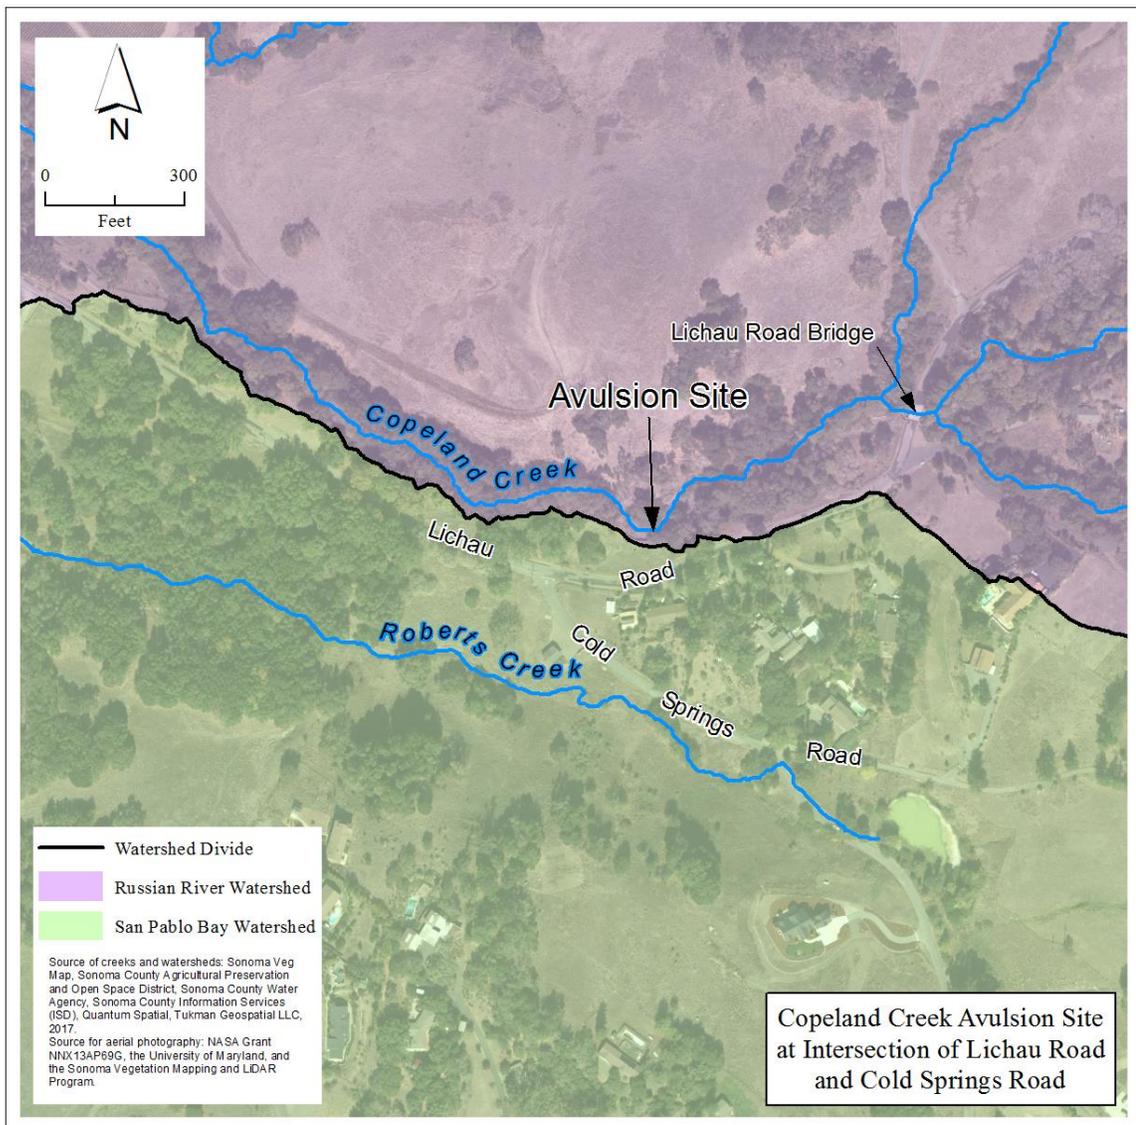
Figure 7 - Copeland Creek Avulsion Site

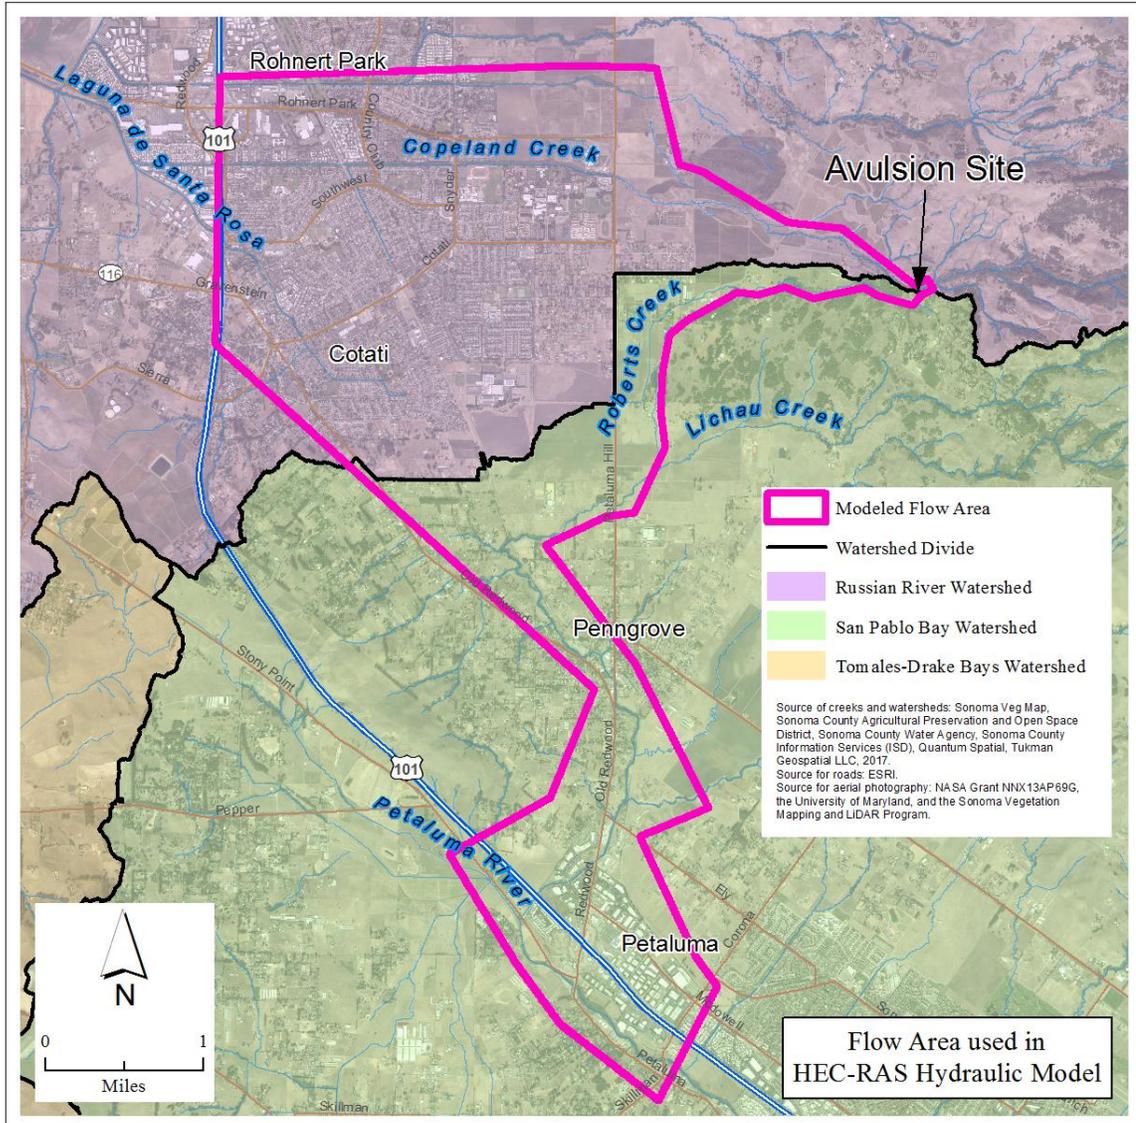
Figure 8 – Flow area used in HEC-RAS hydraulic model, which defines the spatial extent of the model

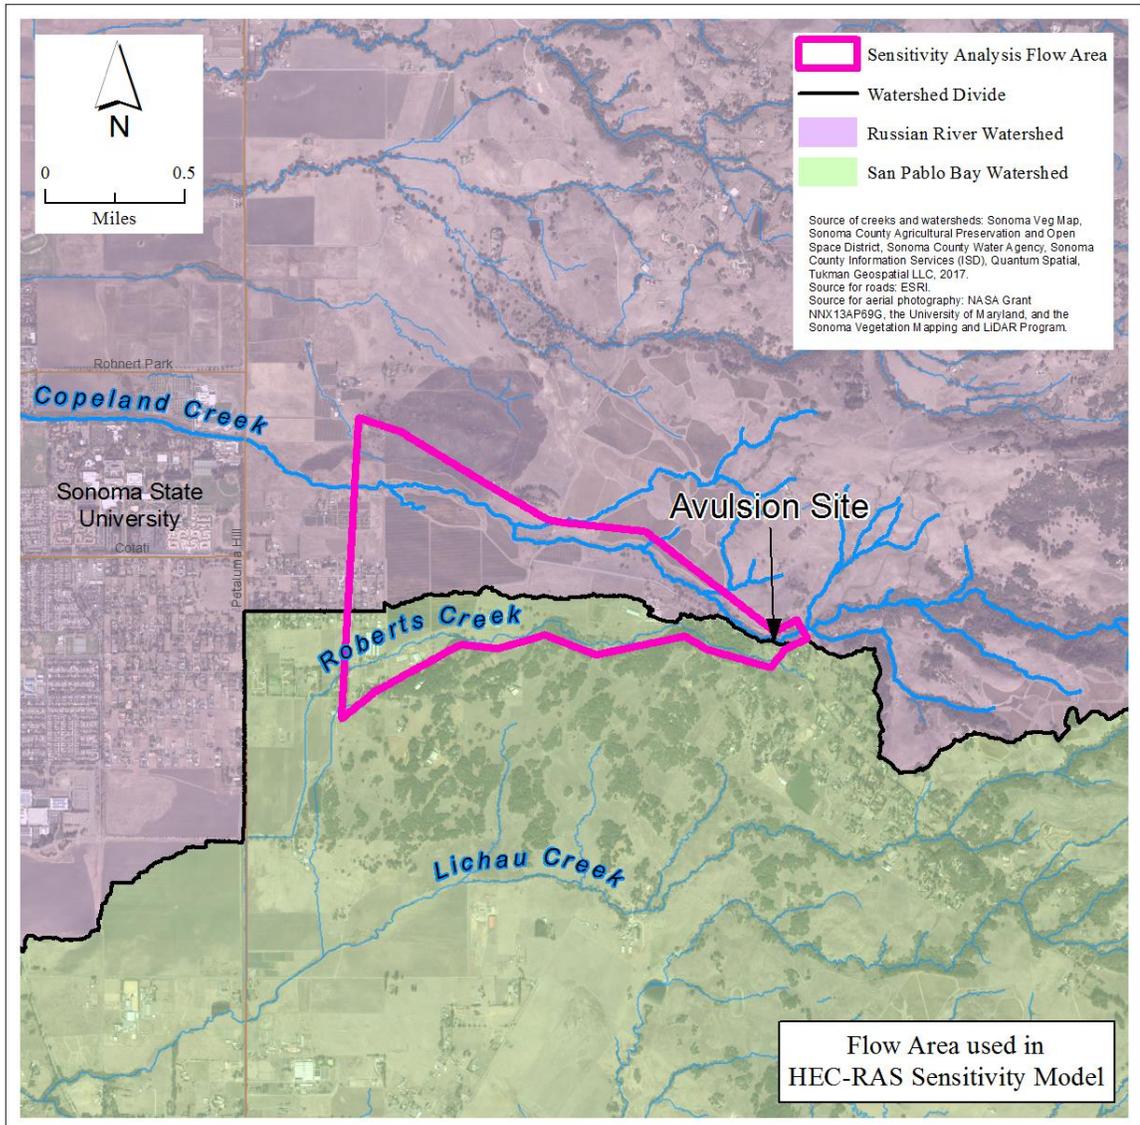
Figure 9 - Test flow area used for sensitivity analysis

A sensitivity analysis was performed to determine the computational mesh cell size. The sensitivity analysis modeled Copeland Creek flows at Lichau Bridge utilizing a 25-year storm event (described later), encompassing the area downstream to just east of Petaluma Hill Road (Figure 9). The sensitivity model was run for 100-foot cell size, 50-foot cell size, 20-foot cell size, and 5-foot cell size. After review of the output and considering computational time, 20-foot cell size was determined to be the best balance

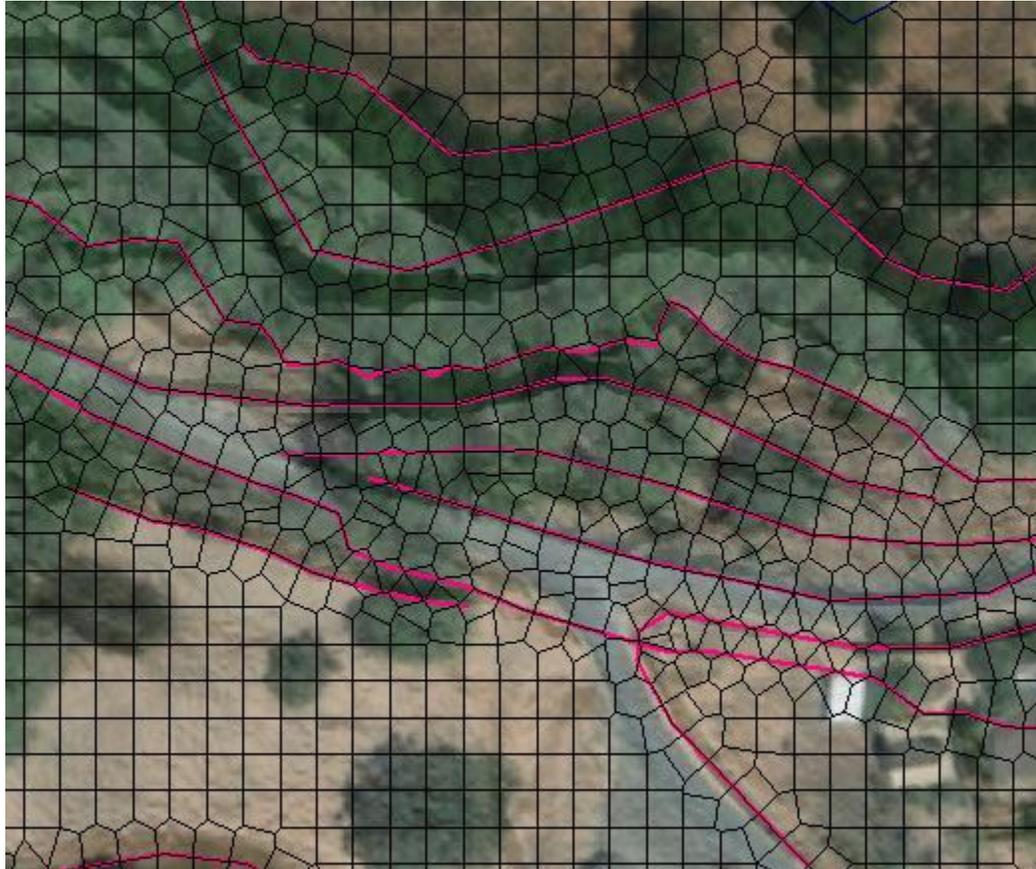
Figure 10 - Subset of breaklines (pink lines) added to reorient cell faces to capture stream banks

captured in the computational mesh, breaklines were manually added along stream banks (and some road ways), along Copeland Creek, Roberts Creek, Lichau Creek, and Petaluma River (Figure 10). This resulted in cell faces that align with the breaklines, ensuring stream bank elevations are more accurately captured in the model.

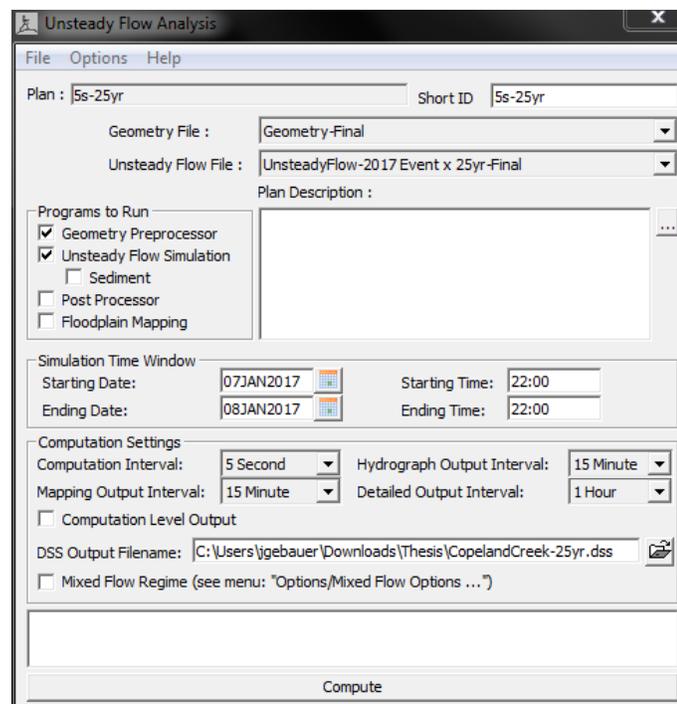
Figure 11 - Example of model parameters prior to model simulation

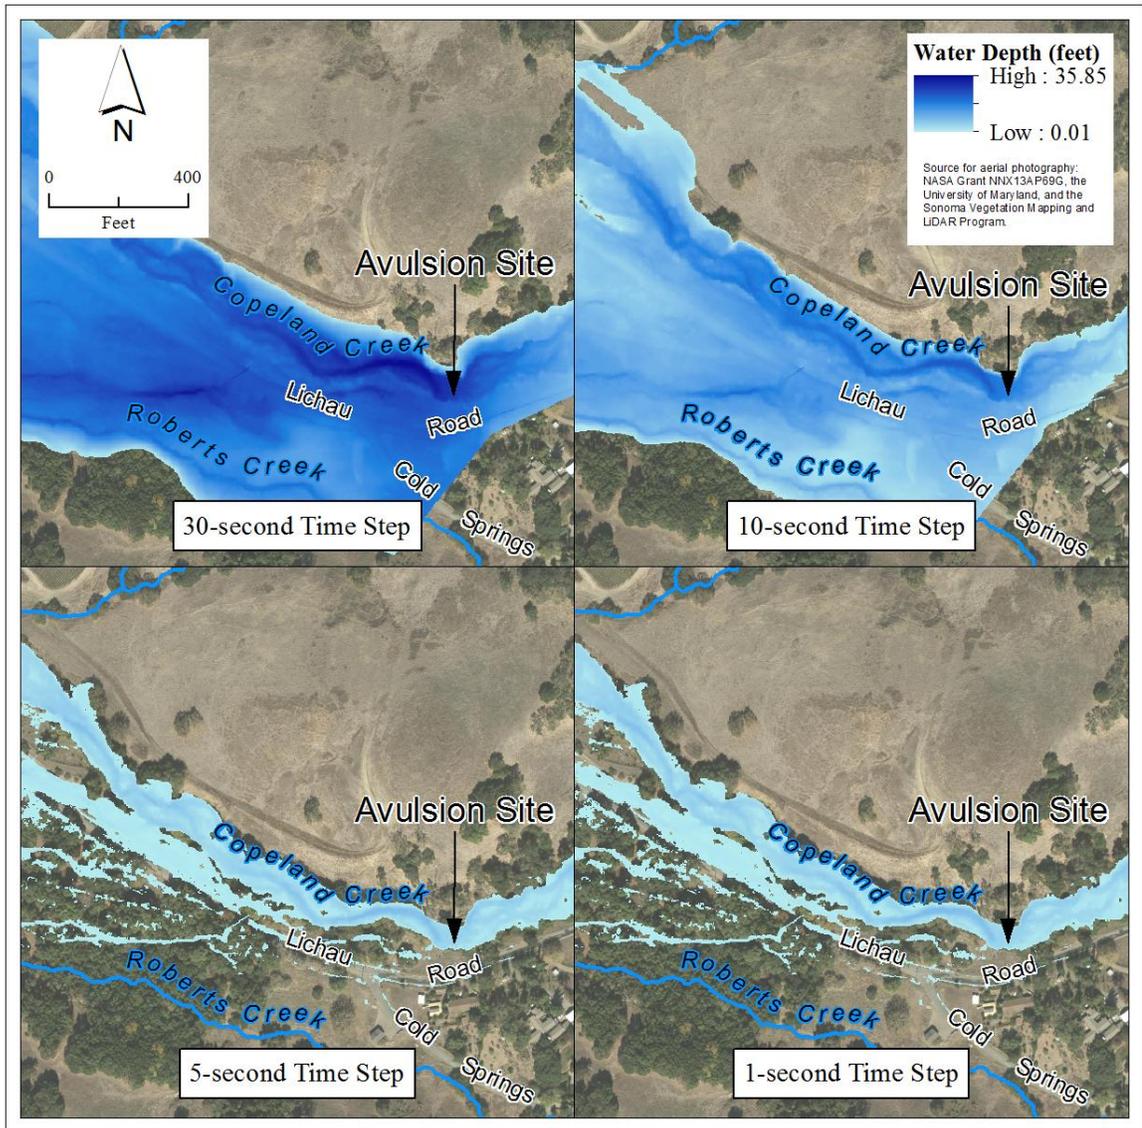
Figure 12 - Sensitivity analysis results of water depths for 30-second (top left), 10-second (top right), 5-second (bottom left), and 1-second (bottom right) computational time steps

The model was run for computational time steps of 1-minute, 30-seconds, 10-seconds (collectively “large time steps”), 5-seconds, and 1-second (“small time steps”). Results for large time steps were shown to be inaccurate; for example, floodwater depths in the floodplain south of Copeland Creek (between Copeland Creek and Roberts Creek) were shown to range from 15 feet for the 10-second time step to over 35 feet for the 1-minute time step (Figure 12). These depths are more than an order of magnitude higher than the depths reported from the online survey (discussed later) during the 25-year peak flow flood event on January 8, 2017. Moreover, the inconsistency in the resulting extents

of inundation and water depths between each of the larger time steps suggest that none of these time steps are able to accurately model the test scenario. Conversely, the small time steps resulted in a convergence of modeled results, with only very slight differences between them related to inundation extent, but identical inundation depths where the two results were coincident (Figure 12). The flood extent differences were deemed minimal and insignificant, and therefore a 5-second time step was selected for the full model run. Selecting a 1-second or sub-second time step would result in significantly longer computation time, with little increase in model accuracy.

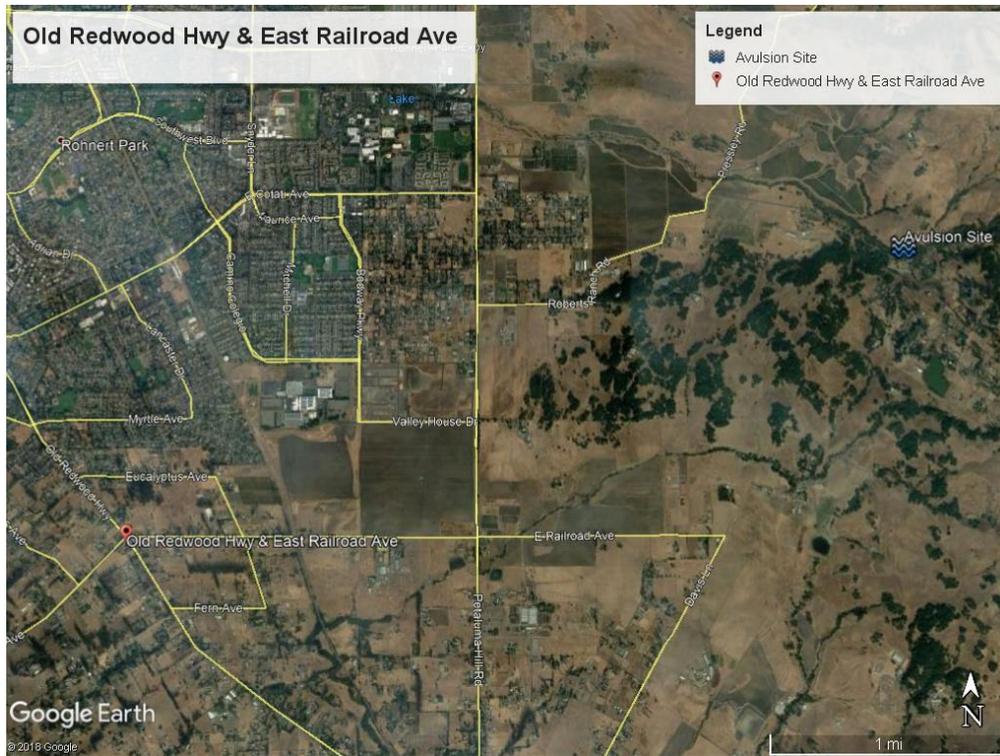
Figure 13 - Location of avulsion site and flooding near Old Redwood Highway and East Railroad Avenue

One respondent reported flooding from the January 8, 2017 event of 3 to 4 feet deep near Old Redwood Highway and East Railroad Avenue (Figure 13). The respondent provided pictures of the flooding (Figure 14), which clearly shows heavy inundation of a property, and stated the flood resulted in the incurrence of \$32,000 in property damages. No other respondents reported property damages from any Copeland Creek flood events.

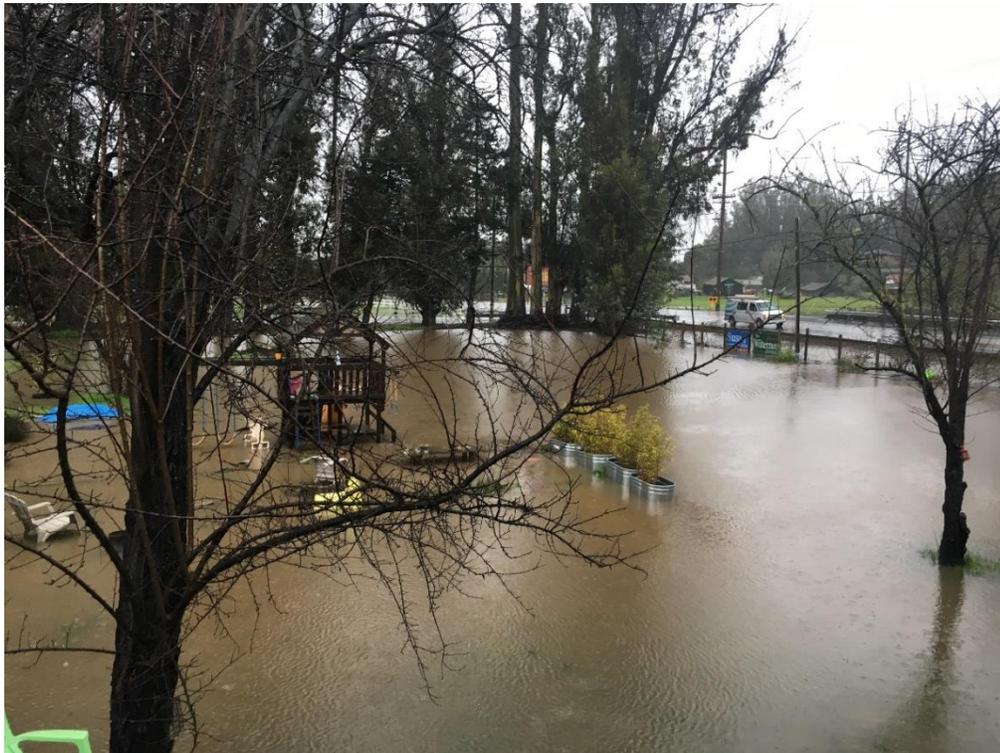
Figure 14 - Flooding near Old Redwood Highway and East Railroad Ave, January 8, 2017 (Source: Paul Efron)

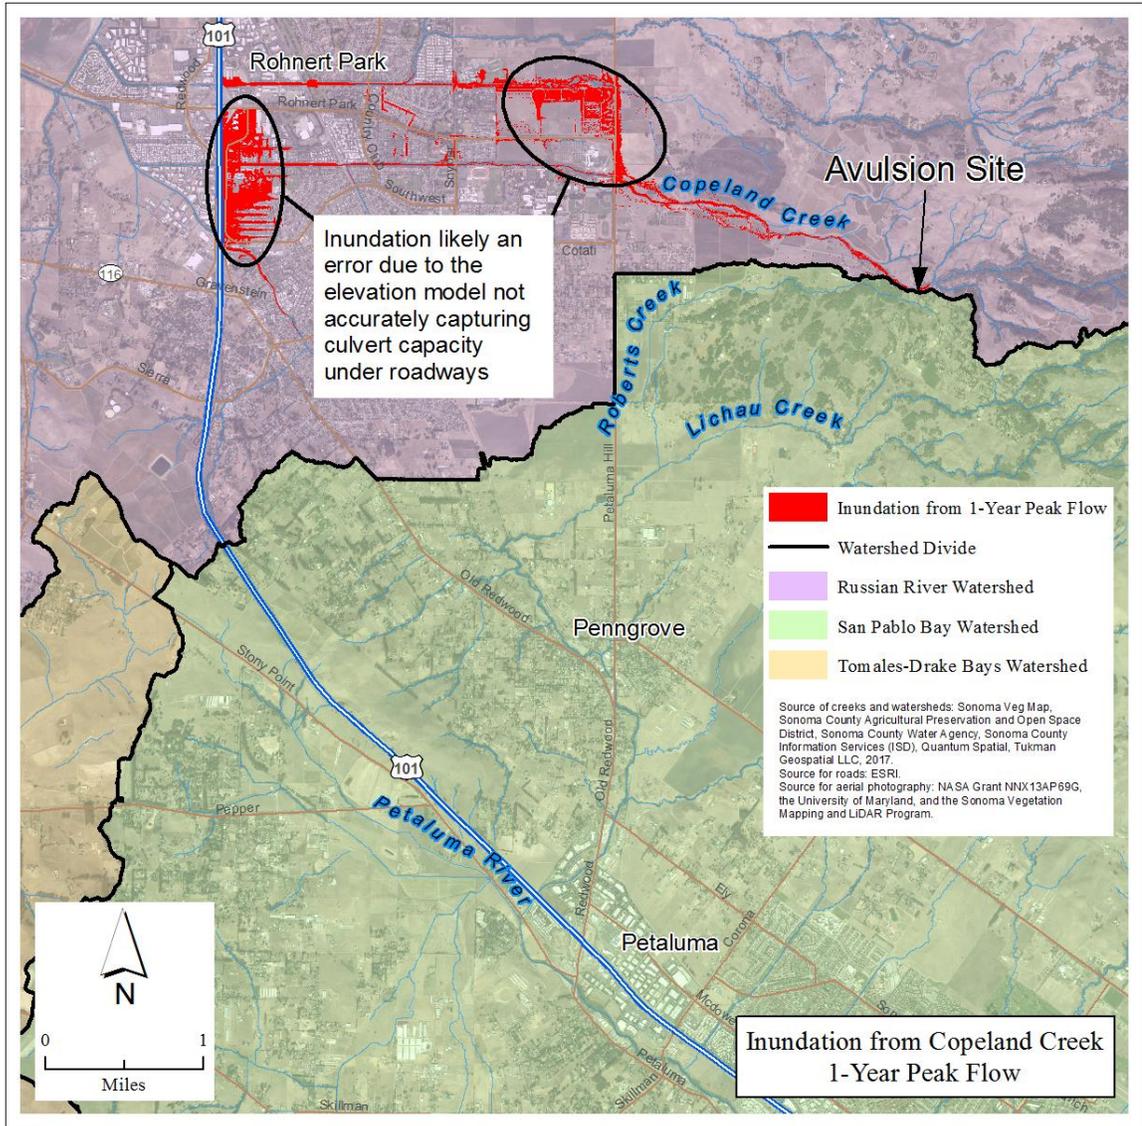
Figure 16 - Inundation from 1-year peak flow

The HEC-RAS 2D hydraulic model results for 1-year, 2-year, 10-year, 25-year, 50-year, and 100-year peak flow events are shown below in Figures 16 through 21. Copeland Creek floodwaters from the avulsion, given the right storm conditions, can leave the Russian River watershed and enter the San Pablo Bay watershed. Overbank flow from Copeland Creek first travels across Lichau Road and the adjacent lands before entering Roberts Creek. Copeland overbank flow then travels through Roberts Creek to Lichau Creek, where it then enters the Petaluma River. The results suggest that Copeland Creek jumps its bank at the avulsion site when a storm that causes 10-year peak flow (or more) at the Lichau Road bridge crossing occurs (Figures 22 through 27). Modeled overbank flow from Copeland Creek contributes up to 1.7 feet to the river stage height of Lichau Creek near Penngrove from 10-year peak flows, up to 4.0 feet from 25-year peak flows, up to 4.5 feet from 50-year peak flows, and up to 5.2 feet from 100-year peak flows. Farther downstream, Copeland Creek overbank flow contributes to river stage height in the Petaluma River during 25-, 50-, and 100-year peak flows, adding up to 2.0 feet, 2.7 feet, and 2.9 feet respectively.

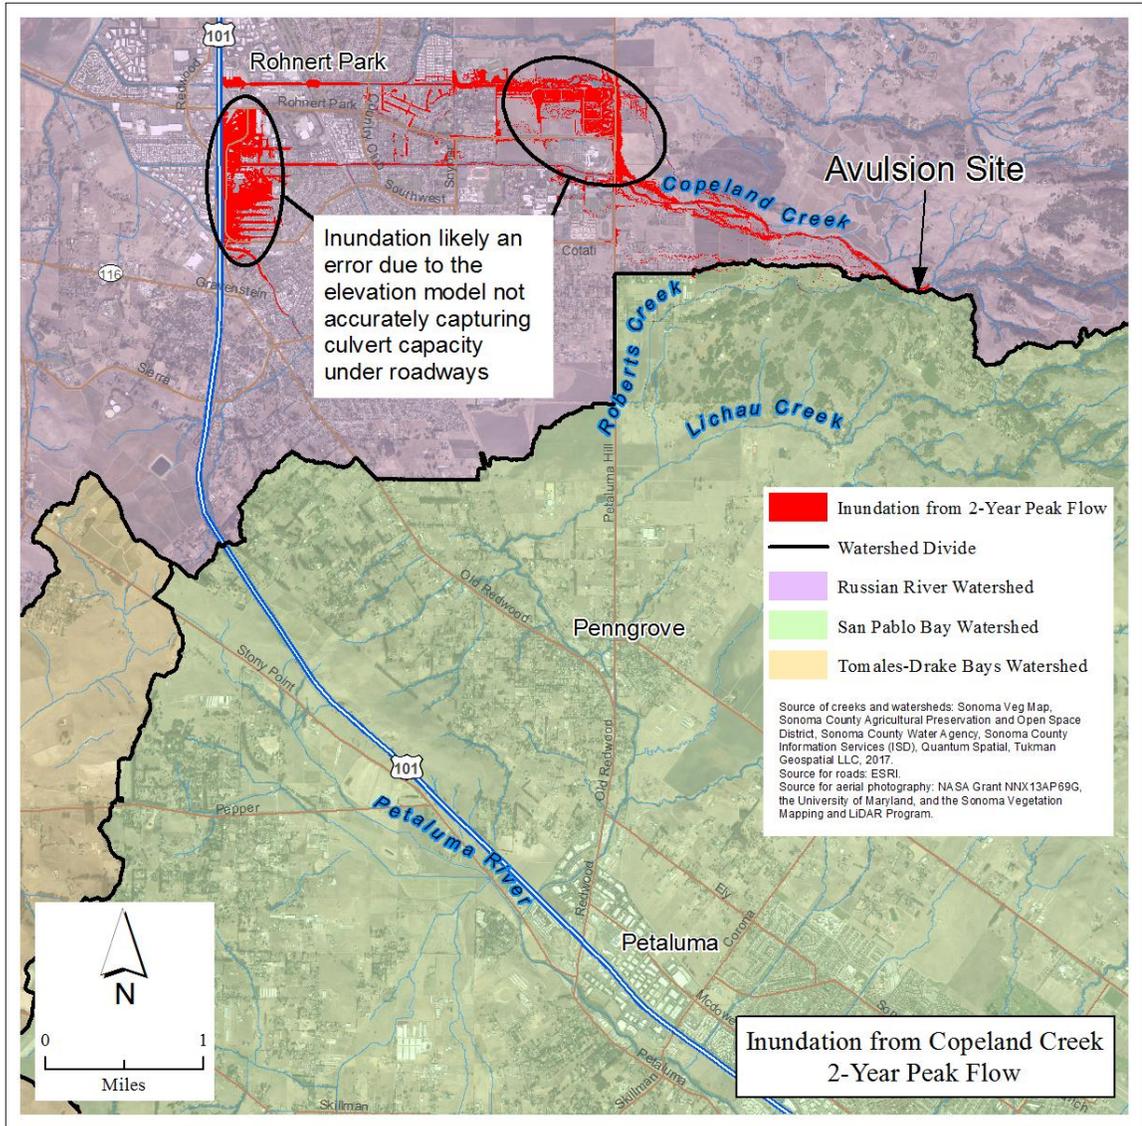
Figure 17 - Inundation from 2-year peak flow

another avulsion site about 1,000 feet downstream of the study avulsion site (Figures 17 and 23). This downstream avulsion site warrants further investigation, as it appears it is at least partially responsible for the flooding seen by many residents along Chester Drive, between Petaluma Hill Road and Roberts Road.

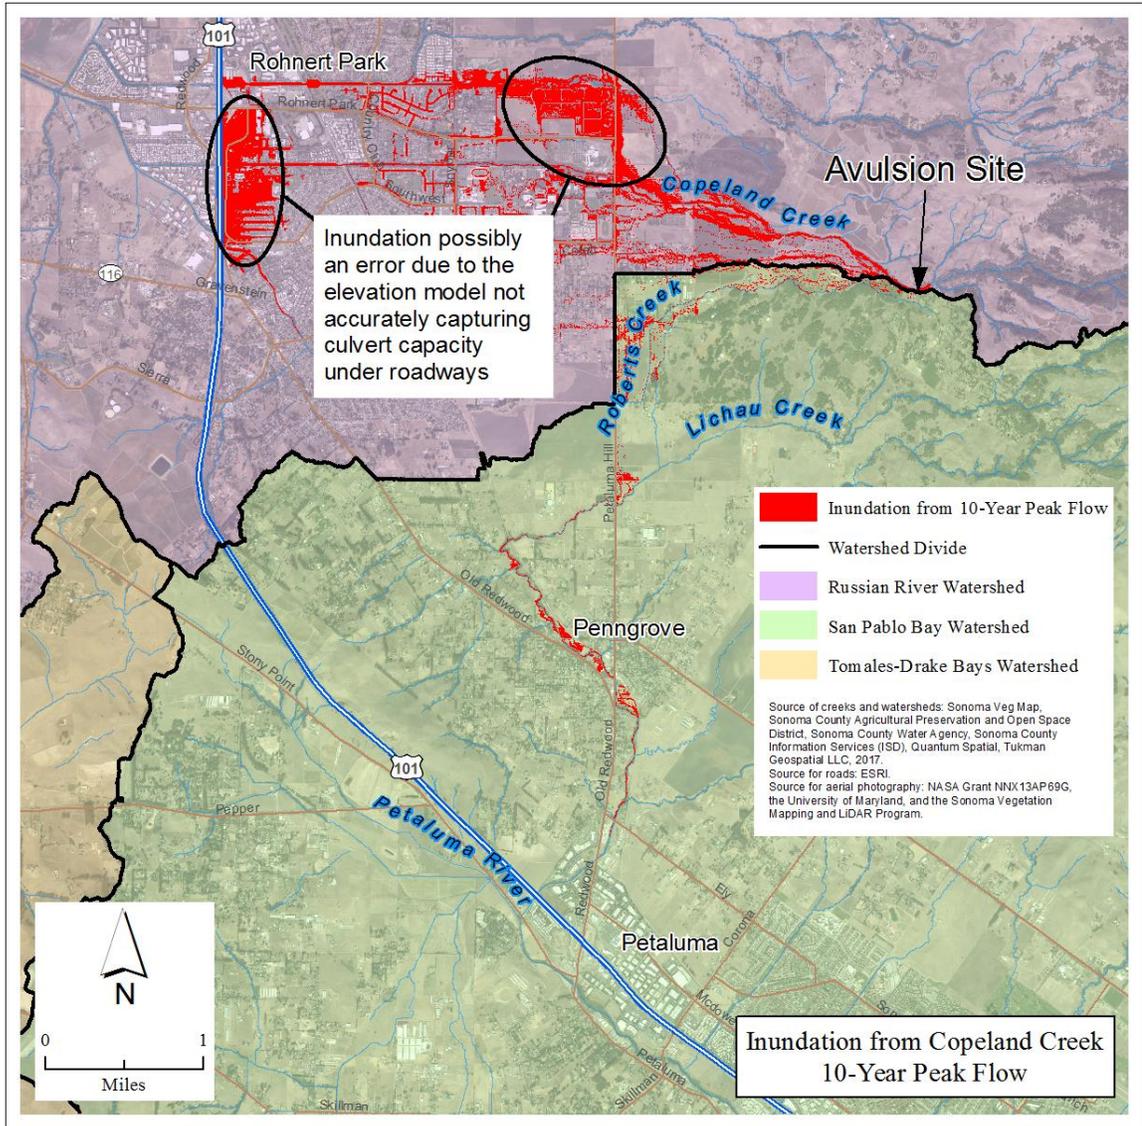
Figure 18 - Inundation from 10-year peak flow

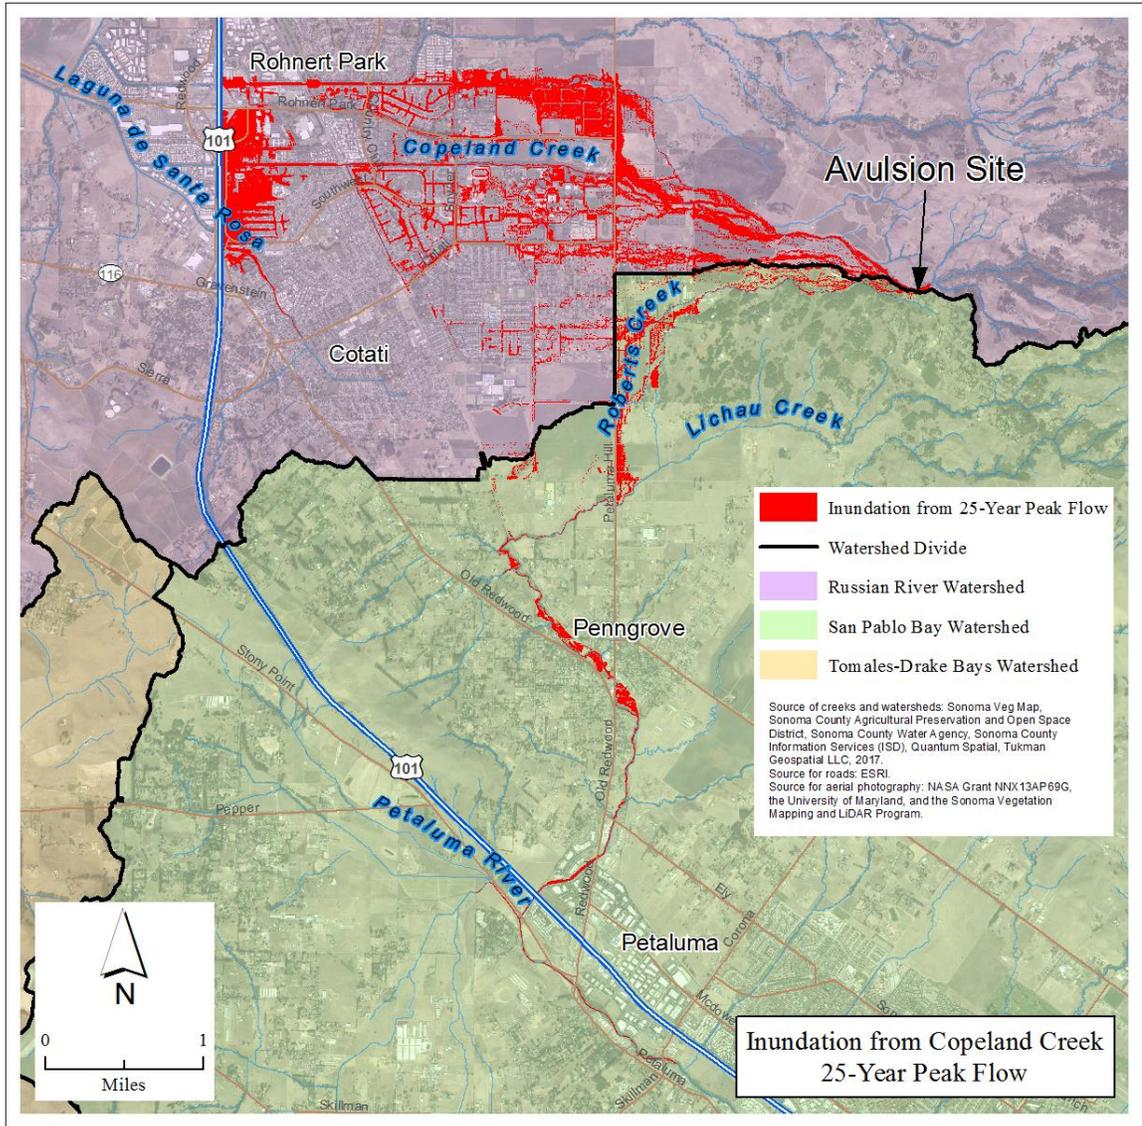
Figure 19 - Inundation from 25-year peak flow

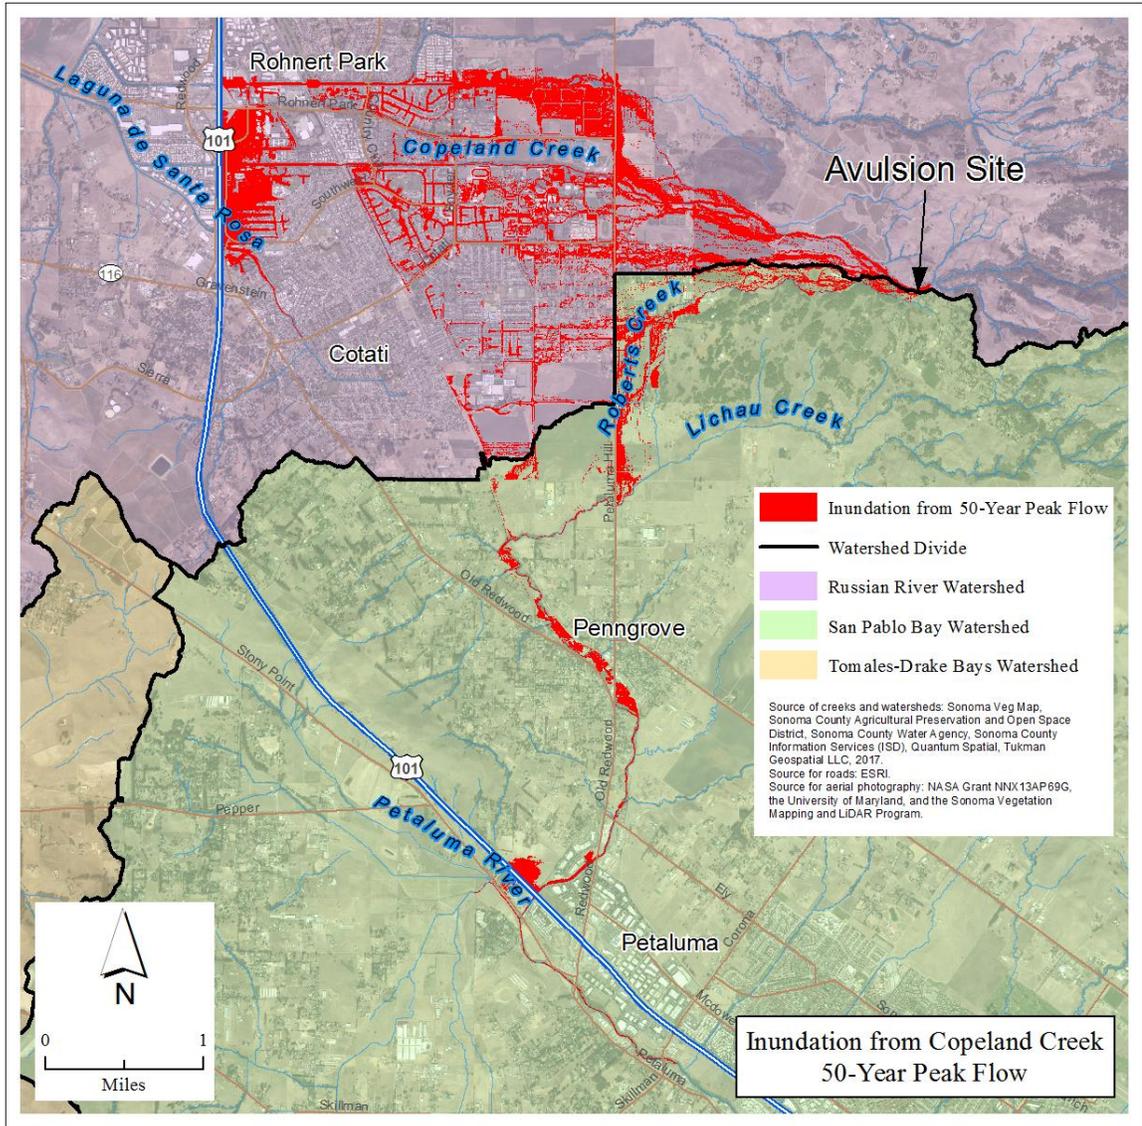
Figure 20 - Inundation from 50-year peak flow

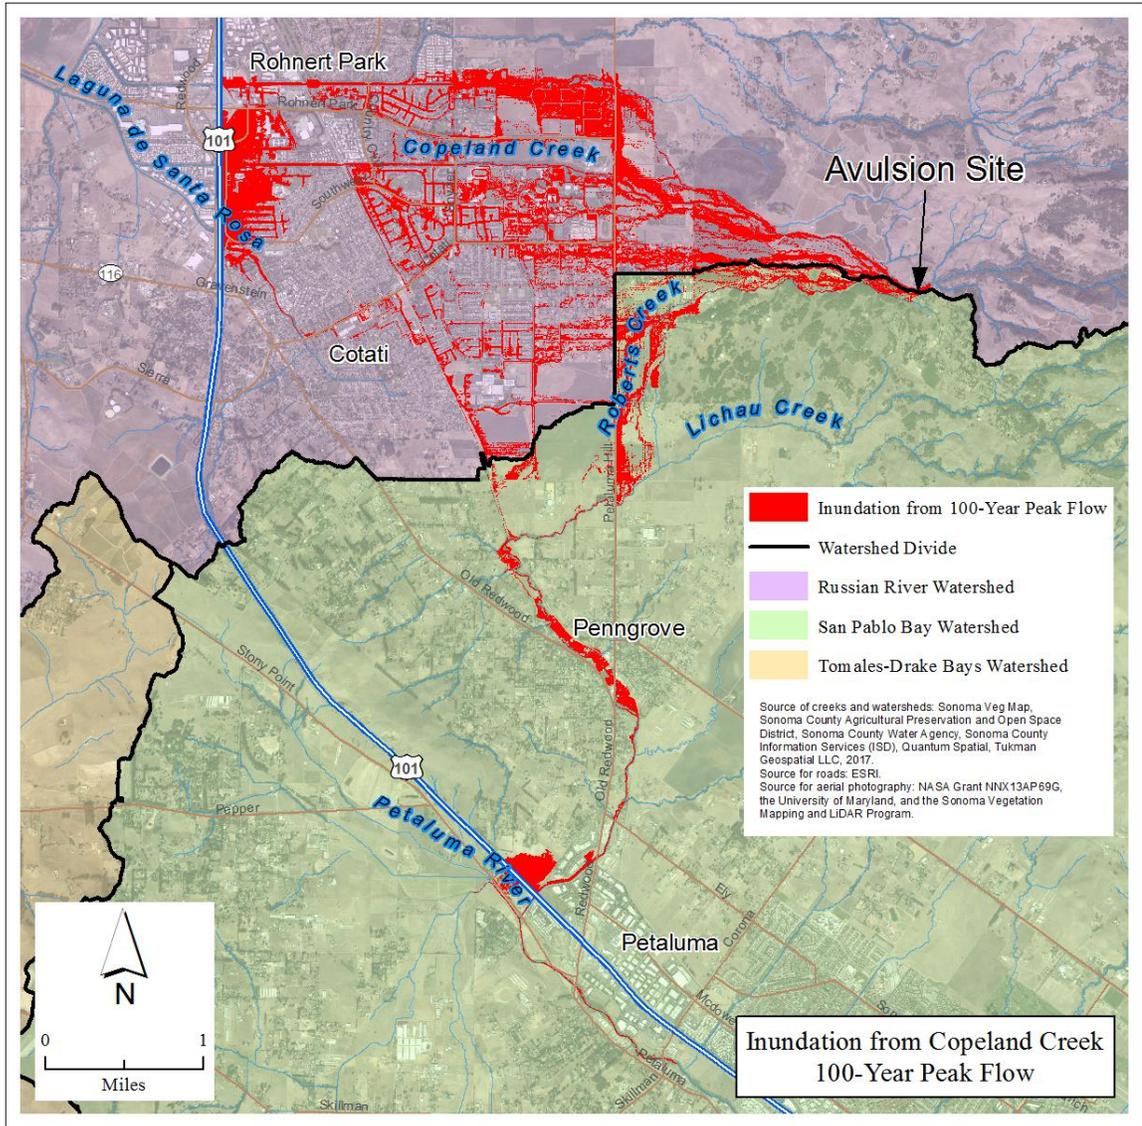
Figure 21 - Inundation from 100-year peak flow

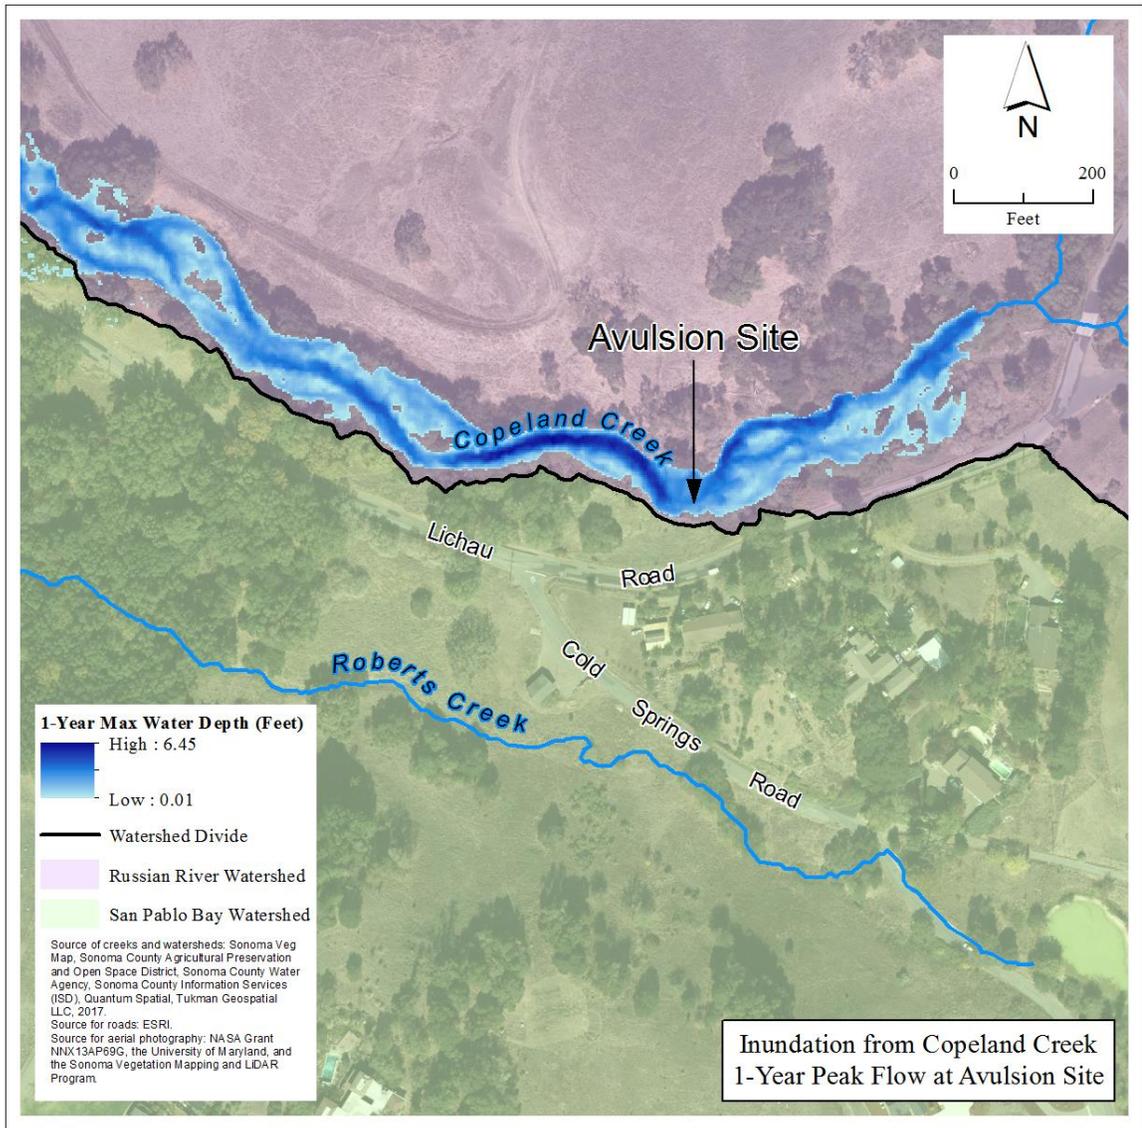
Figure 22 - Inundation from 1-year peak flow at the avulsion site
