**ASSESSING COPELAND CREEK INTER-WATERSHED
OVERBANK FLOW, A PILOT STUDY**

A THESIS

Presented to the Department of Geography, Environment,
and Planning of Sonoma State University

May 9, 2018

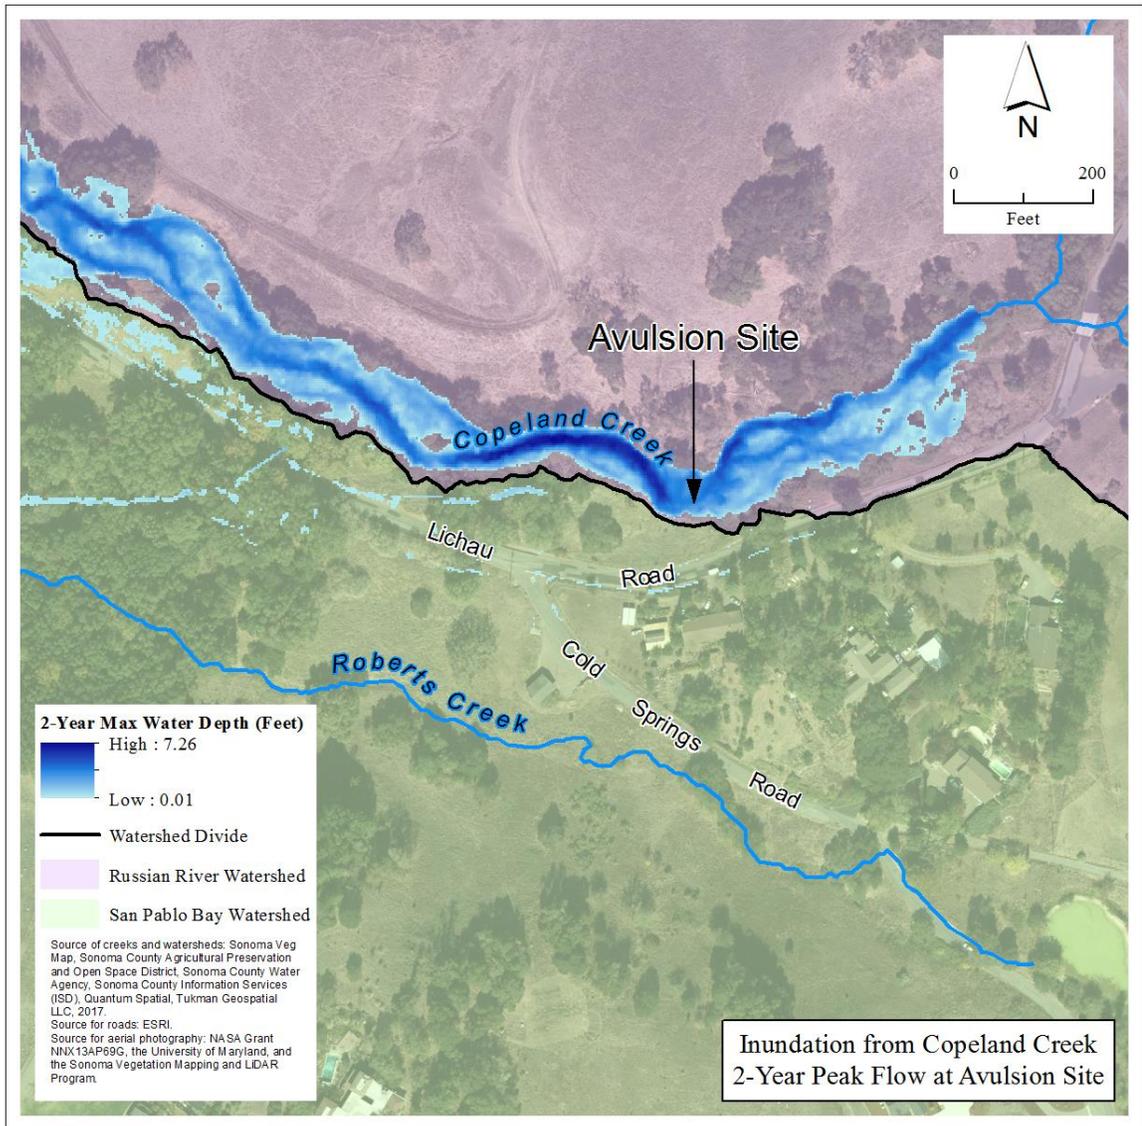
Figure 23 - Inundation from 2-year peak flow at the avulsion site

another avulsion site about 1,000 feet downstream of the study avulsion site (Figures 17 and 23). This downstream avulsion site warrants further investigation, as it appears it is at least partially responsible for the flooding seen by many residents along Chester Drive, between Petaluma Hill Road and Roberts Road.

The 2-year peak flow model shows some overbank flow on the south side of the watershed divide and along the south side of Lichau Road (Figure 23). The water is not shown to be contiguous to the creek, and is therefore likely an error called “leaking,” whereby topography along the streambank may not have been accurately captured by the computational mesh (even though breaklines were added to improve the model). HEC-RAS version 5.0.4, released after modeling for this study had concluded, includes a tool to incorporate polygonal areas with higher computational mesh densities embedded within the larger flow area. Using this new functionality in the model would likely solve the leaking issue shown in Figure 23. Moreover, the model shows excessive flooding during 1-year and 2-year peak flow events where Copeland Creek goes under Roberts Road, under Petaluma Hill Road, and under Highway 101. Flooding of this magnitude at these locations during low flow events is most certainly an error in the model. The issue likely stems from the hydro-enforced DEM not adequately capturing the conveyance capacity of culverts beneath roadways, causing the water to back up and flood the banks. Future two-dimensional models should field verify the conveyance capacities of all culverts in the system and update the model accordingly.

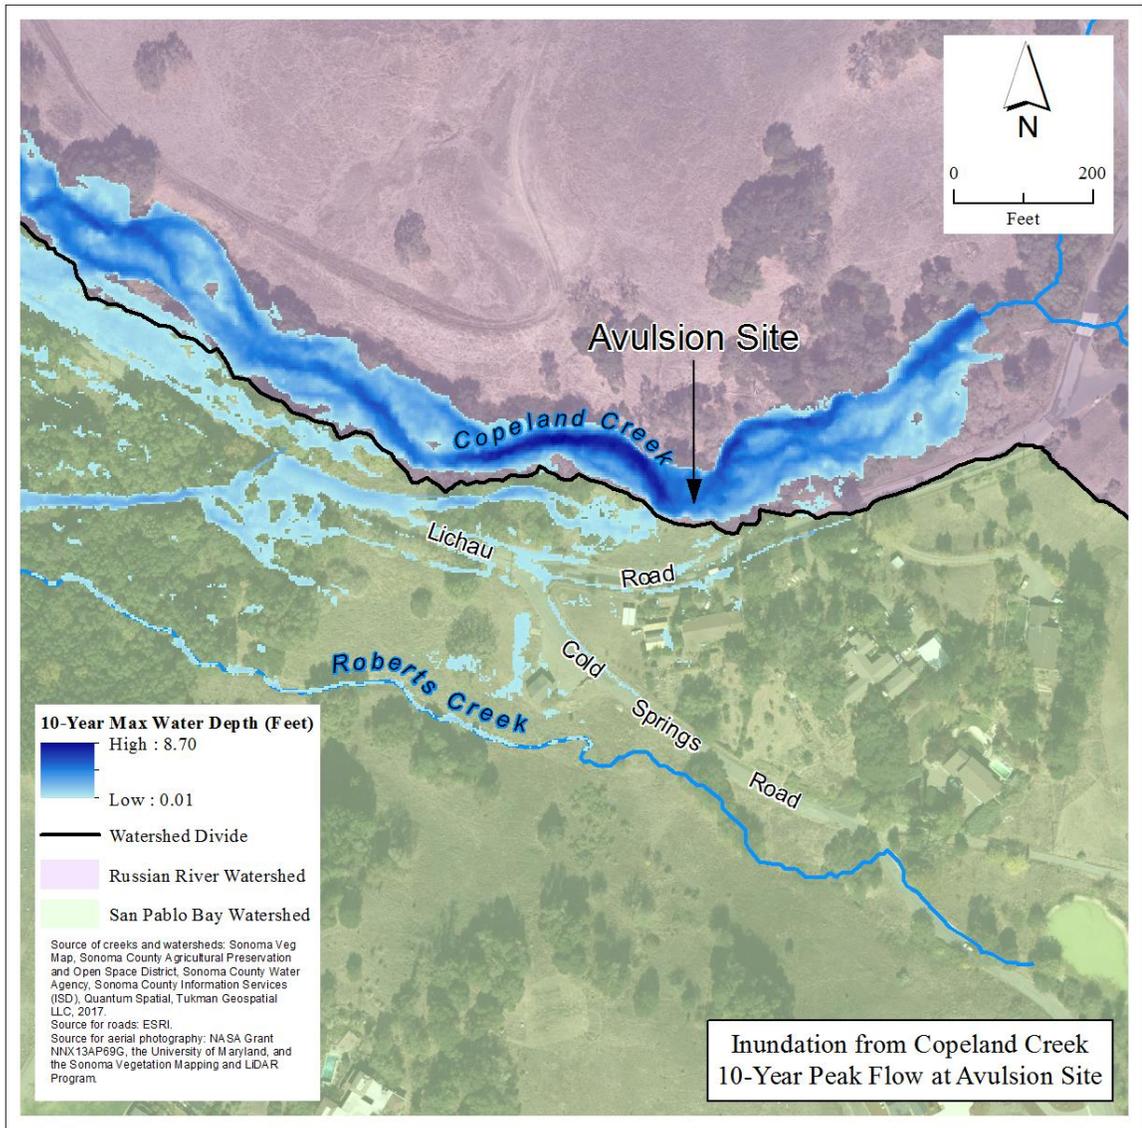
Figure 24 - Inundation from 10-year peak flow at the avulsion site

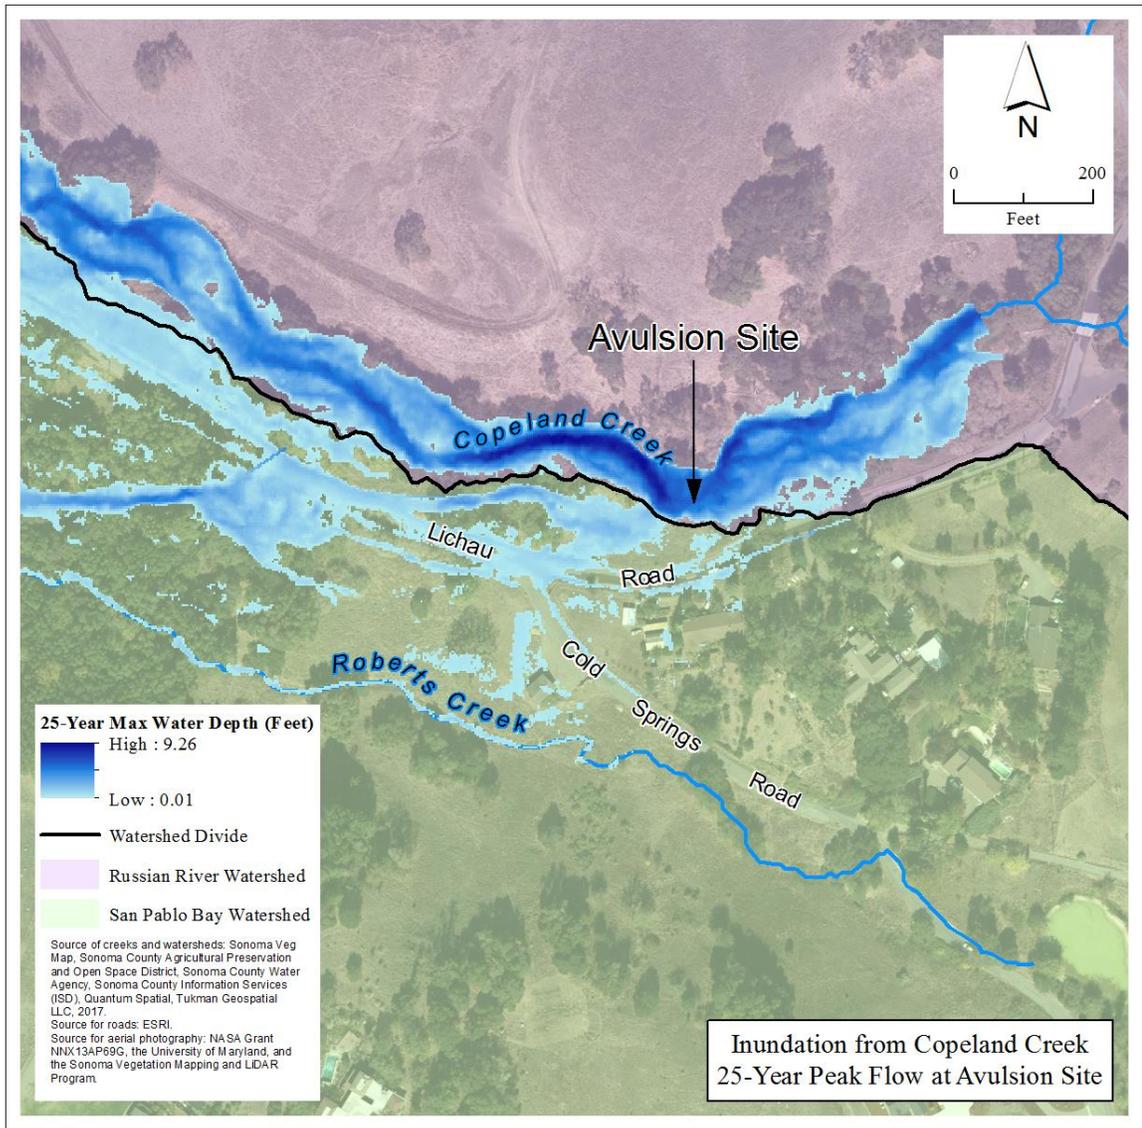
Figure 25 - Inundation from 25-year peak flow at the avulsion site

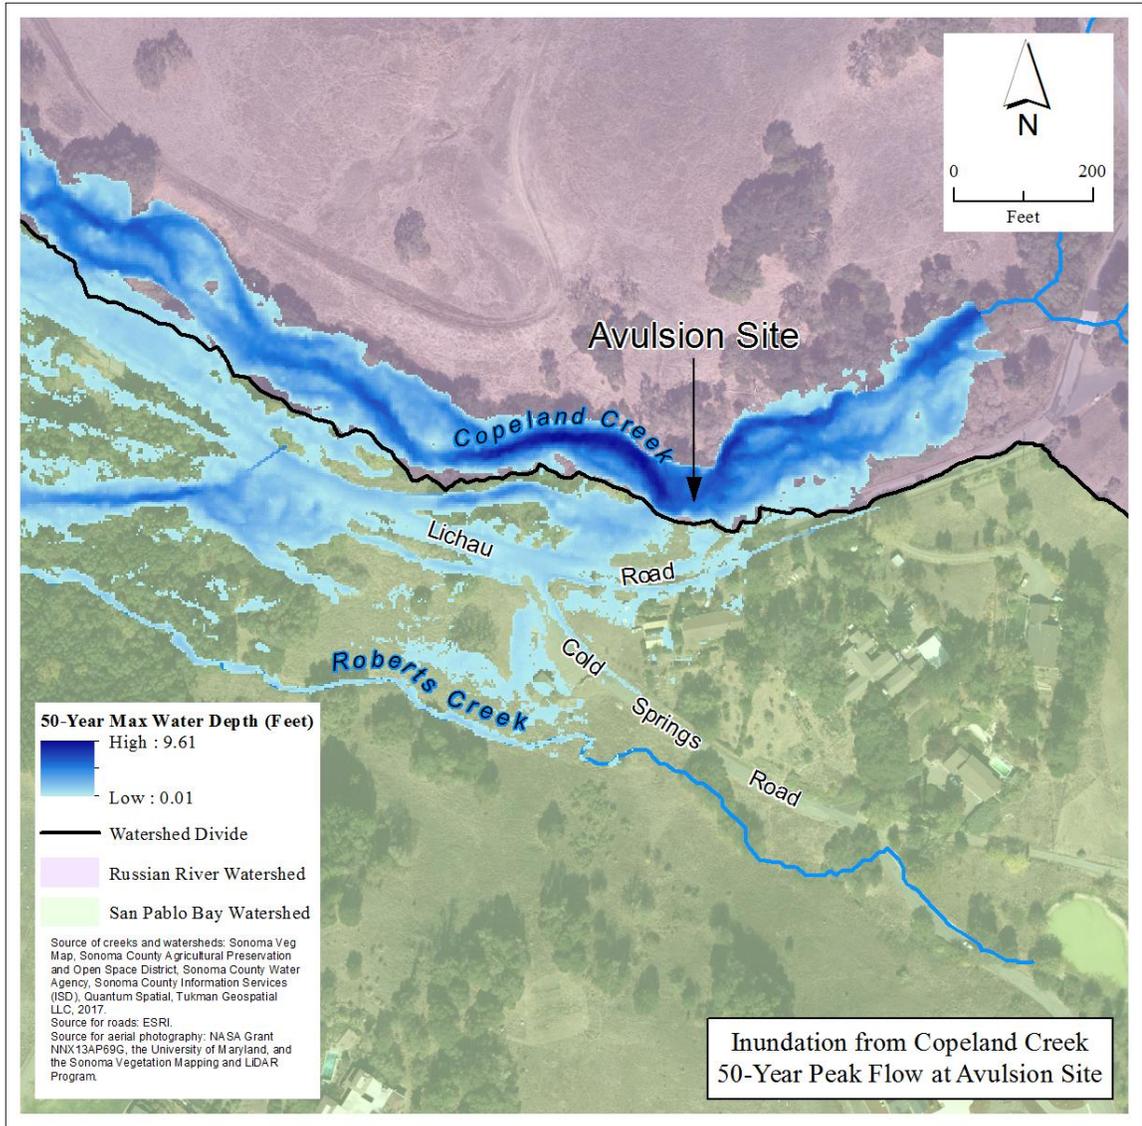
Figure 26 - Inundation from 50-year peak flow at the avulsion site

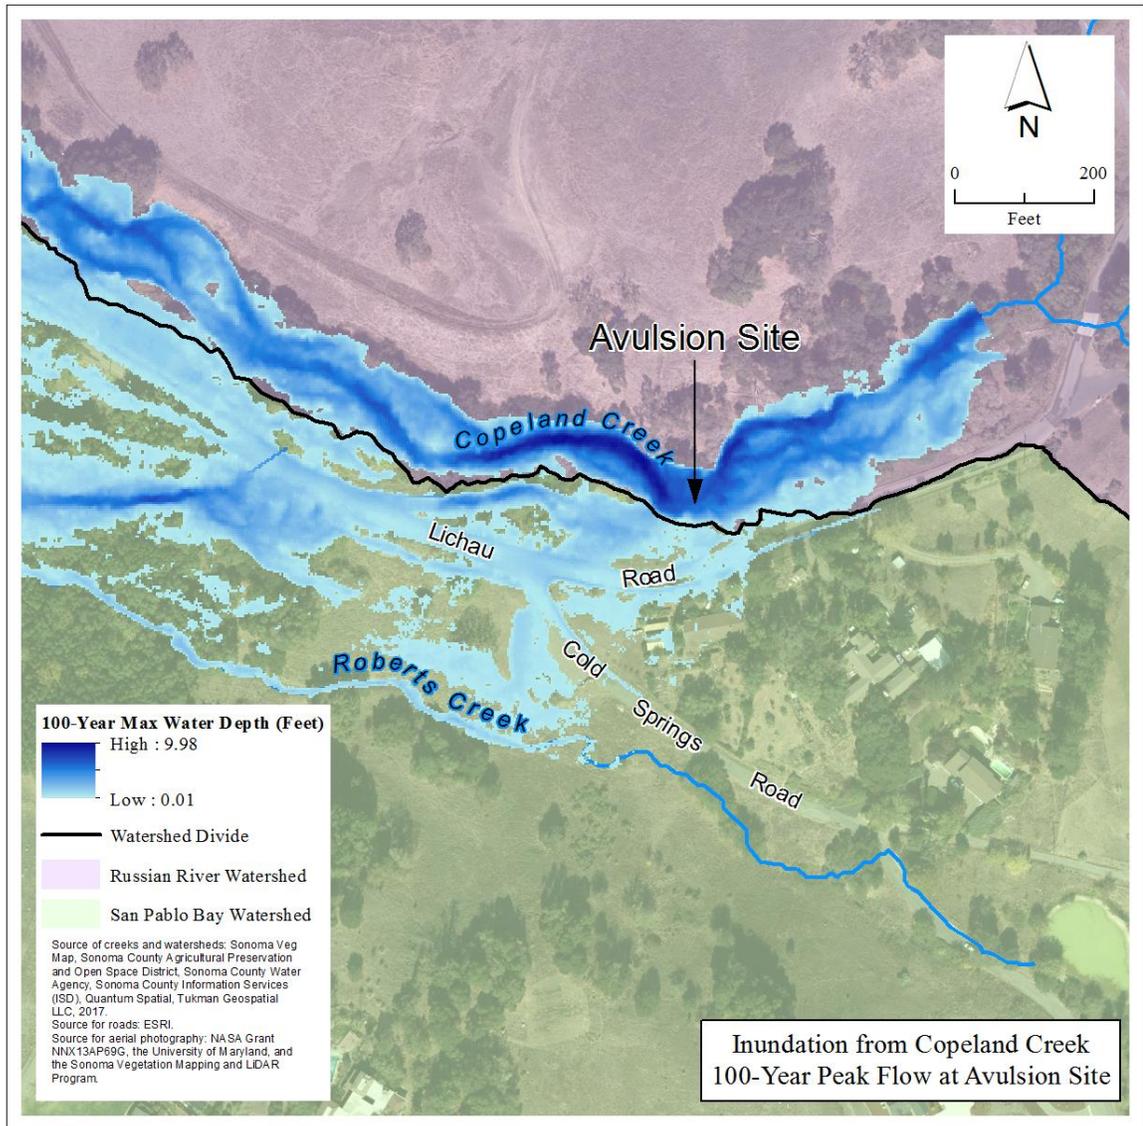
Figure 27 - Inundation from 100-year peak flow at the avulsion site
