Trail Erosion Mitigation at the Fairfield Osborn Preserve

Katherine Bruzzone
Sonoma State University Preserves

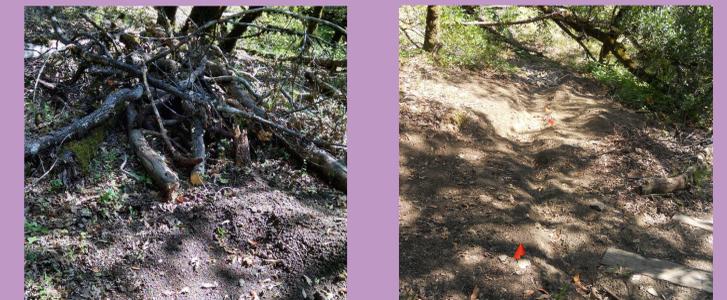
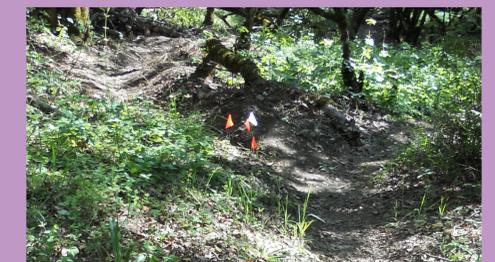
This project is still in progress at the preserves. At this point in time both of the drainage ditches have been dug out, with materials added to them to further slow down the water. River rocks line bottom most portion of the lower ditch. Woody debris has been placed at an angle in the bottom of the upper ditch to further guide the water away from the trail. When viewed from the bottom of the trail a visitor would not be able to see the ditches until they are right next to them. The stairs have yet to be replaced, and the strategic steps have not been added. Unfortunately there has not been a rain event since the ditches were constructed to see if they are functioning as planned.

The first drainage ditch was marked for being between the 12th and 13th steps, with the second 45'6" from the topmost step with the water bar incorporated into it. All three of the strategic steps were planned for the area above the 20th step. The first strategic step was planned for 13'2" away from the end of the stair case, and the second strategic step 12' from the first. 49'3" uphill from the end of the stairs is the last strategic step. All of the strategic steps will work together to slow down the water before it can reach the ditches. 29'6" from the bottom most step there lies a fallen tree that has been determined to be beneficial to the trail because it acts as a natural water bar that would slow down any remaining runoff after treatment. The area where the lowermost drainage ditch was to be placed was cleared of debris and *Toxicodendron diversilobum*, otherwise known as poison oak, by the end of the first day. On the next day the land managers and land stewards dug out the lower ditch to a length of 24'. Once that was completed the group cleared the area for the second ditch and dug the ditch out to a length of 31'. Materials used for the treatment included loppers, McLeods, pick-mattocks, and bow saws.
