Upper Rancheria Creek
Preliminary Bio-geomorphic Assessment

Prepared By: West Coast Watershed

Prepared For: Mendocino County Resource Conservation District

May 14, 2007

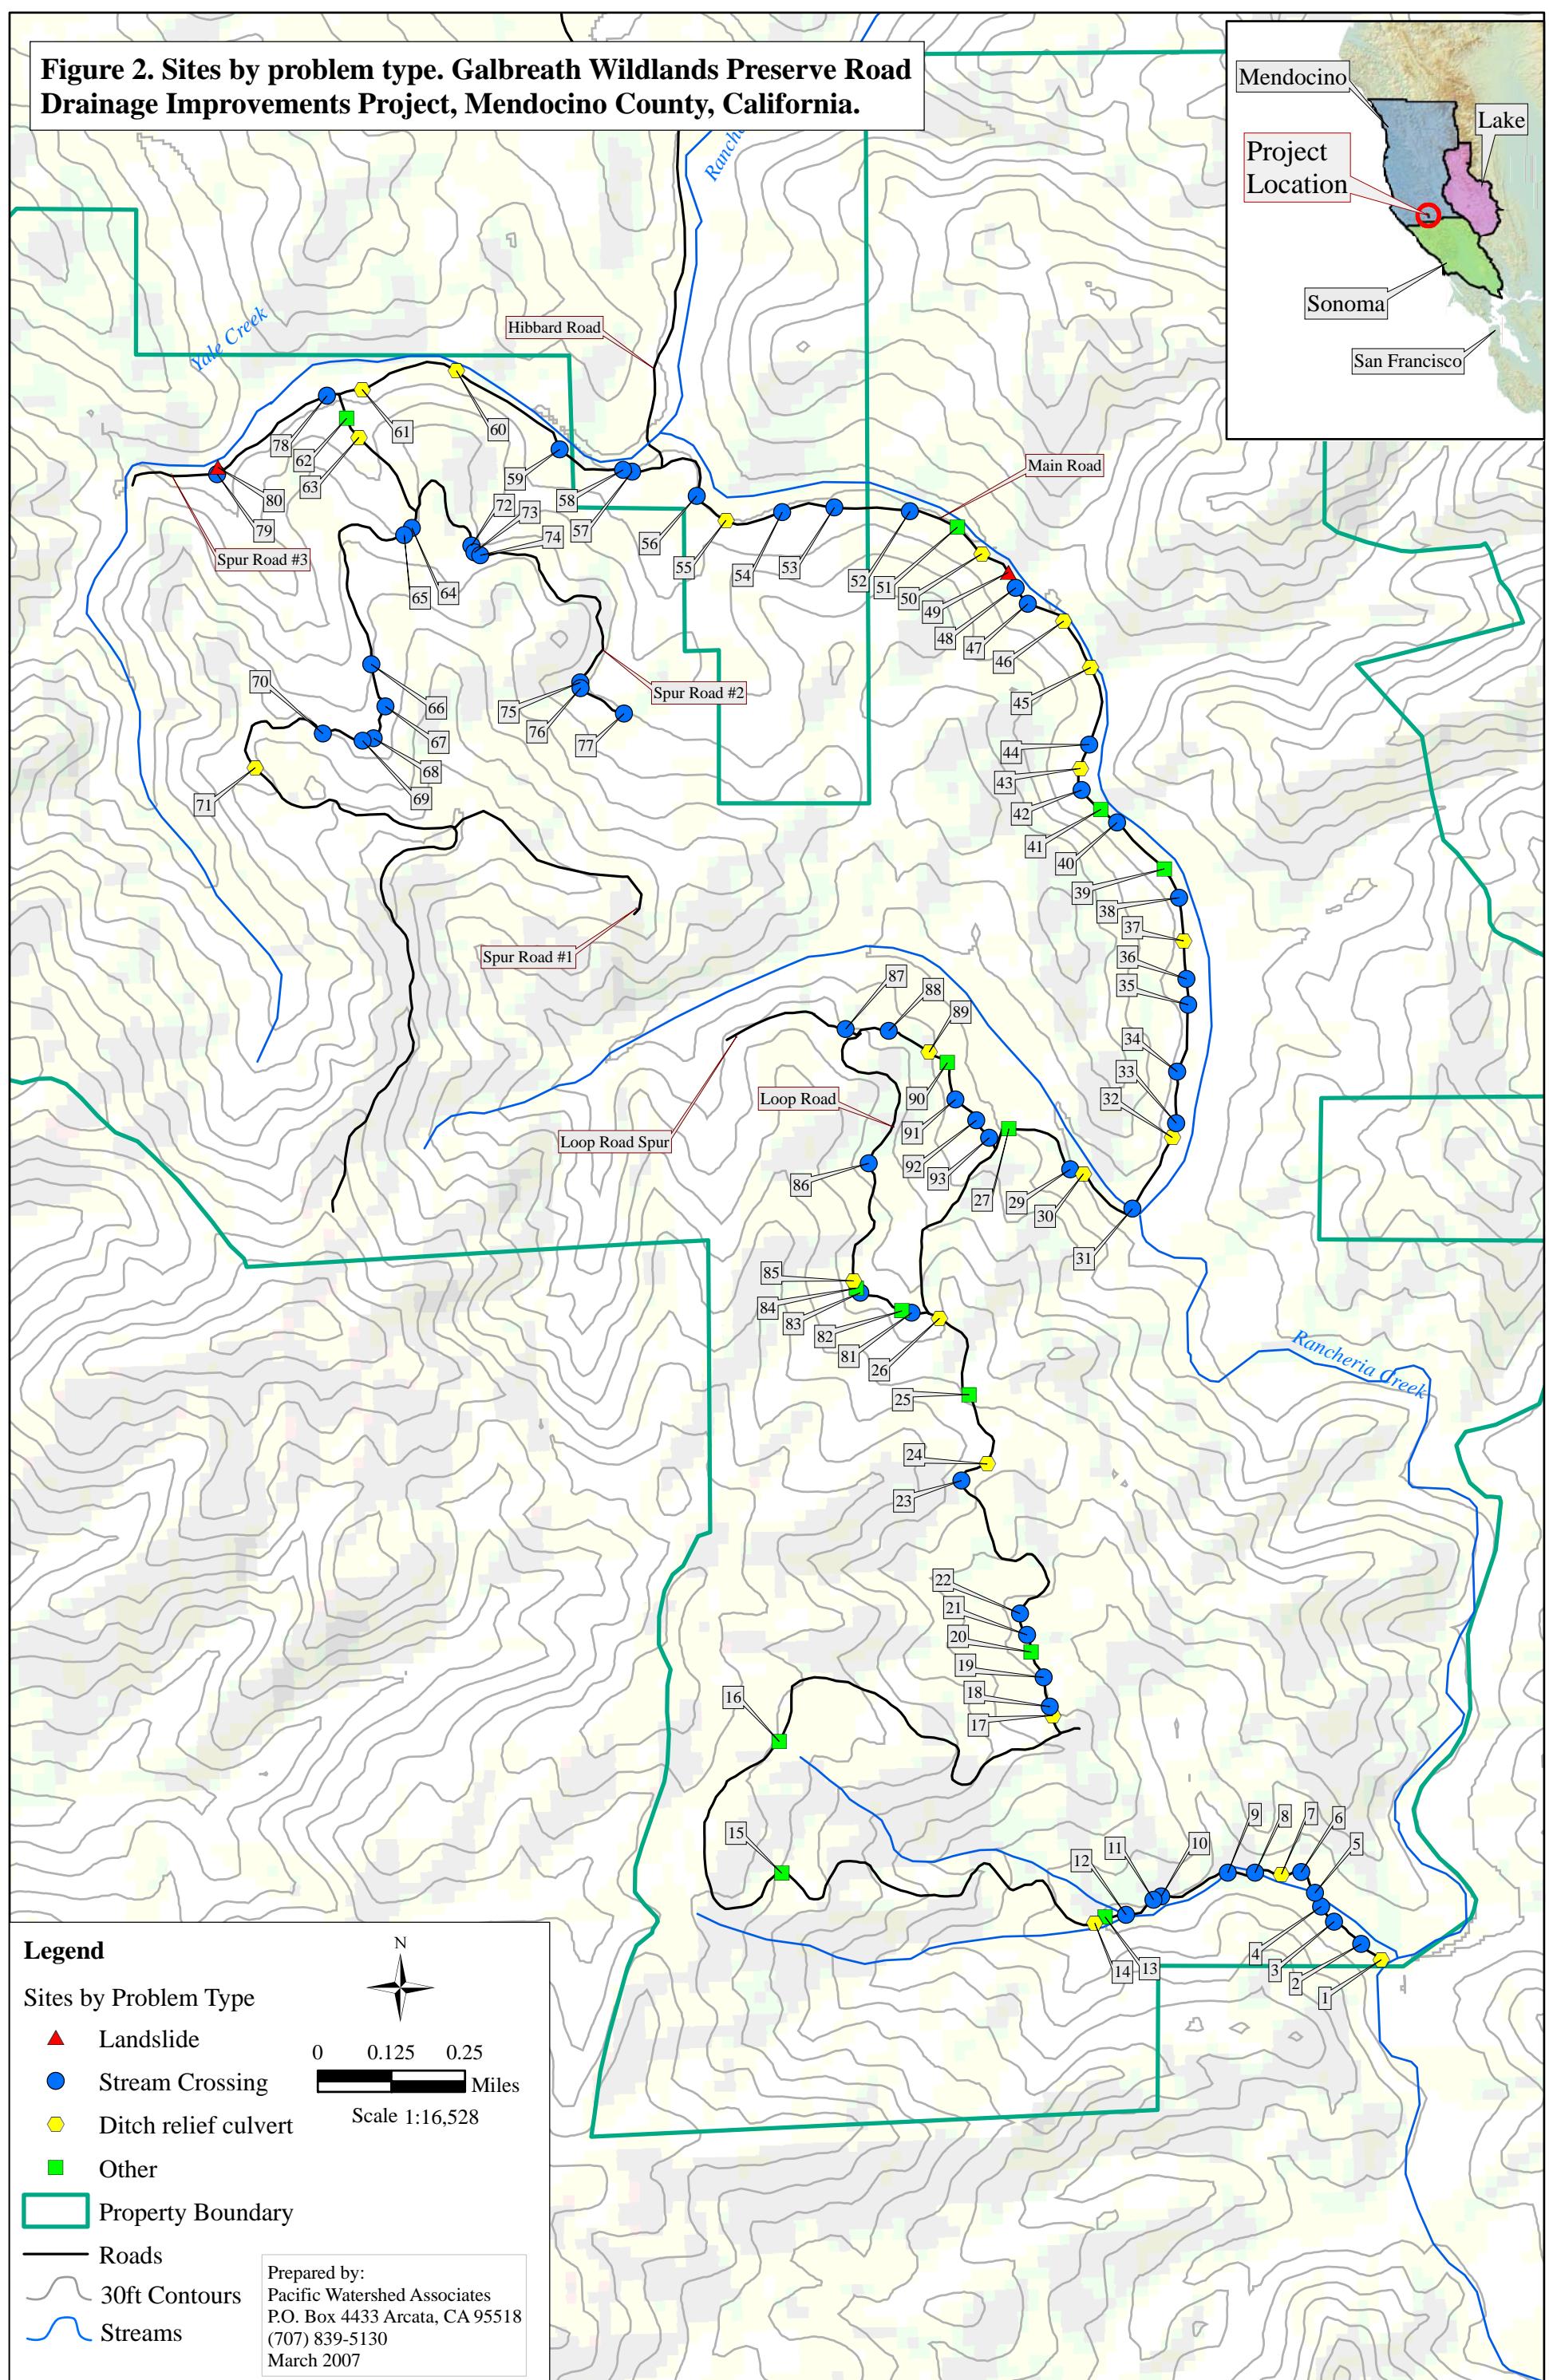
Figure 2. Sites by problem type. Galbreath Wildlands Preserve Road Drainage Improvements Project, Mendocino County, California.

Potential landslide problems in the GWP exist along roads where sidecast material from earlier road construction has become unstable (Figure 2; Table 1). During field inventories, PWA personnel identified tension cracks or scarps showing vertical displacement, corrective re-growth on trees (i.e. pistol butt trees), and perched, hummocky fill as indicating slope instability. Correcting or preventing potential road-fill landslides is relatively straight forward, generally requiring excavation of unstable road fill and sidecast materials, and disposing of the excavated material in a stable location.

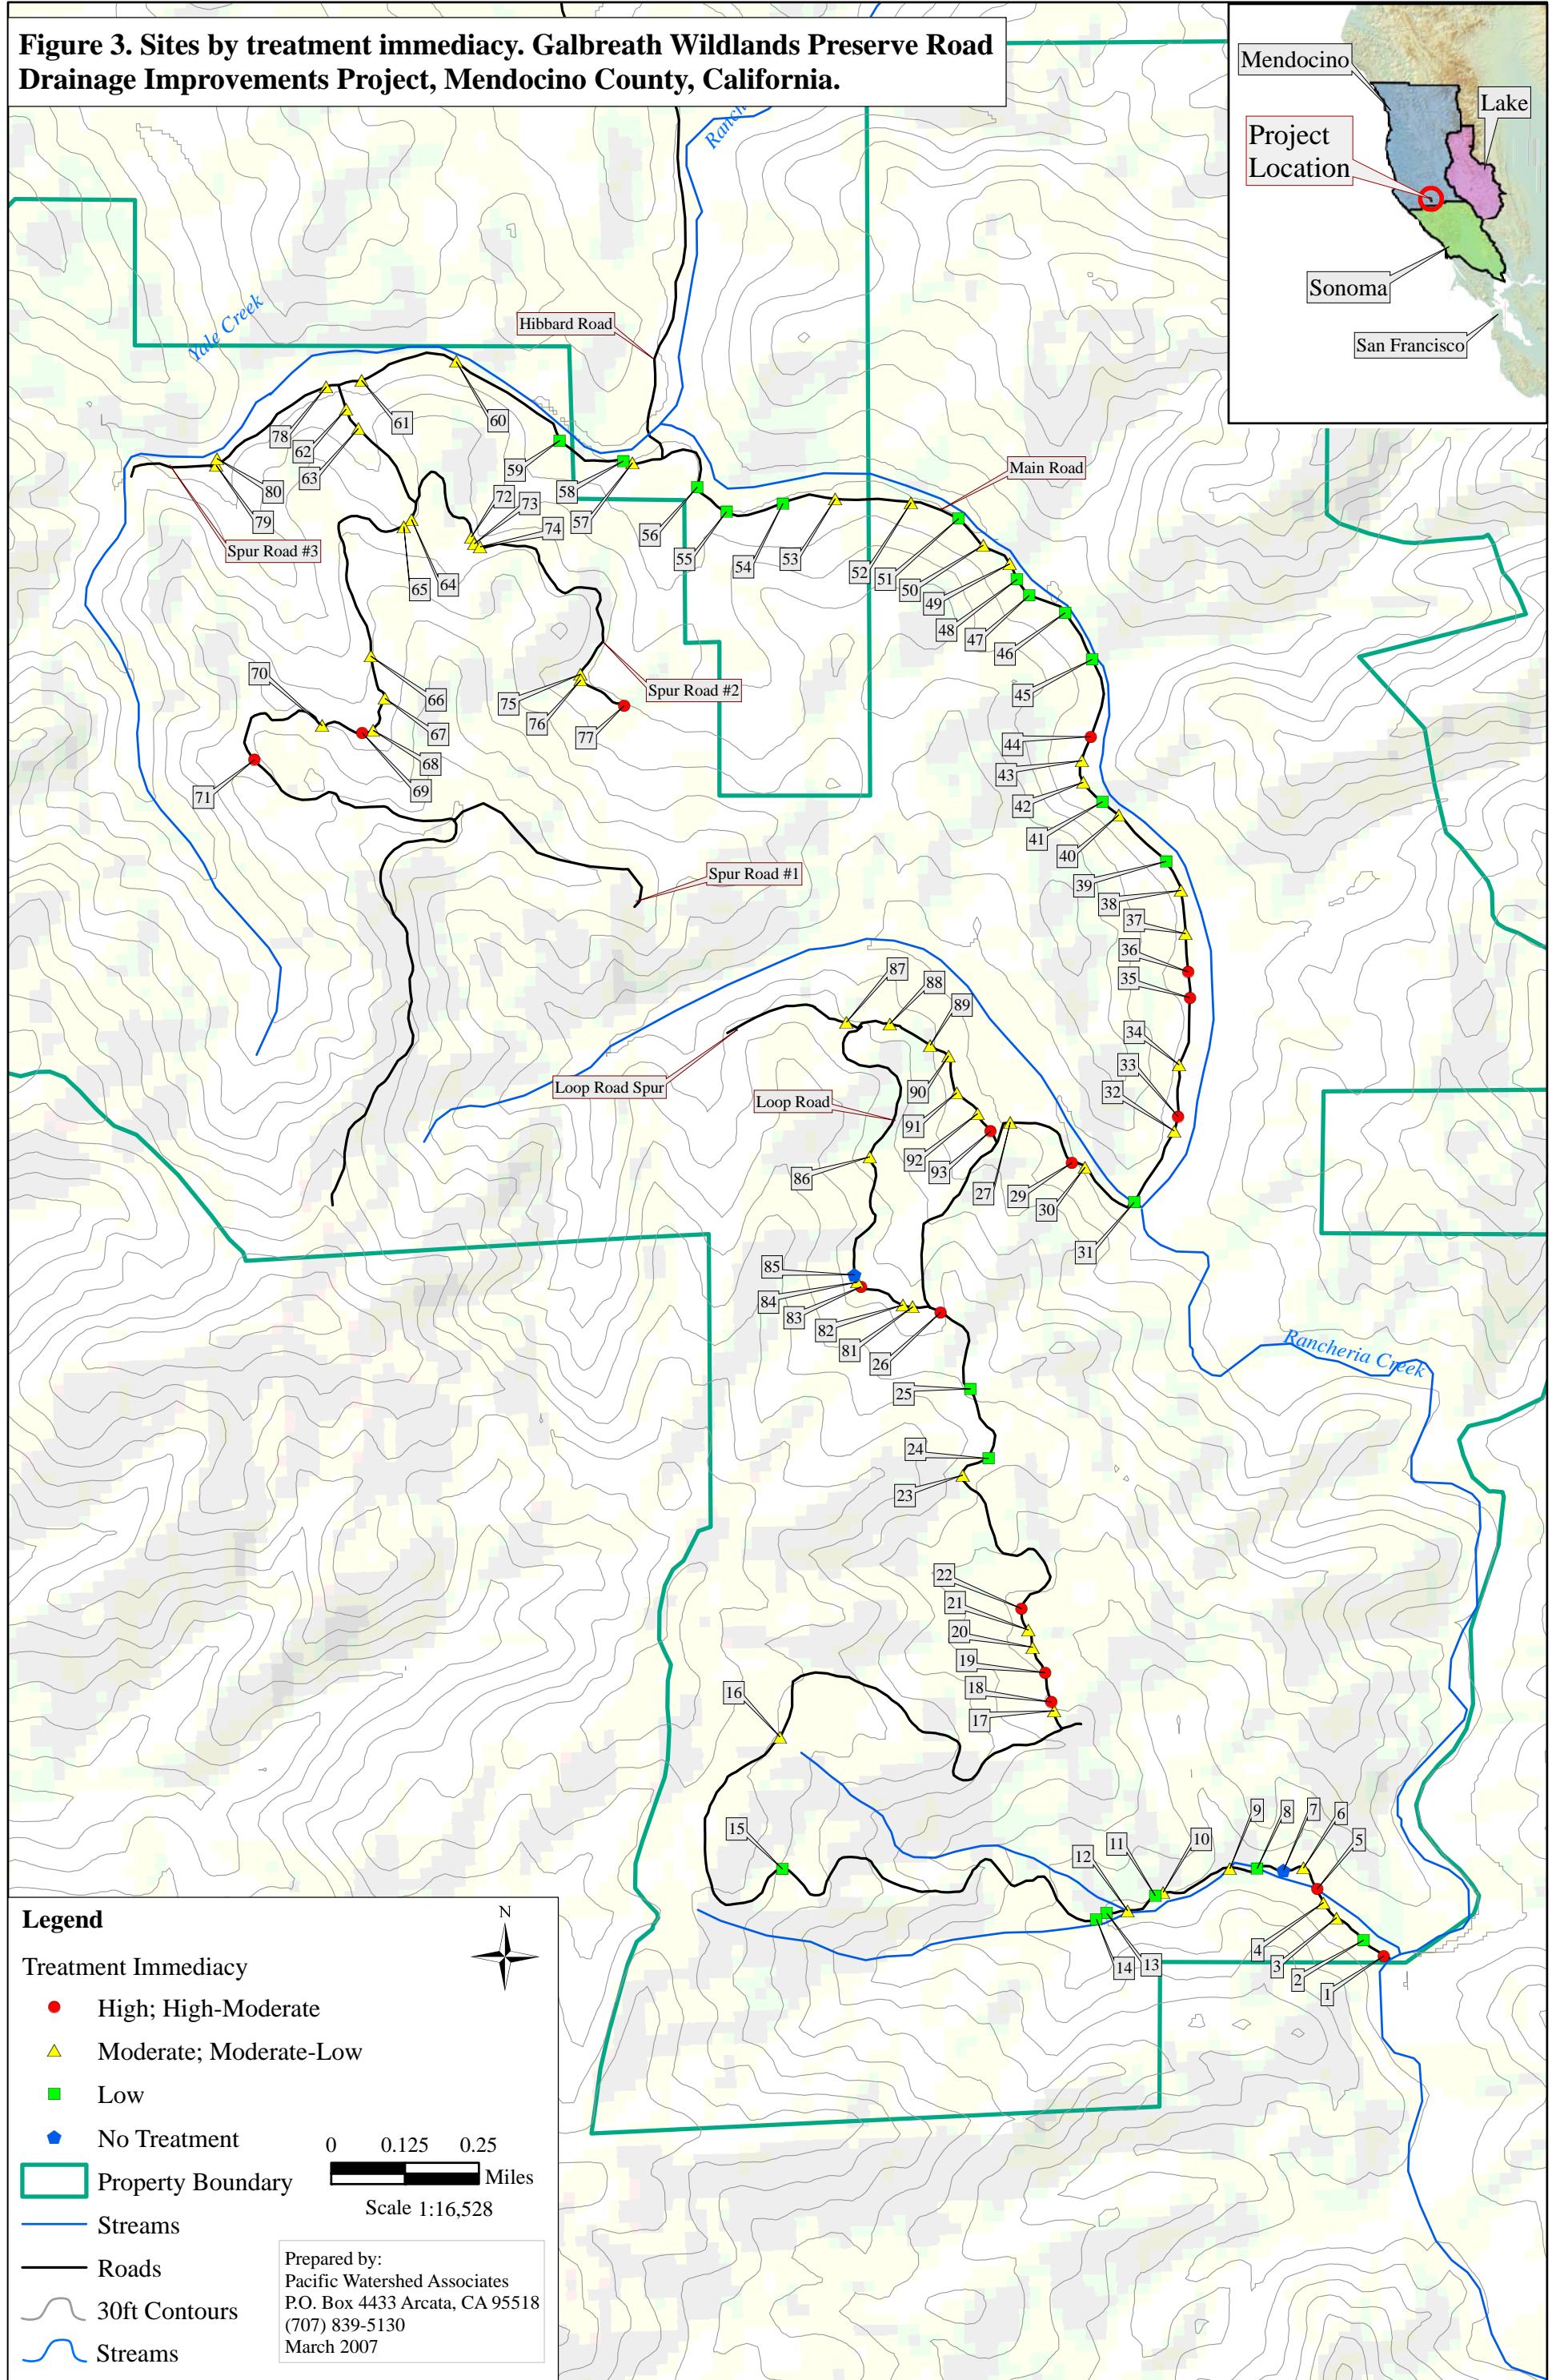
Figure 3. Sites by treatment immediacy. Galbreath Wildlands Preserve Road Drainage Improvements Project, Mendocino County, California.

Of the 90 inventoried sites that we recommend for treatment, we designate 16 with priority ratings of high or high-moderate (Figure 3; Table 4). The potential sediment delivery for these 16 sites is approximately 2,160 yd³, which equates to nearly 20% of the expected sediment savings for the GWP. We assign moderate or moderate-low priorities to 57 sites, which accounts for approximately 6,650 yd³, or nearly 60% of the expected sediment savings. Finally, we assign a low priority to 17 sites, which accounts for approximately 2,200 yd³, or nearly 20% of the expected future sediment delivery.
