Upper Rancheria Creek
Preliminary Bio-geomorphic Assessment

Prepared By: West Coast Watershed

Prepared For: Mendocino County Resource Conservation District

May 14, 2007

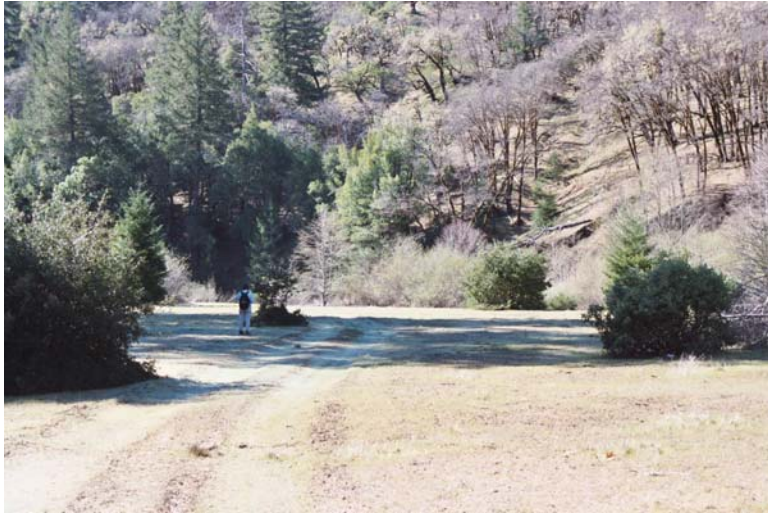
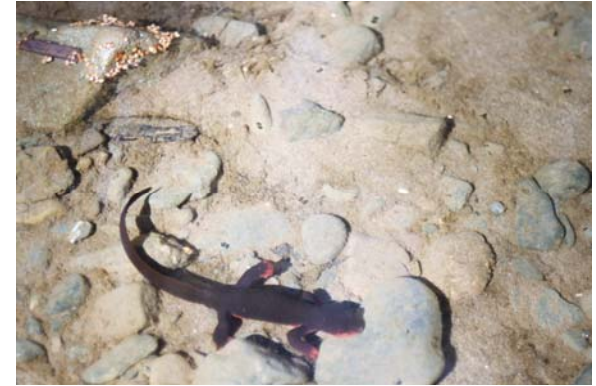
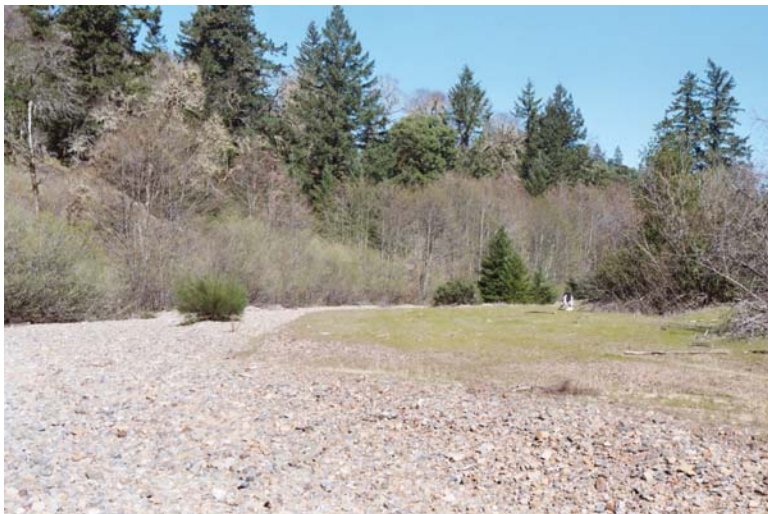
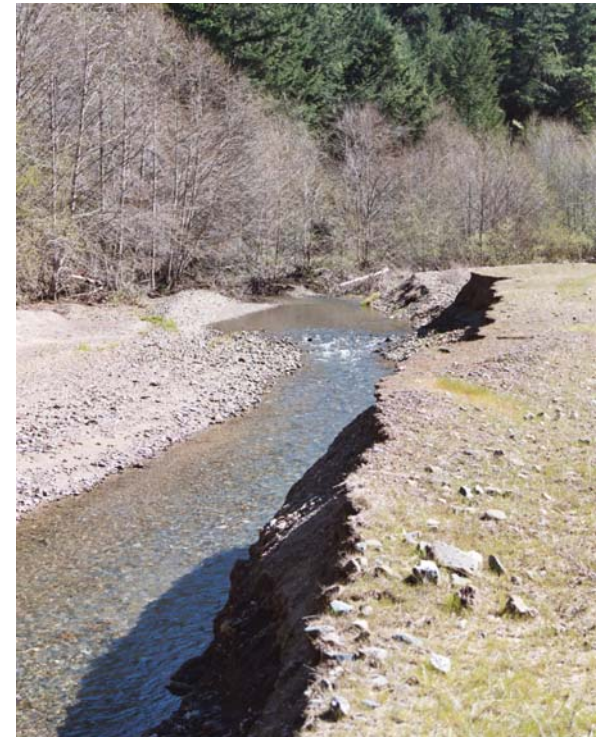
Photo Figure 4.
Bio-geomorphic Research and Management Demonstration Sites

A series of bio-geomorphic management and research sites should be established (see Map E and Photo figure 4) that will allow for a multi-year investigation of the riparian corridors along Rancheria Creek, and upslope processes affecting these areas. Following are recommendations to aid in understanding the relationship between geomorphic features and ecology.

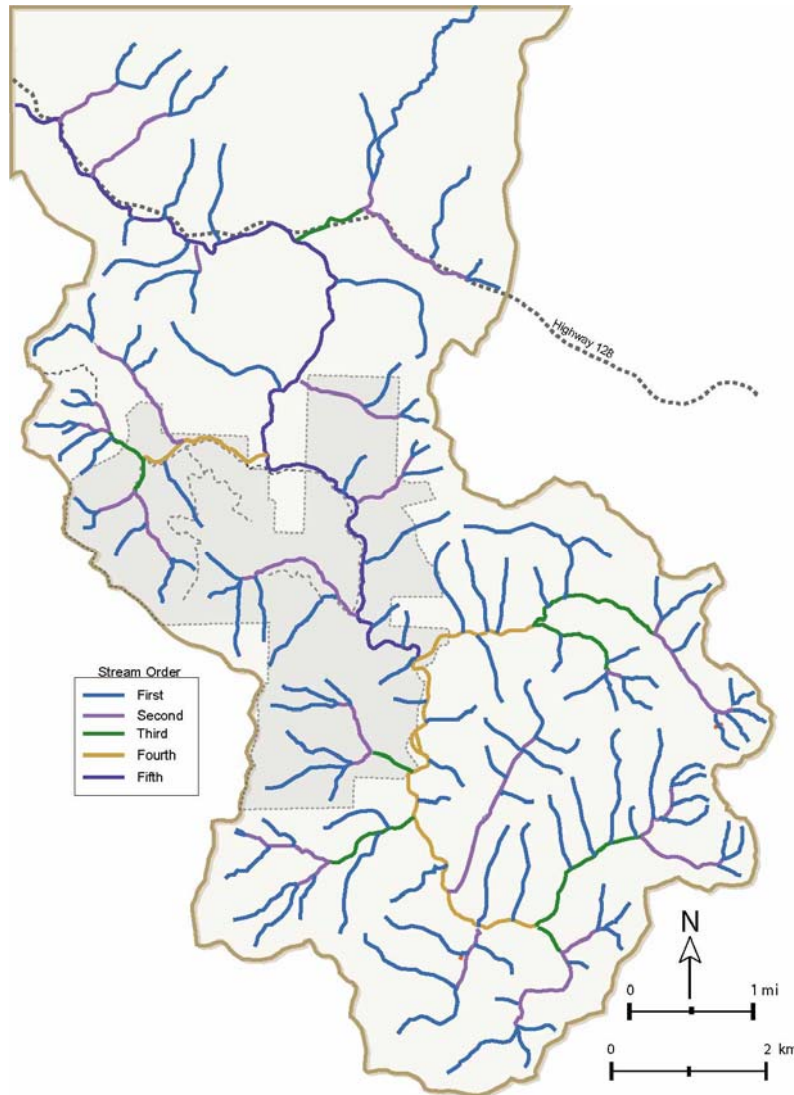
Figure 6. Preliminary Stream Order Map of Upper Rancheria Creek.

Figure 6 illustrates stream order in upper Rancheria Creek. Stream order is a useful indicator of channel processes and functions—with the smallest first order channels influenced by landslides and debris flows and the highest order channels dominated by fluvial processes. Figure 6 suggests that the main stem of Rancheria Creek is a fifth order stream within the Preserve. The tool is limited by the methods used to generate the stream order classification system—here a 1:24,000 scale topographic map was used as the base map. Thus, finer resolution images such as lidar combined with detailed field mapping can show smaller streams than was possible with the data used here. Despite this limitation, the stream order map illustrates that the majority of channels present in the Galbreath Preserve are headwater streams of the Yale-Adams and Upper Rancheria Creek tributaries. Attributes of mountain rivers are described in Wohl (2000) as relatively steep streams with high spatial complexity, where bedrock and coarse clasts such as cobbles and boulders are common. She notes the potential for extraordinary high sediment yields over a period of a few years following wildfire or timber harvest.

Within the Galbreath Preserve, numerous low order headwater channels are present. Although many are unnamed, such streams are significant because they form the linkage between stream channel networks and the surrounding land. Low order channels typically are important source areas for sediment, water, large woody debris, and nutrients. Headwater streams play a role in water

supply and quality, sediment supply, and biodiversity. In these small channels, landslides, debris flows, and fluvial flood flows occur episodically—creating diverse aquatic habitat and riparian wetlands.

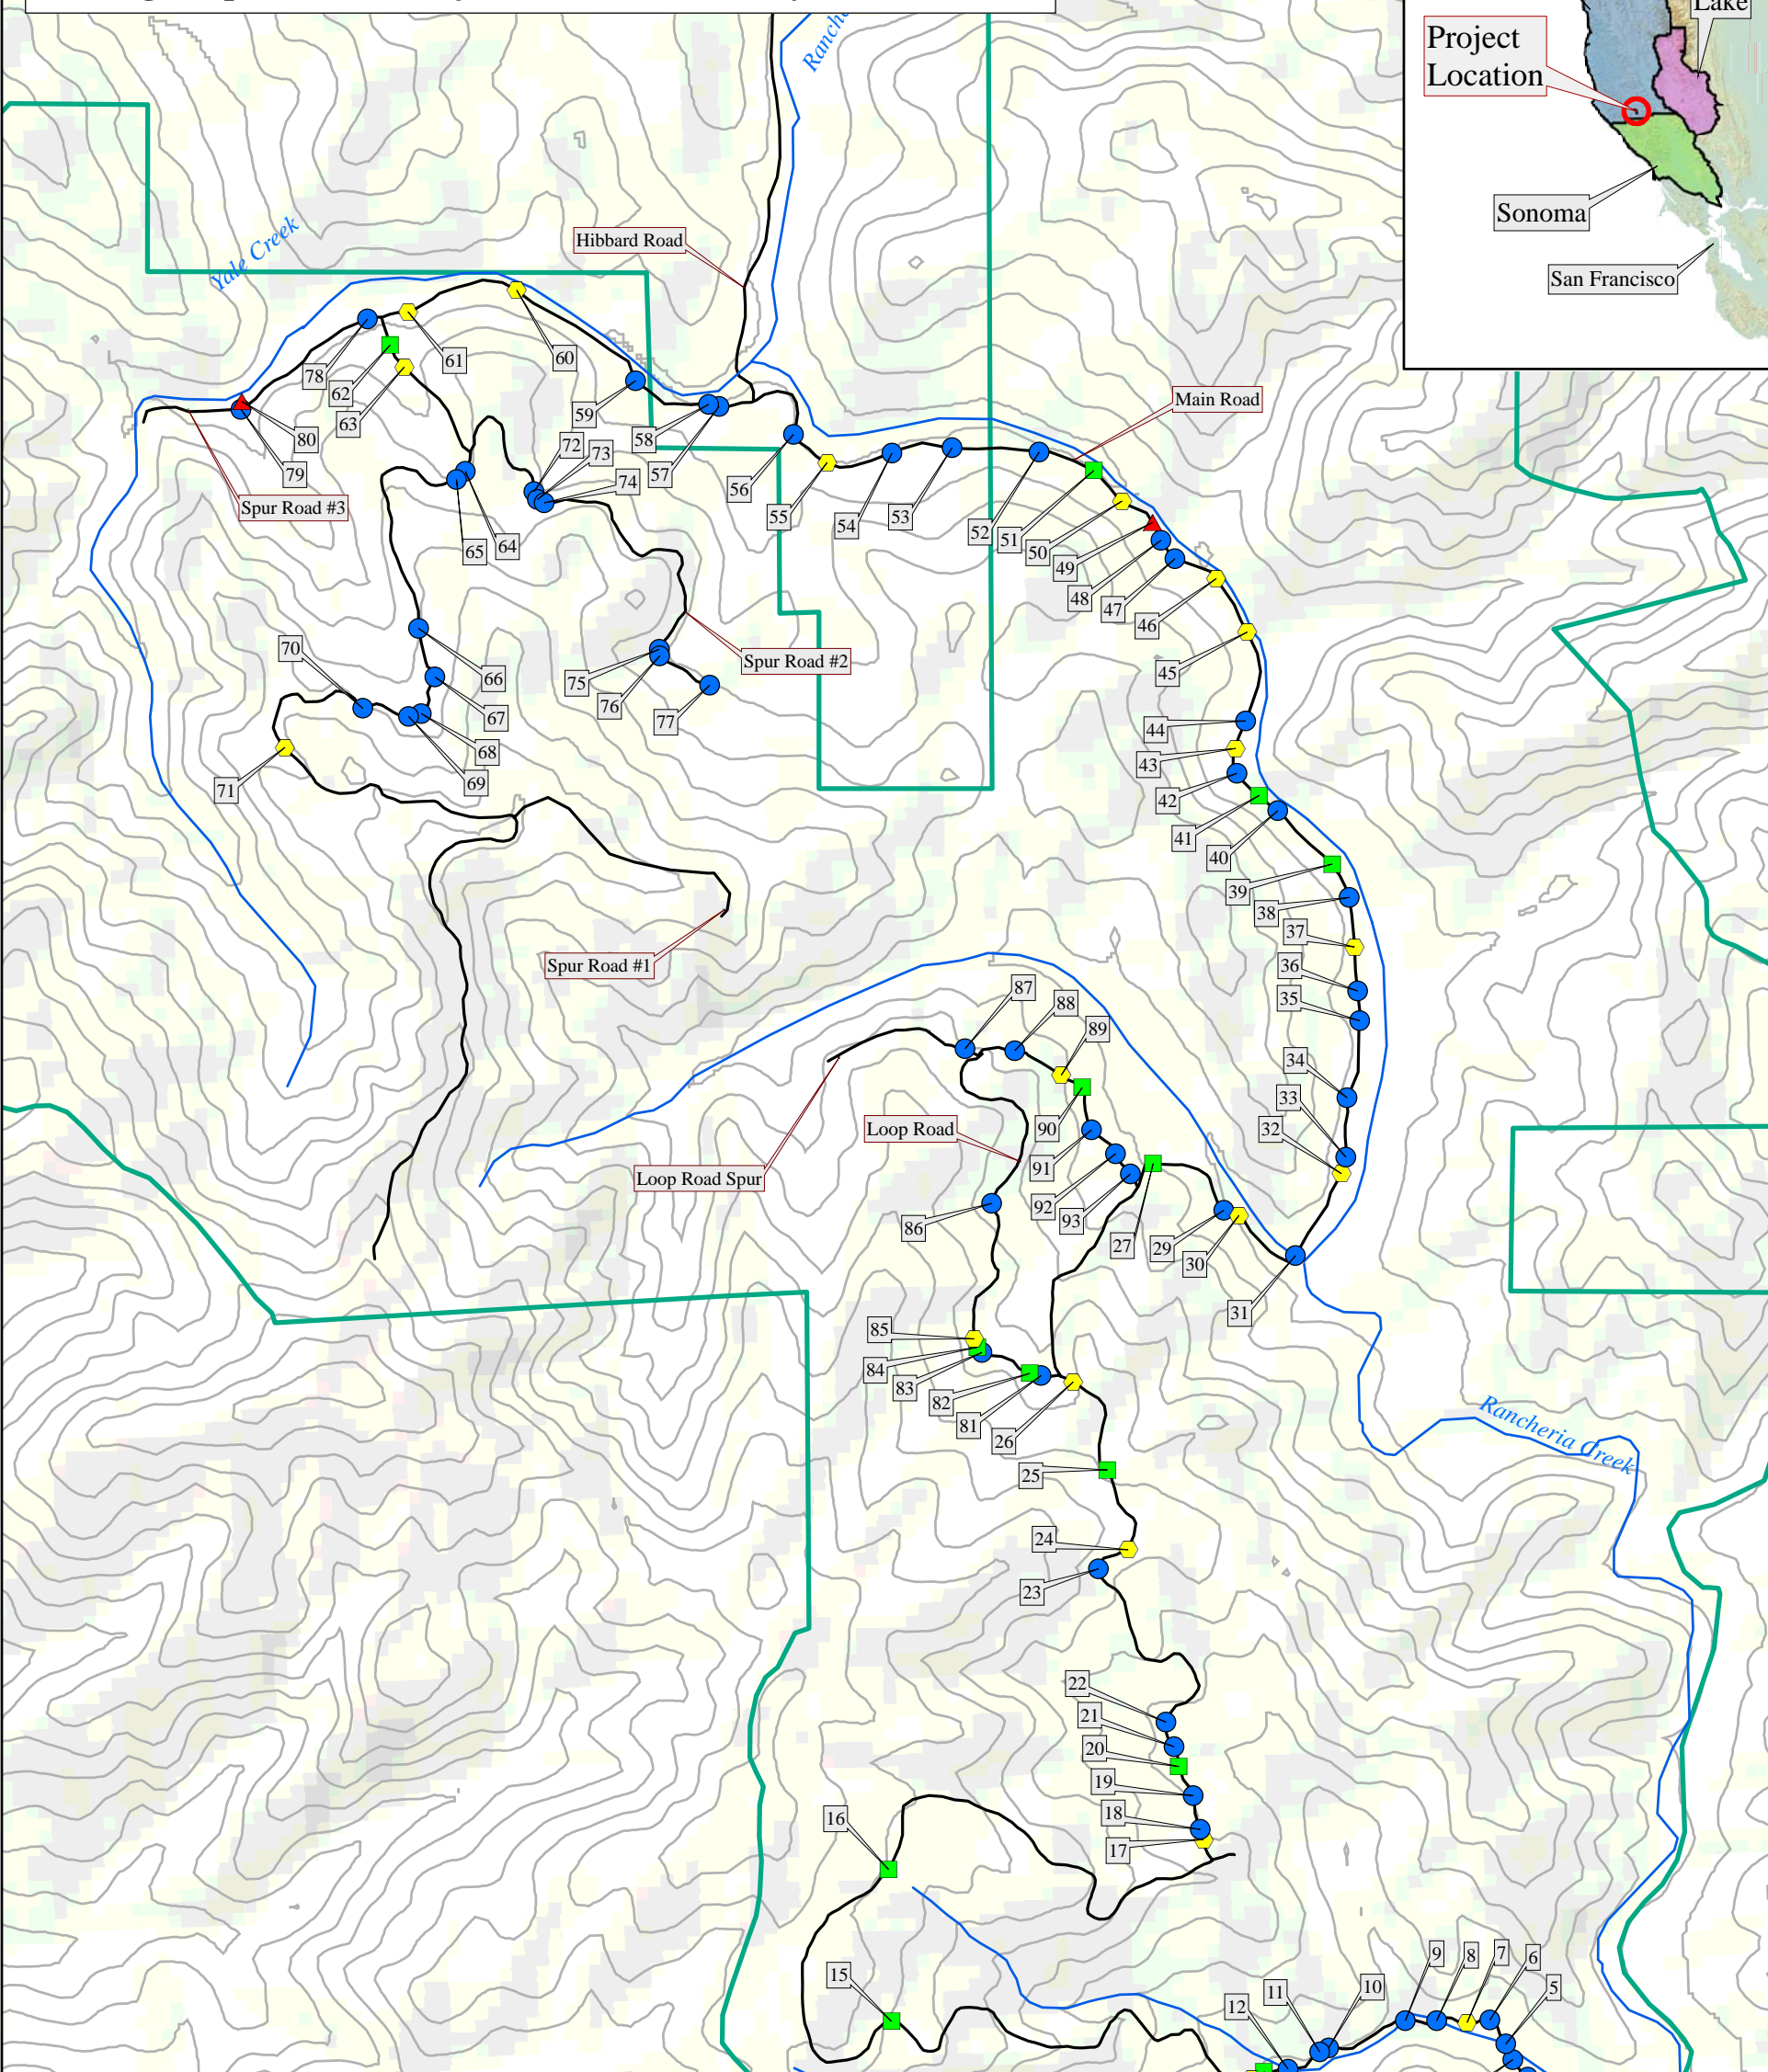
Figure 2. Sites by problem type. Galbreath Wildlands Preserve Road Drainage Improvements Project, Mendocino County, California.

Potential landslide problems in the GWP exist along roads where sidecast material from earlier road construction has become unstable (Figure 2; Table 1). During field inventories, PWA personnel identified tension cracks or scarps showing vertical displacement, corrective re-growth on trees (i.e. pistol butt trees), and perched, hummocky fill as indicating slope instability. Correcting or preventing potential road-fill landslides is relatively straight forward, generally requiring excavation of unstable road fill and sidecast materials, and disposing of the excavated material in a stable location.

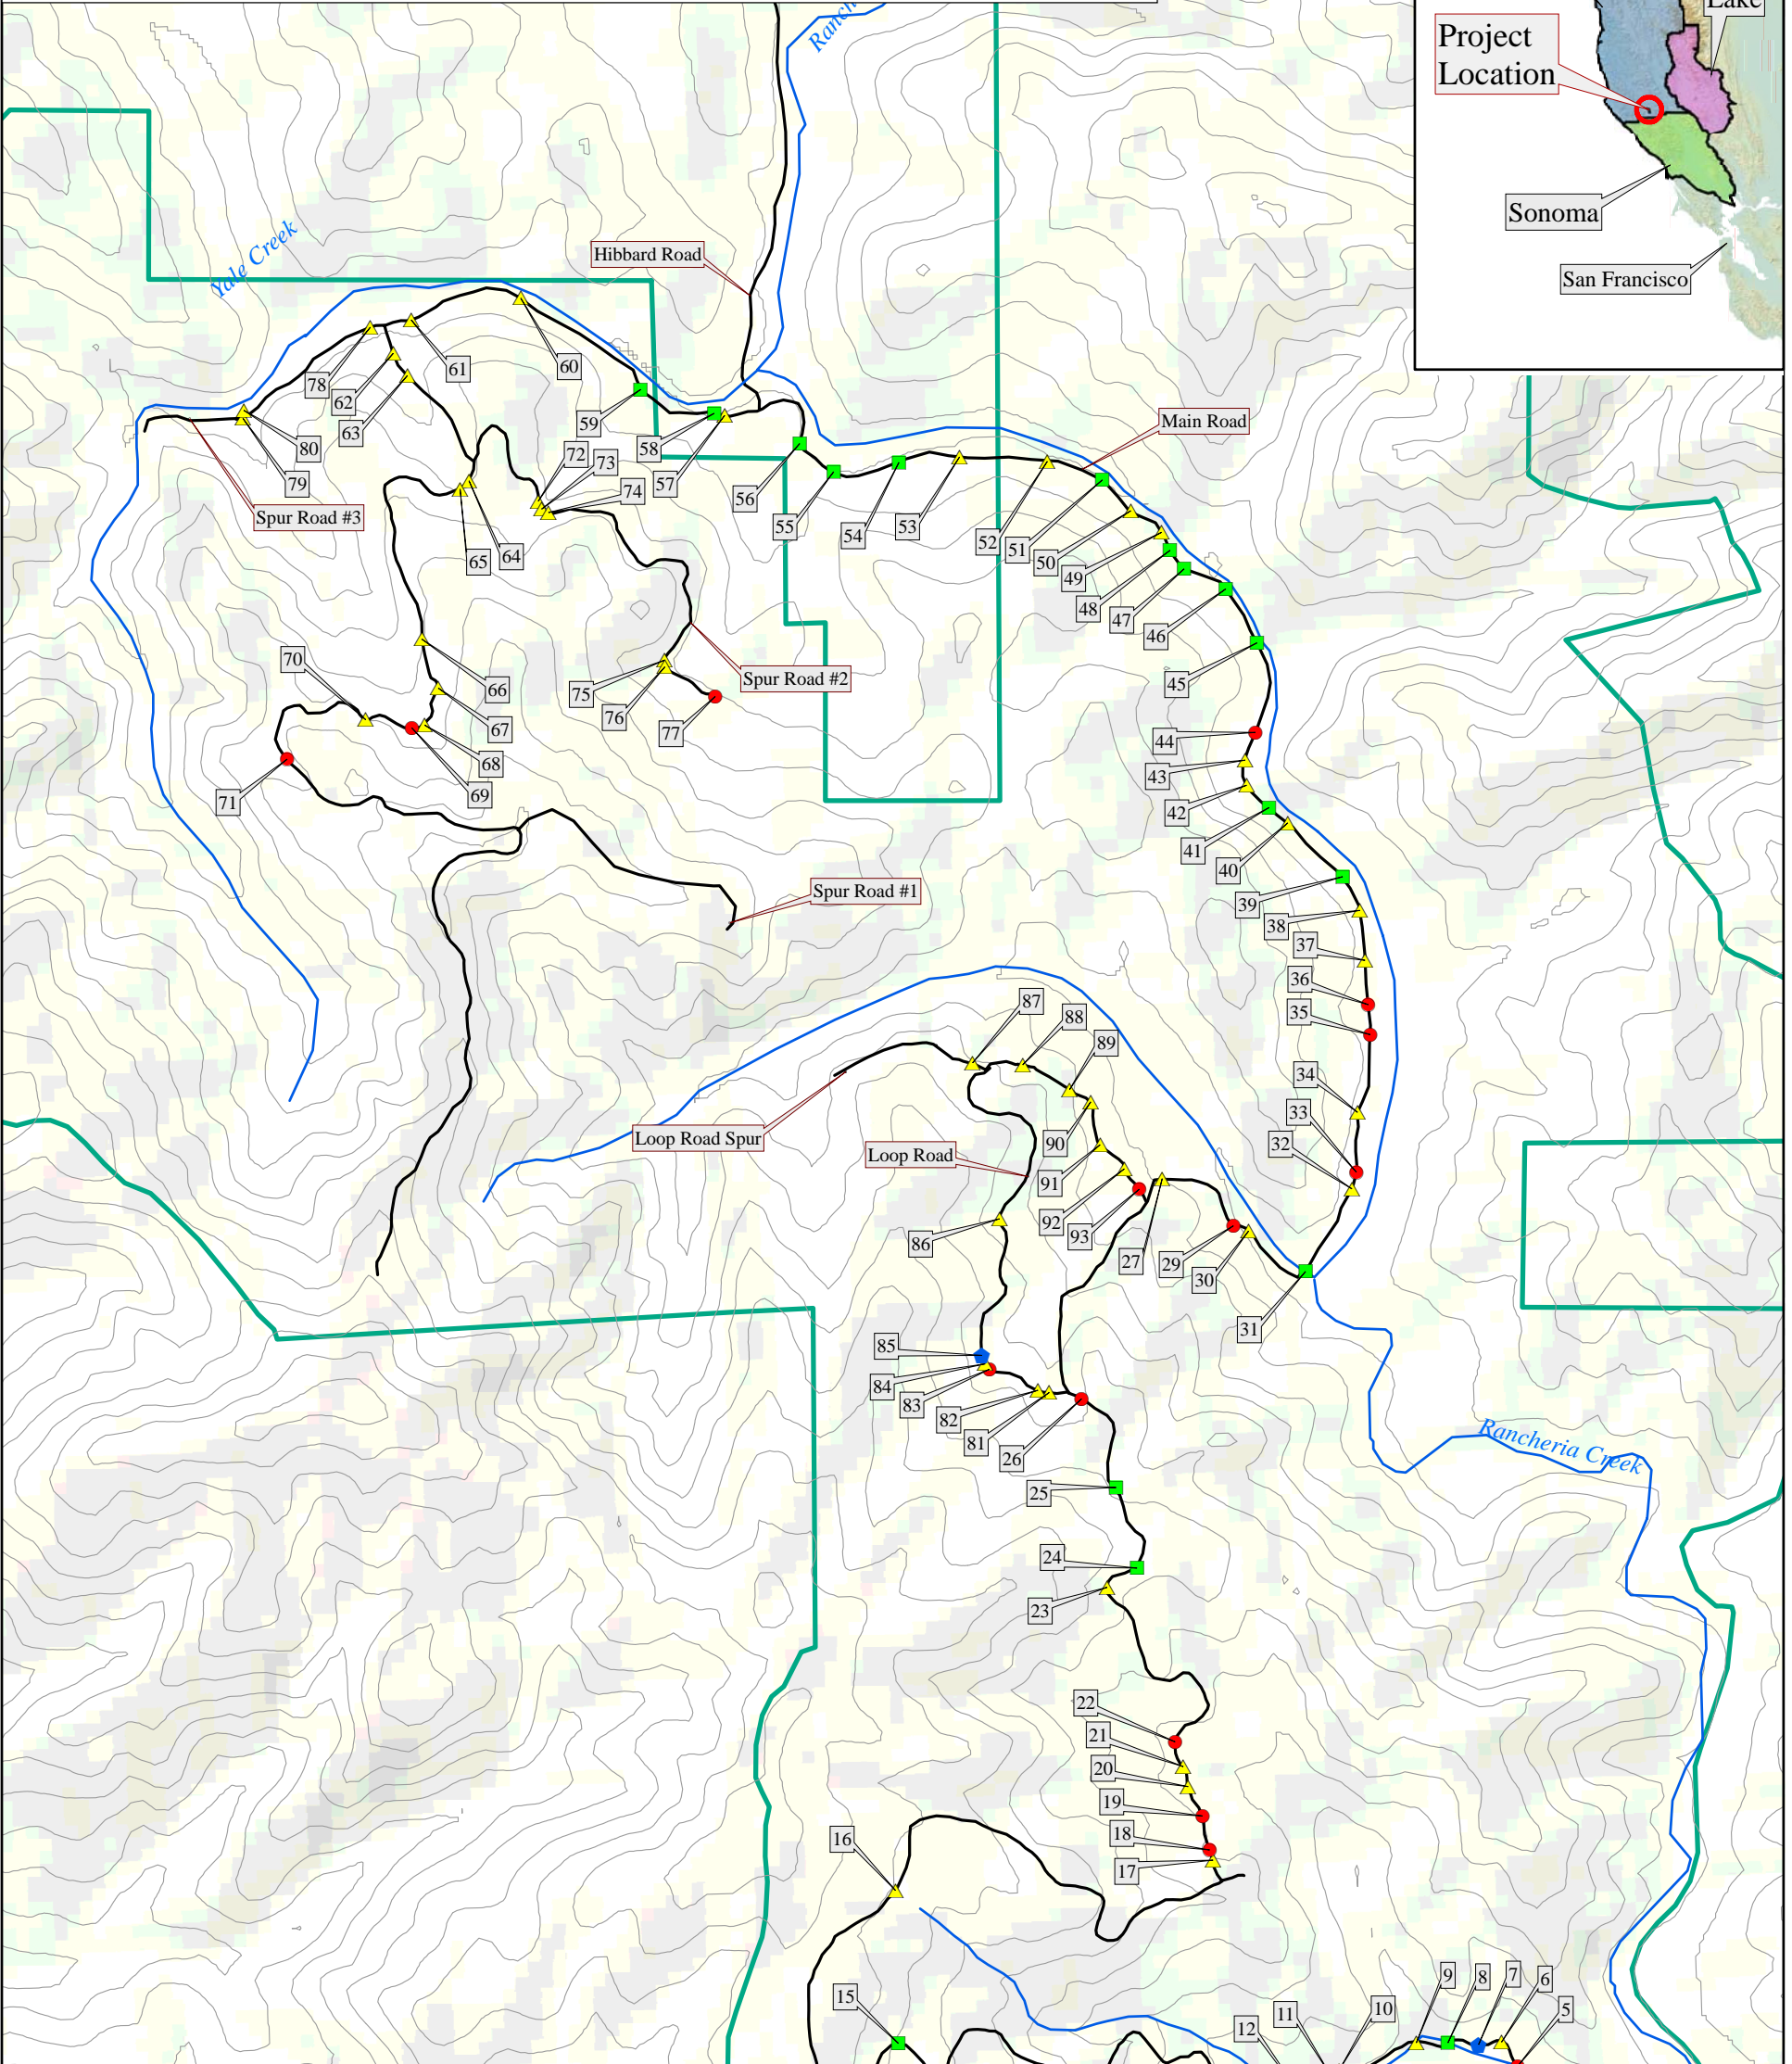
Figure 3. Sites by treatment immediacy. Galbreath Wildlands Preserve Road Drainage Improvements Project, Mendocino County, California.

Of the 90 inventoried sites that we recommend for treatment, we designate 16 with priority ratings of high or high-moderate (Figure 3; Table 4). The potential sediment delivery for these 16 sites is approximately 2,160 yd³, which equates to nearly 20% of the expected sediment savings for the GWP. We assign moderate or moderate-low priorities to 57 sites, which accounts for approximately 6,650 yd³, or nearly 60% of the expected sediment savings. Finally, we assign a low priority to 17 sites, which accounts for approximately 2,200 yd³, or nearly 20% of the expected future sediment delivery.
